INVESTIGATION NO. 3000
THE NASHVILLE, CHATTANOOGA & ST. LOUIS
RAILWAY COMPANY
REPORT IN RE ACCIDENT
AT ATLANTA, GA., ON
JULY 8, 1946

Railroad: Nashville, Chattanooga & St. Louis
Date: July 8, 1946
Location: Atlanta, Ga.
Kind of accident: Rear-end collision
Trains involved: L. & N. freight : A. C. L. passenger
Train numbers: Extra 1337 North : 112
Engine numbers: 1337 : 7351
Consist: 15 cars, caboose : 7 cars
Estimated speed: Standing : 12 m. p. h.
Operation: Timetable and automatic block-signal system; yard limits
Track: Double; 4°03' curve; 0.51 percent descending grade northward
Weather: Clear
Time: 1:52 a. m.
Casualties: 13 injured
Cause: Failure properly to control speed of following train in accordance with signal indications

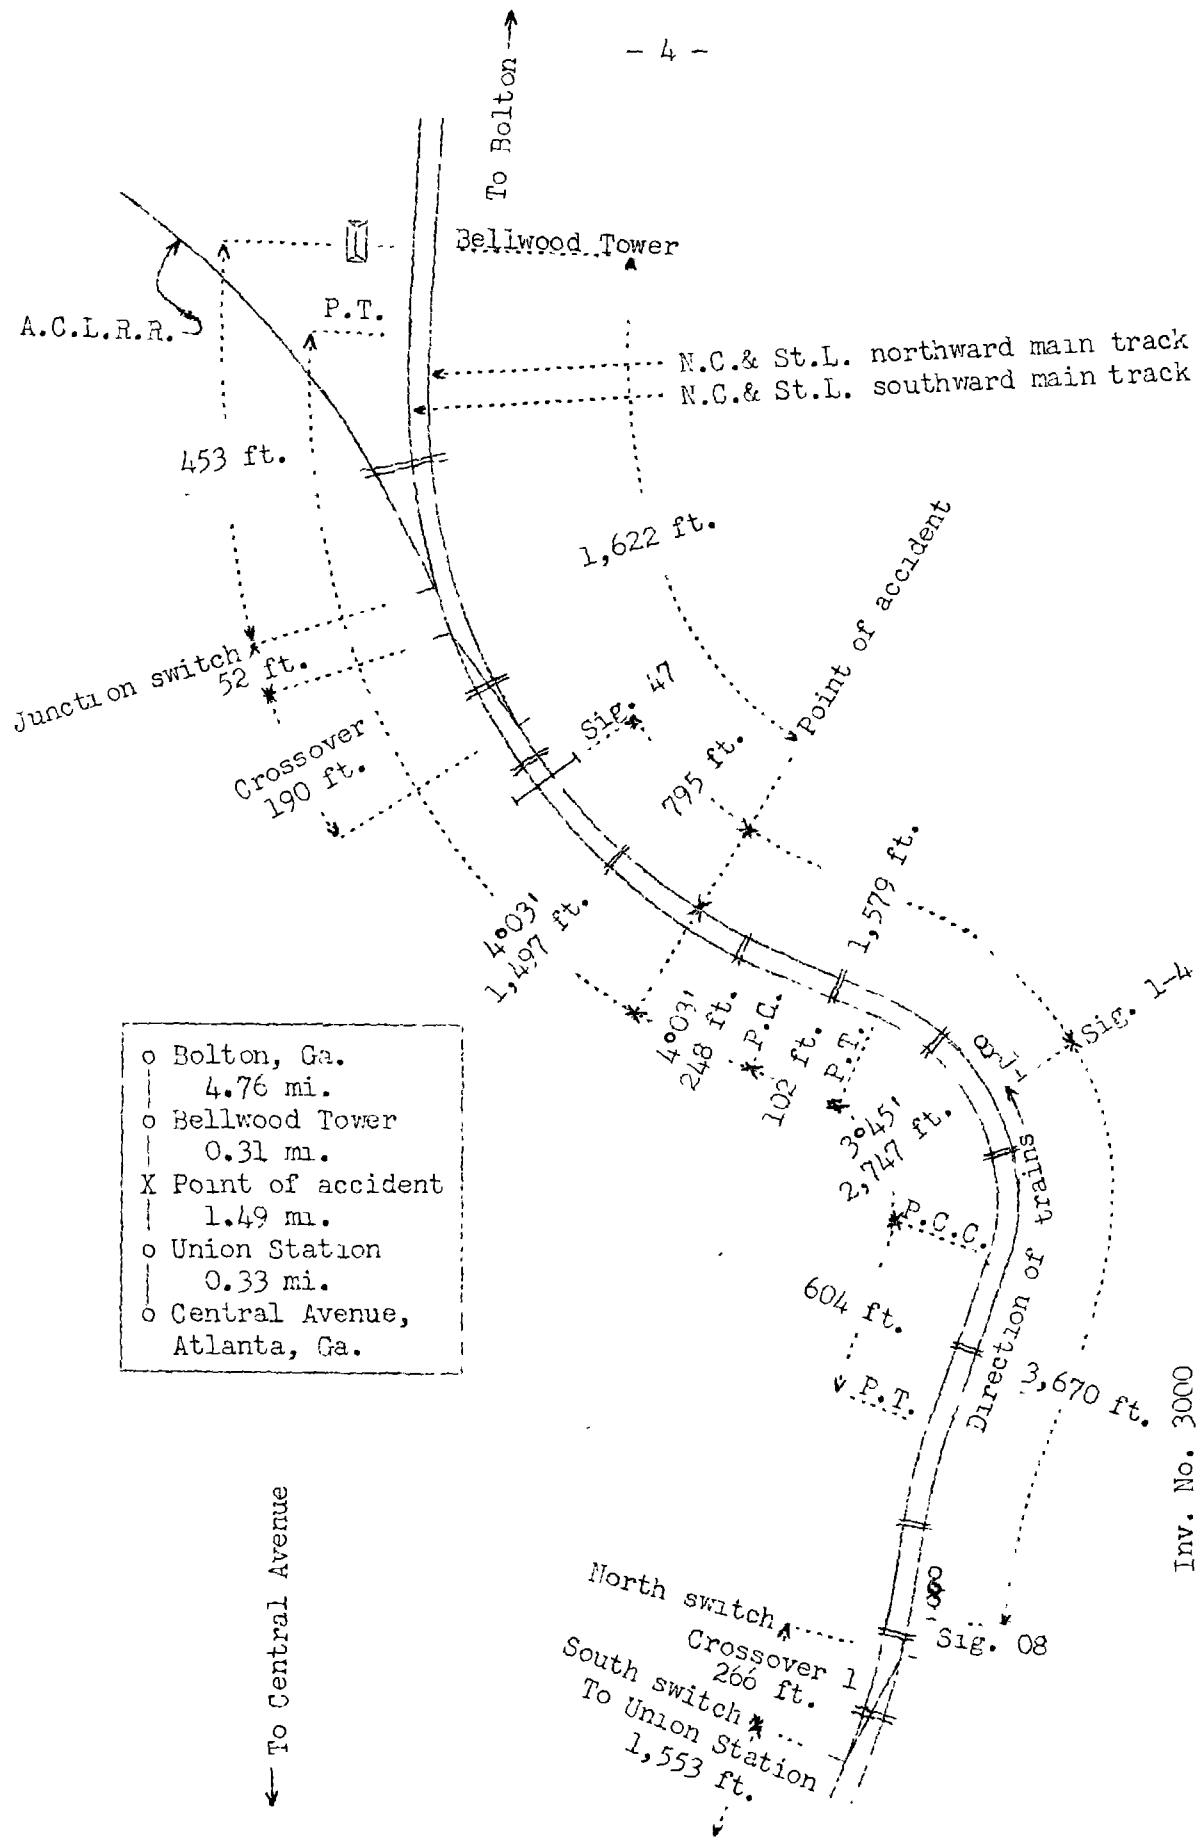
Inv. No. 3000
 Nashville, Chattanooga & St. Louis Railway
 Atlanta, Ga.
 July 8, 1946

- o Bolton, Ga. 4.76 mi.
- o Bellwood Tower 0.31 mi.
- X Point of accident 1.49 mi.
- o Union Station 0.33 mi.
- o Central Avenue, Atlanta, Ga.

Location of Accident and Method of Operation

This accident occurred on the Atlanta Terminal Division, which extends between Central Avenue, Atlanta, and Bolton, Ga., 6.82 miles. In the vicinity of the point of accident this is a double-track line over which movements with the current of traffic are operated by timetable and an automatic block-signal system. The accident occurred within yard limits on the northward main track, at a point 1.82 miles north of Central Avenue, 1.49 miles north of Union Station, Atlanta, and 1,322 feet south of Bellwood Tower. Trains of the L. & N. are regularly operated over this line, and trains of the A.C.L. are regularly operated over that portion of the line extending between Union Station and Bellwood Tower. From the south there are, in succession, a tangent 604 feet in length, a compound curve to the left, the maximum curvature of which is 3°45', 2,747 feet, a tangent 102 feet and a 4°03' curve to the right 248 feet to the point of accident and 1,497 feet northward. The grade for north-bound trains varies between 0.13 percent and 0.89 percent descending throughout a distance of 4,790 feet, then it is, successively, level 310 feet, 0.43 percent descending 300 feet, 0.70 percent descending 600 feet and 0.51 percent descending 253 feet to the point of accident and 247 feet northward.
