INVESTIGATION NO. 2744
THE NASHVILLE, CHATTANOOGA & ST. LOUIS
RAILWAY COMPANY

REPORT IN RE ACCIDENT
AT CHATTANOOGA, TENN., ON
NOVEMBER 22, 1943

Accident at Chattanooga, Tenn., on November 22, 1943, caused by the absence of a light with which the switch was normally equipped, and by failure properly to control speed of a yard engine moving within yard limits.

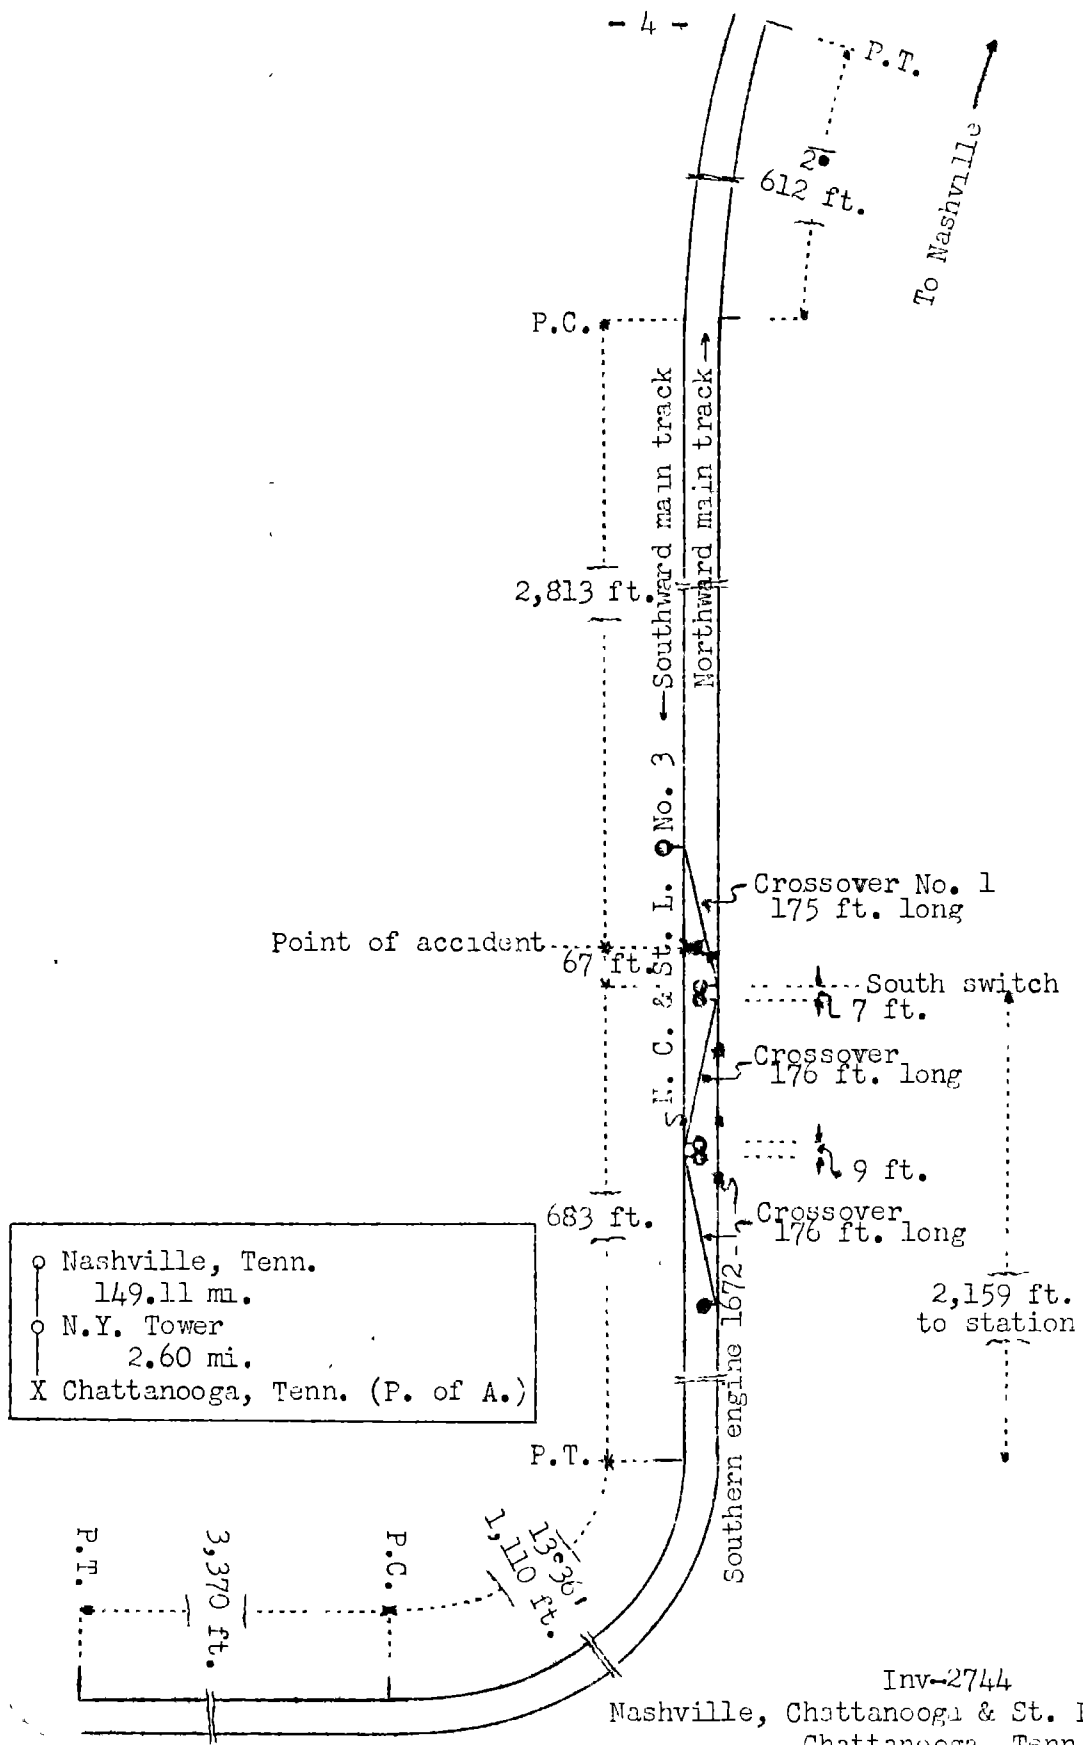
o Nashville, Tenn.
 149.11 mi.
 o N.Y. Tower
 2.60 mi.
 X Chattanooga, Tenn. (P. of A.)

This accident occurred on that part of the Chattanooga Division extending between Nashville and Chattanooga, Tenn., 151.71 miles. In the vicinity of the point of accident this was a double-track line, within yard limits, over which trains were operated by timetable and train orders. There was no block system in use. Between N. Y. Tower and East End Avenue, respectively, 2.6 miles north and 1.14 miles south of Chattanooga, trains and yard engines of the Southern Railway, hereinafter referred to as the Southern, were operated over the tracks of the Nashville, Chattanooga & St. Louis Railway, hereinafter referred to as the N. C. & St. L. In the vicinity of the point of accident three crossovers connected the northward and the southward main tracks. The most northerly crossover, 175 feet in length, was facing-point for movements with the current of traffic, and its south switch was 2,159 feet north of the station. The accident occurred on the southward main track at the fouling point of crossover No. 1, 67 feet north of the south switch. From the north there was a tangent 2,815 feet to the point of accident. From the south there were, in succession, a tangent 3,370 feet in length, a $13^{\circ}36'$ curve to the left 1,110 feet, a tangent 683 feet and a turnout to the left 67 feet to the point of accident. The grade was practically level.
