INVESTIGATION NO. 2686  
THE NASHVILLE, CHATTANOOGA & ST. LOUIS  
RAILWAY COMPANY  
REPORT IN RE ACCIDENT  
AT GORMAN, TENN., ON  
MARCH 17, 1945

Accident at Gorman, Tenn., on March 17, 1943, caused by  
train fouling the main track immediately in front of  
an opposing superior train.

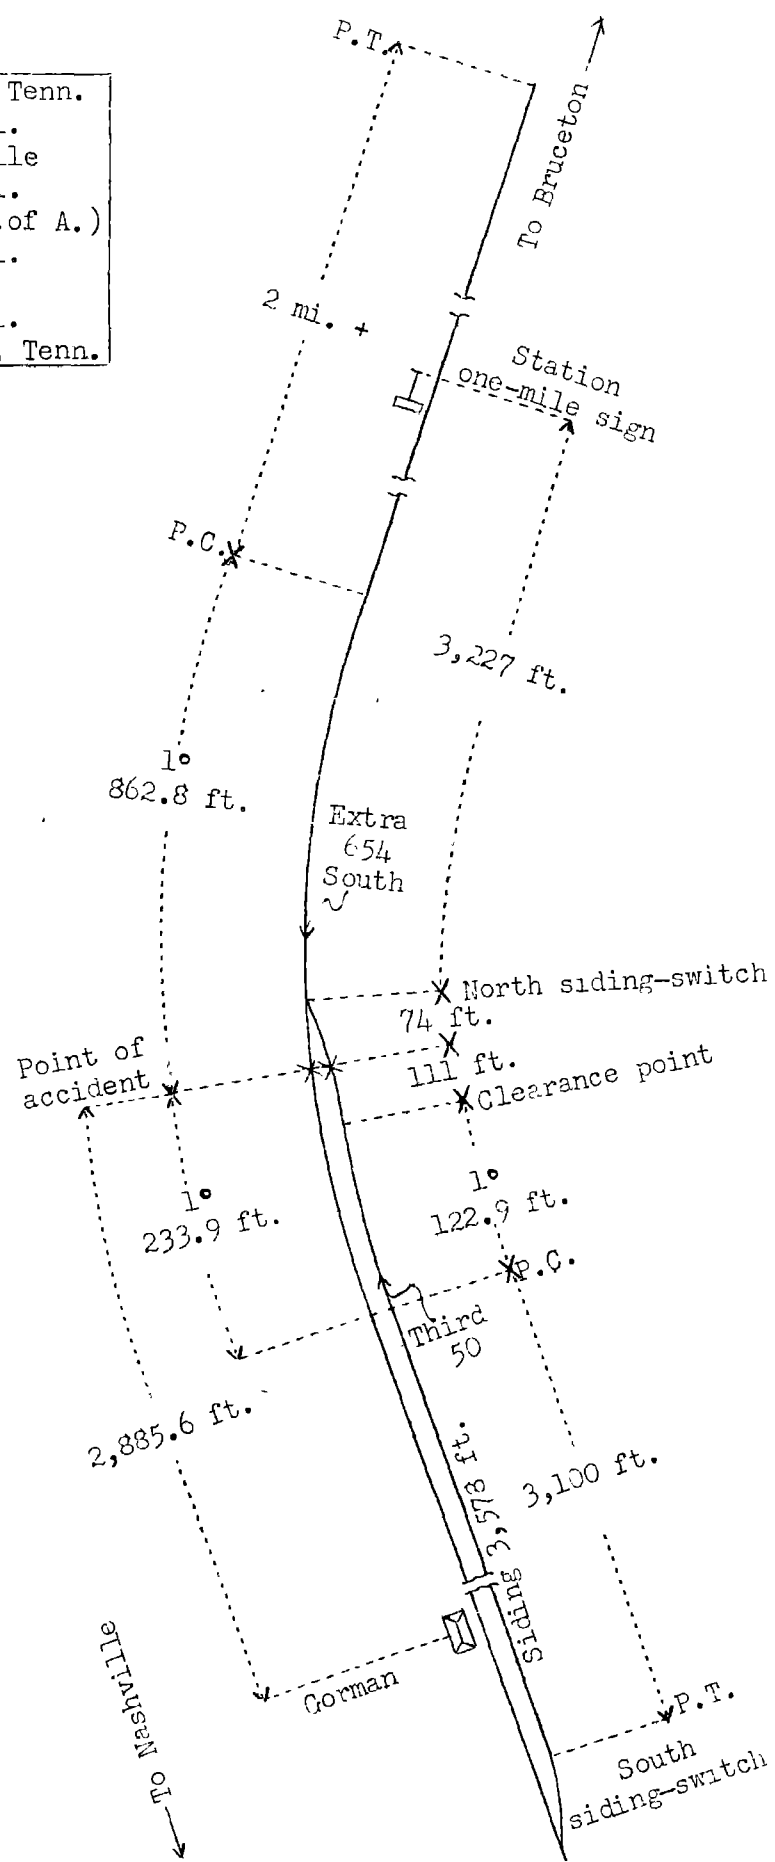
Inv. No. 2686  
 Nashville, Chattanooga & St. Louis Railway  
 Gorman, Tenn.  
 March 27, 1943

o	Bruceton, Tenn.	17.15 mi.
o	Johnsonville	15.90 mi.
x	Gorman (P. of A.)	22.20 mi.
o	Colesburg	39.62 mi.
o	Nashville, Tenn.

Location of Accident and Method of Operation
