ACCIDENT NO. 2571
THE NORTHEAST, CHATTANOOGA & ST. LOUIS
RAILWAY COMPANY
REPORT IN RE ACCIDENTS
AT HOOVER, GA., ON
MARCH 1, 1942

Kind of accidents: Derailments

Track: Double; 6°38' curve to left; 1.21
percent descending grade southward

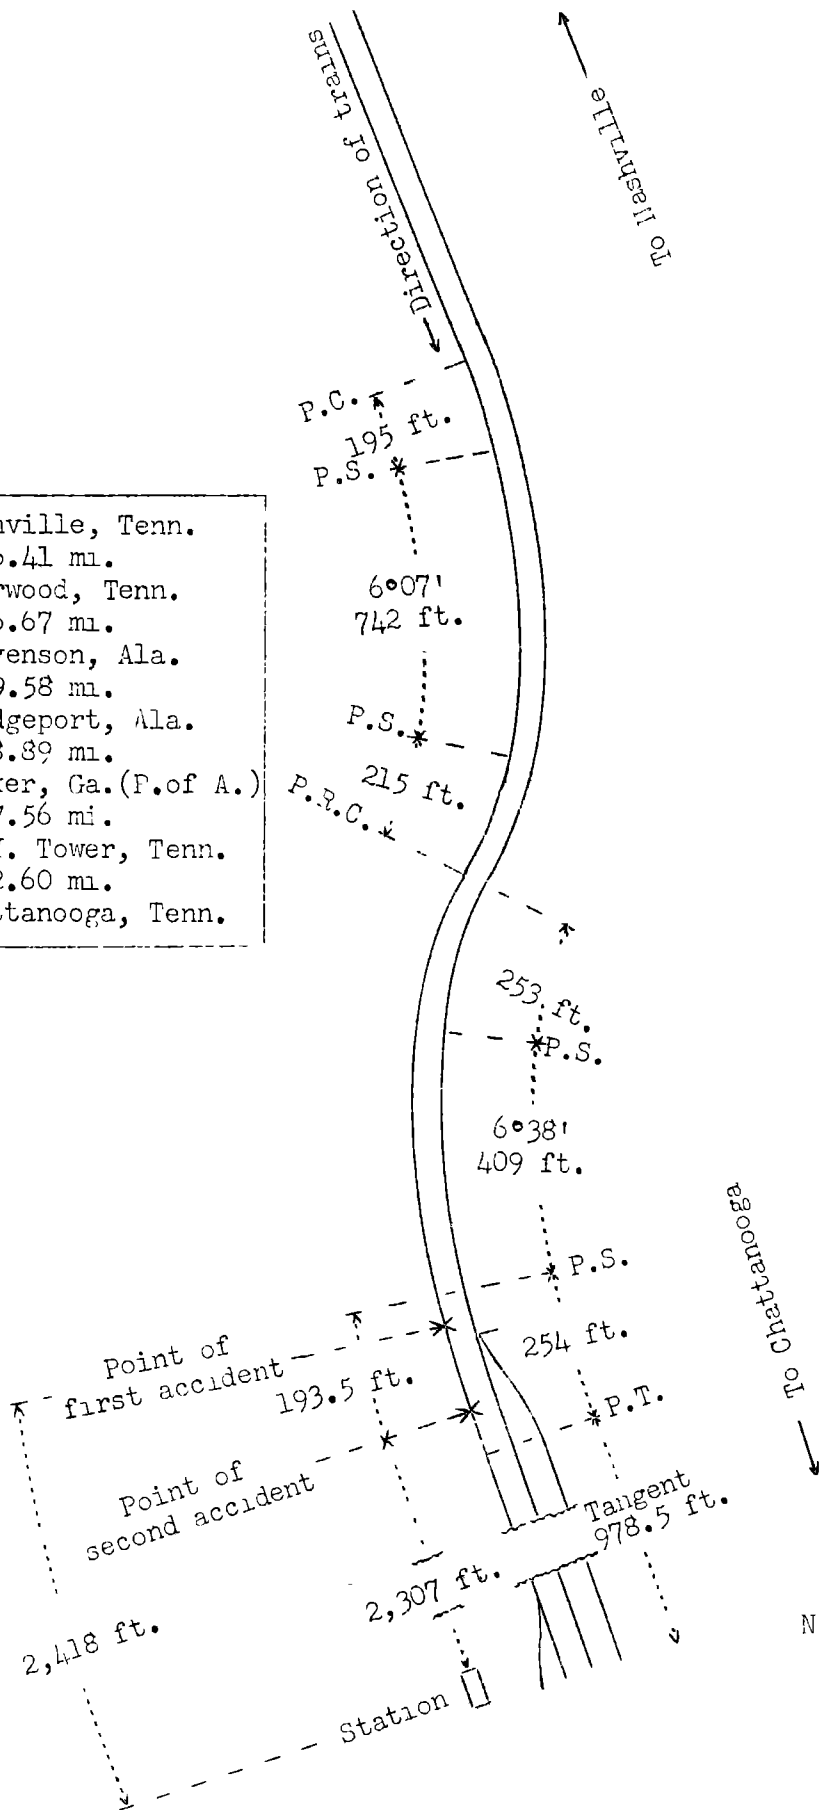
Inv-2574
N., C. & St. L. Ry.
Hooker, Ga.
March 1, 1942

- o Nashville, Tenn. 96.41 mi.
- o Sherwood, Tenn. 16.67 mi.
- o Stevenson, Ala. 9.58 mi.
- o Bridgeport, Ala. 18.89 mi.
- X Hooker, Ga. (P. of A.) 7.56 mi.
- o N. Y. Tower, Tenn. 2.60 mi.
- o Chattanooga, Tenn.

Location of Accident and Method of Operation
