INVESTIGATION NO. 2862
THE NEW YORK & LONG BRANCH RAILROAD COMPANY
REPORT IN RE ACCIDENT
AT RED BANK, N. J., ON
JANUARY 18, 1945

Railroad: New York & Long Branch
Date: January 18, 1945
Location: Red Bank, N. J.
Kind of accident: Side collision
Trains involved: Freight : Passenger
Train numbers: C. N. J. Extra : C. N. J. 3330
863 East
Engine numbers: 863 : 754
Consist: 55 cars, caboose : 5 cars
Estimated speed: Standing : 35 m. p. h.
Operation: Timetable, train orders and an
automatic block-signal and a
cab-signal system
Track: Double; 1°50' curve; 0.456 percent
ascending grade eastward
Weather: Clear
Time: 9:25 p. m.
Casualties: 1 killed; 28 injured
Cause: Derailed cars obstructing adjacent
main track immediately in front
of approaching passenger train

Accident at Red Bank, N. J., on January 18, 1945, caused
by derailed cars obstructing adjacent main track
immediately in front of an approaching passenger
train.

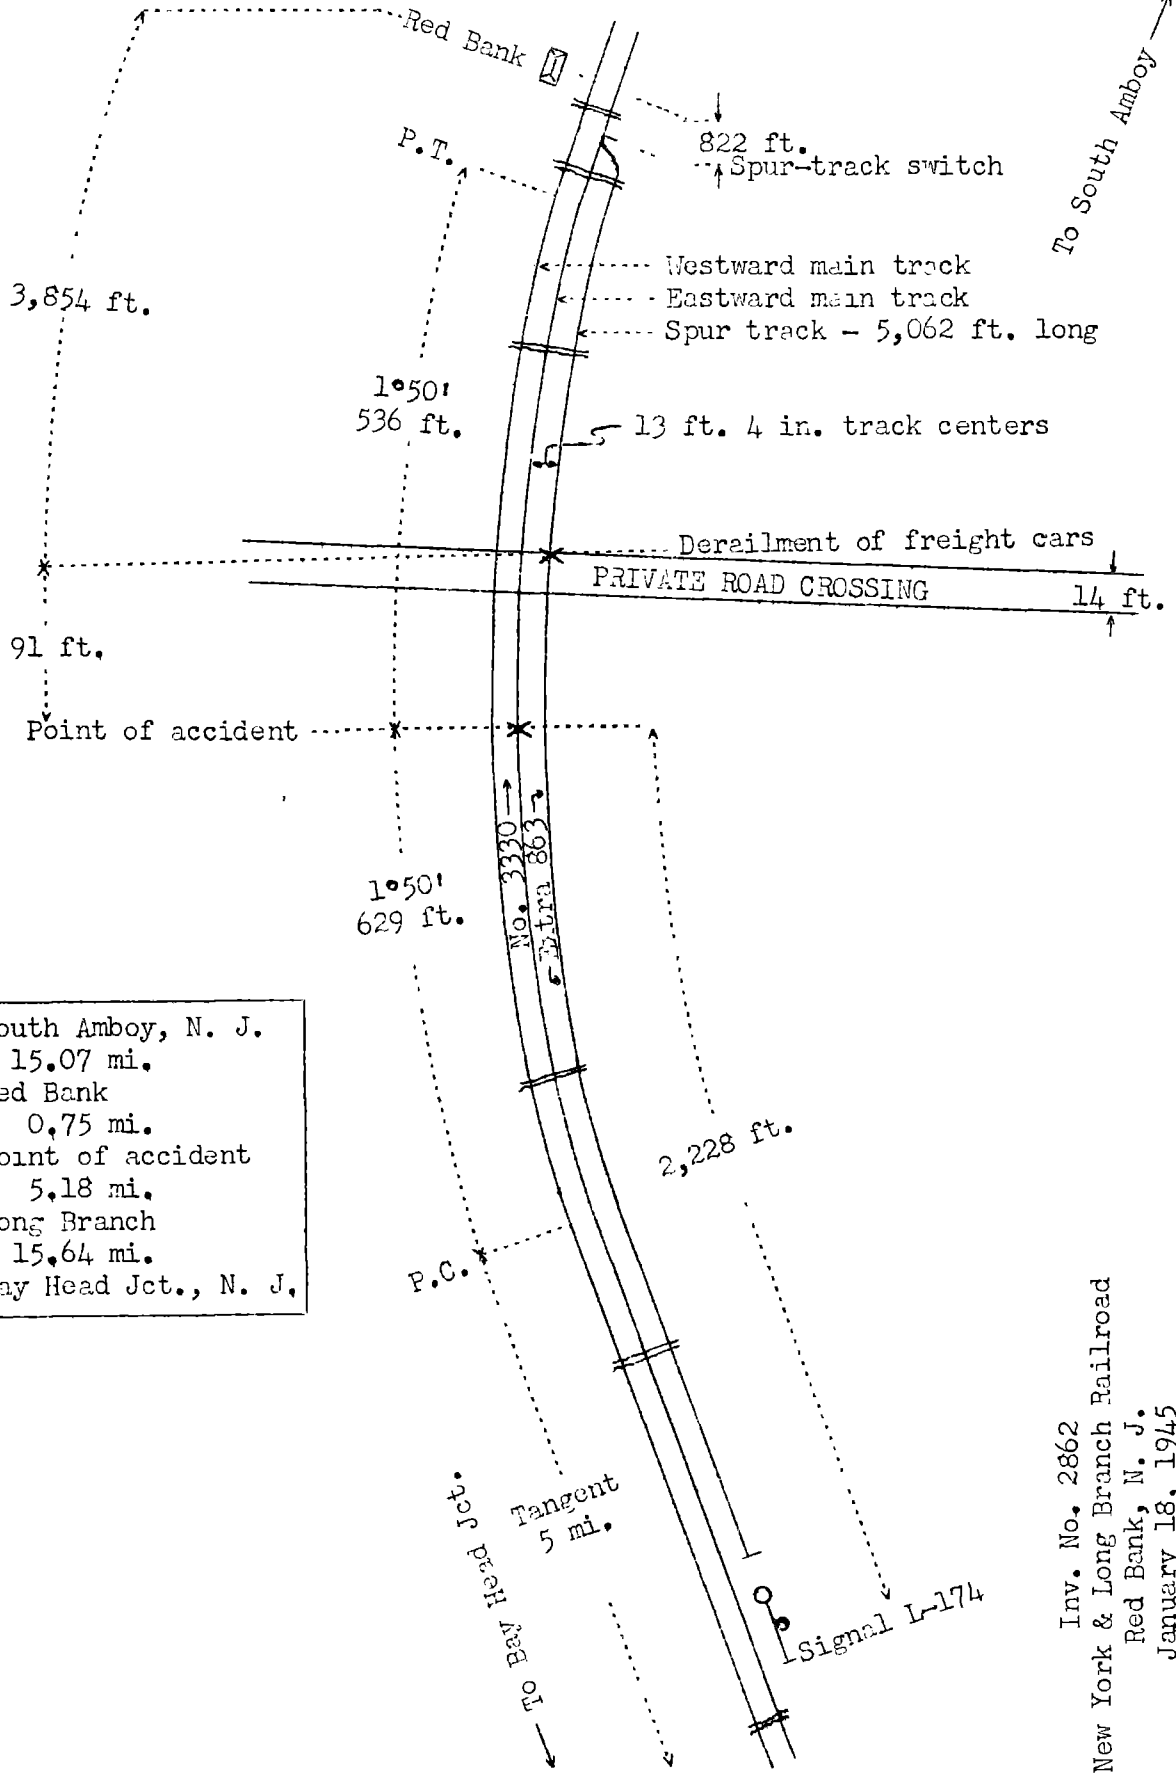
Inv. No. 2862
 New York & Long Branch Railroad
 Red Bank, N. J.
 January 18, 1945

To South Amboy →

To Bay Head Jct. ↓

| ○ | South Amboy, N. J. | 15.07 mi. |
| ○ | Red Bank | 0.75 mi. |
| X | Point of accident | 5.18 mi. |
| ○ | Long Branch | 15.64 mi. |
| ○ | Bay Head Jct., N. J. | |

Location of Accident and Method of Operation
