INVESTIGATION NO. 2845
THE NEW YORK CENTRAL RAILROAD COMPANY
REPORT IN RE ACCIDENT
NEAR CORFU, N. Y., ON
NOVEMBER 15, 1944

Accident near Corfu, N. Y., on November 15, 1944, caused
by failure to provide adequate protection for the
movement of the front and rear portions of a train
which had parted.

Inv. No. 2845
 New York Central Railroad
 Corfu, N. Y.
 November 15, 1944

Location of Accident and Method of Operation

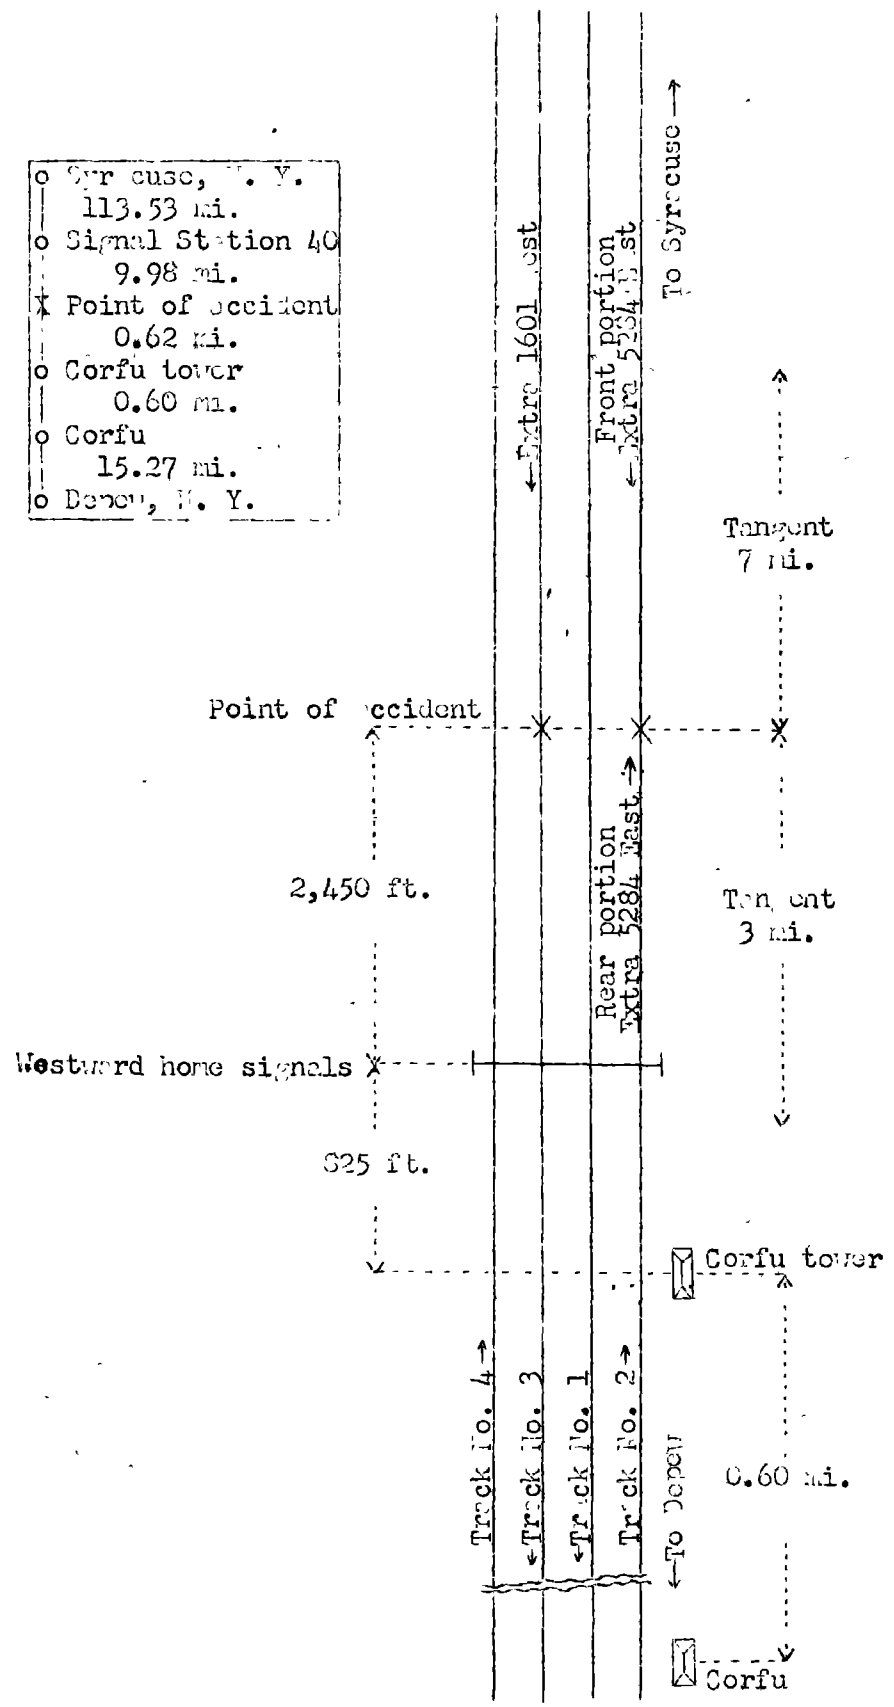
- o Syracuse, N. Y. 113.53 mi.
- o Signal Station 40 9.98 mi.
- x Point of accident 0.62 mi.
- o Corfu tower 0.60 mi.
- o Corfu 15.27 mi.
- o Berou, N. Y.

Westward home signals governing the use of routes of the interlocking at Corfu were located 825 feet east of the tower.
