INTERSTATE COMMERCE COMMISSION

REPORT OF THE DIRECTOR OF THE BUREAU OF SAFETY CONCERNING AN
ACCIDENT ON THE NEW YORK CENTRAL RAILROAD AT KILE, OHIO,
ON FEBRUARY 7, 1935.

March 25, 1935.

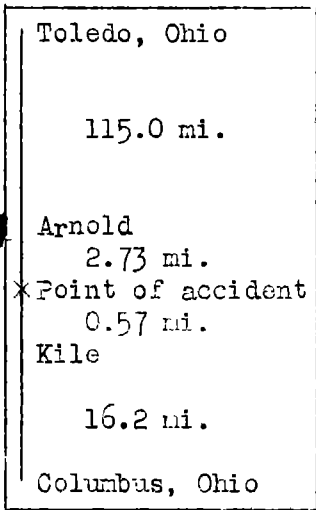
Inv. No. 1965
 New York Central R.R.
 Kile, Ohio
 Feb. 7, 1935

North switch of passing track

* Point of accident

2,453 ft.

South switch of passing track

562 ft.

Station

This accident occurred on that part of the Ohio Central Division extending between Columbus and Toledo, Ohio, a distance of 134.5 miles; in the vicinity of the point of accident this is a single-track line over which trains are operated by time table, train orders, and a manual block-signal system. A passing track parallels the main track on the east, the switches being located 562 feet and 5,514 feet north of the station; the accident occurred 2,453 feet north of the south switch. The track is tangent for several miles in both directions. The grade for north-bound trains is generally ascending for several miles; at Kile the grade is practically level, followed by 0.1 percent descending grade for approximately 7,000 feet and then ascending grade varying from 0.2 to 0.5 percent to Arnold, a station 3.3 miles north of Kile.
