INVESTIGATION NO. 2648
THE NEW YORK CENTRAL RAILROAD COMPANY
REPORT IN RE ACCIDENT
NEAR OSSING, N. Y., ON
NOVEMBER 11, 1942

Railroad: New York Central
Date: November 11, 1942
Location: Ossining, N. Y.
Kind of accident: Rear-end collision
Trains involved: Express : Freight
Train numbers: Extra 316 West : Extra 309 West
Engine numbers: 316 : 309
Consist: 18 cars : 33 cars, caboose
Speed: Standing : 35-40 m. p. h.
Operation: Signal indications; accident
occurred within yard limits
Track: Four tracks; tangent;
practically level
Weather: Clear
Time: 1:08 a. m.
Casualties: 2 killed; 10 injured
Cause: Accident caused by failure to provide adequate flag protection for preceding train, and by failure to operate following train in conformity with yard-limit rule and signal indications

Inv-2648
 New York Central Railroad
 Ossining, N. Y.
 November 11, 1942

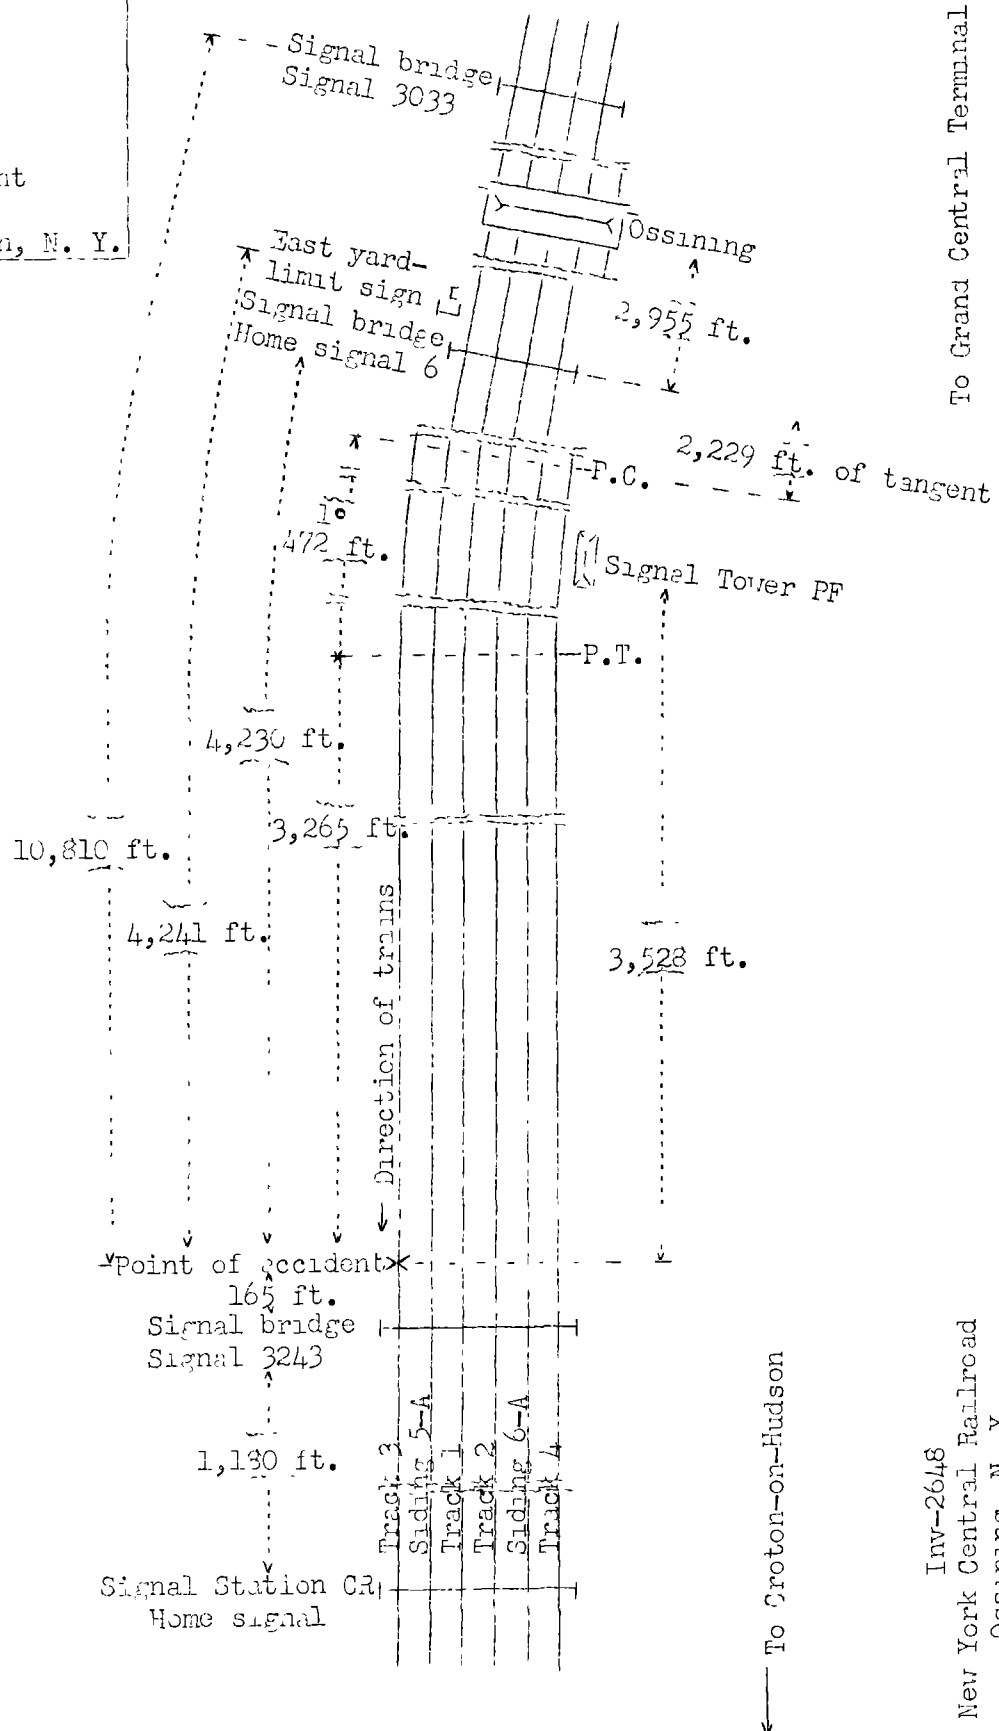
- o New York City, N. Y.
Grand Central Terminal
10.41 mi.
- o Spuyten Duyvil
19.76 mi.
- o Ossining
1.36 mi.
- X Point of accident
2.33 mi.
- o Croton-on-Hudson, N. Y.

To Grand Central Terminal ↑

↓ To Croton-on-Hudson

Location of Accident and Method of Operation
