INVESTIGATION NO. 3267  
THE NEW YORK CENTRAL RAILROAD COMPANY  
REPORT IN RE ACCIDENT  
NEAR PHILADELPHIA, N. Y., ON  
JULY 22, 1949

Accident near Philadelphia, N. Y., on July 22, 1949,  
caused by a train being admitted under clear-  
block authority to a block occupied by an  
opposing track motor-car.

On July 22, 1949, there was a head-end collision between a track motor-car and a passenger train on the New York Central Railroad near Philadelphia, N. Y., which resulted in the death of one maintenance-of-way employe.

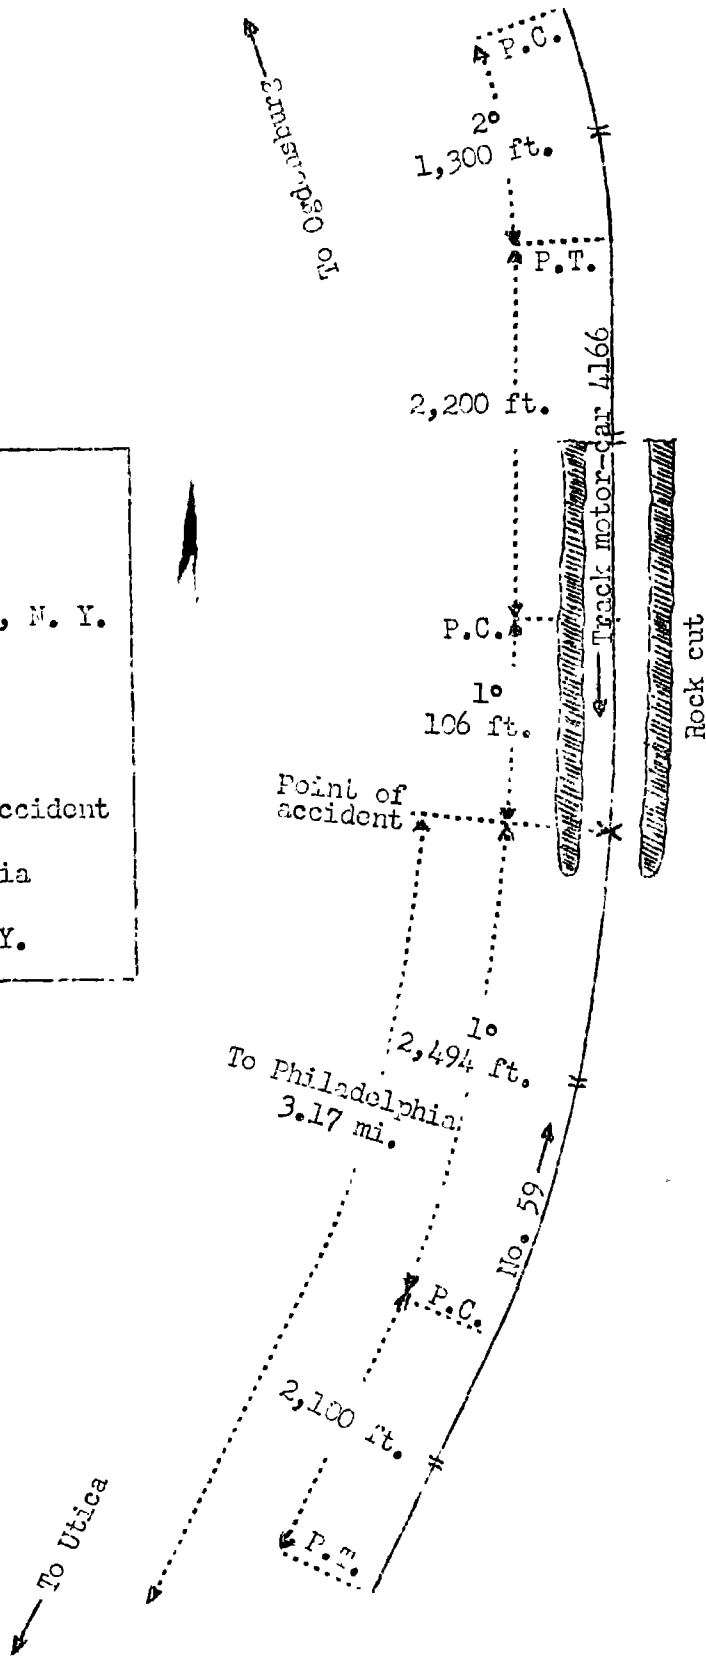
Inv. No. 3267  
 New York Central Railroad  
 Philadelphia, N. Y.  
 July 22, 1949

Location of Accident and Method of Operation
