INTERSTATE COMMERCE COMMISSION  
WASHINGTON

-----  
ACCIDENT ON THE  
NEW YORK CENTRAL RAILROAD

-----  
SYRACUSE, N. Y.

-----  
INVESTIGATION NO. 2245

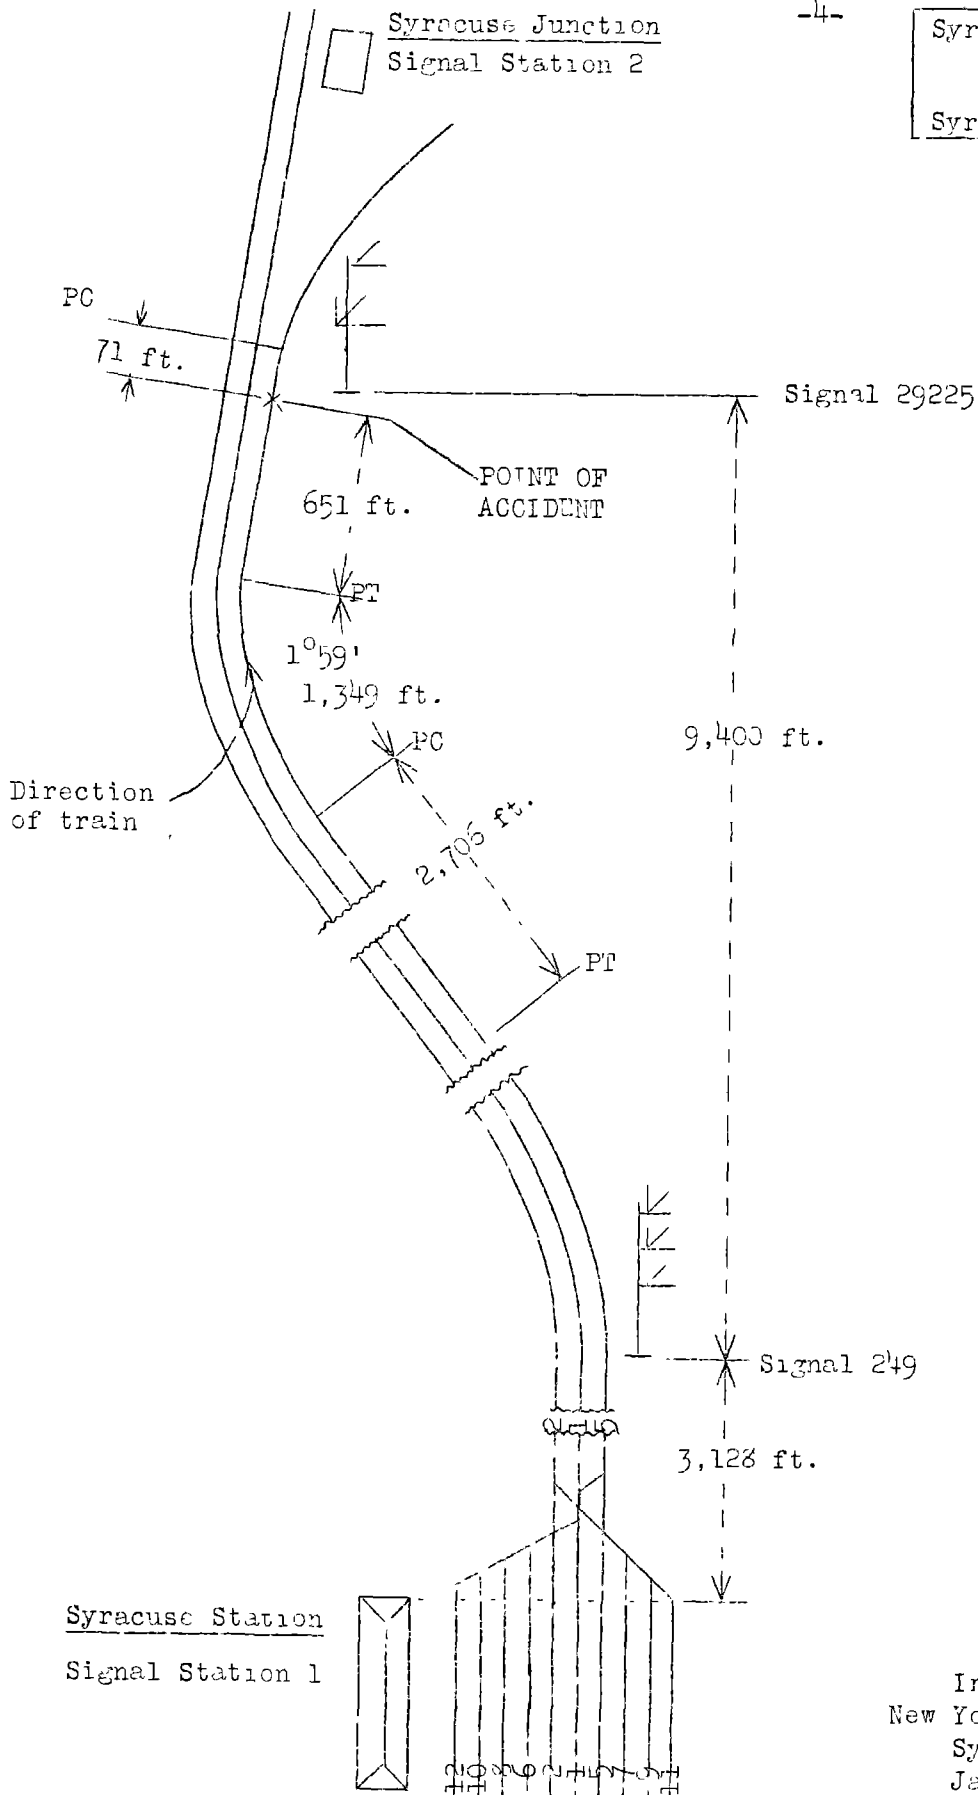
Inv. No. 2245  
 New York Central R.R.  
 Syracuse, N.Y.  
 Jan. 19, 1938

Syracuse Junction
3.32 miles
Syracuse

This accident occurred on that part of the Syracuse Division which extends between Syracuse and Syracuse Junction, N.Y., a distance of 3.32 miles. This is a 3-track line over which trains are operated by time-table and an automatic block-signal system; the automatic train-stop system of the intermittent-inductive type in use on the New York Central was not effective on the track involved in this accident. The tracks, numbered from south to north, are: 2, eastward; 1, westward; and 5, eastward and westward. The accident occurred on track 5 about 2.34 miles west of the station at Syracuse; Tracks 2, 1, and 5 extend through the station; three additional station tracks, lying to the north of track 5, and four other station tracks lying to the south of track 2, connect with the three main tracks just west of the depot. All movements through the station and from the station tracks are controlled by an electric interlocking of the all-relay type installed at signal station 1 located in the depot. The west limits of this plant are 4,800 feet west of the depot. From this point westward movements on track 5 are governed by an automatic block-signal; this automatic signal territory extends westward for a distance of about 2.25 miles to the east limits of interlocking signal station 2. The maximum authorized speed for all trains in this territory is 30 miles per hour.

The signals involved in this accident were west-bound interlocking signal 249, a semi-automatic 3-unit signal, mounted on a cantilever bridge, and signal 29225, a 2-unit automatic signal mounted on a high mast; these signals are located 3,128 feet and 12,528 feet, respectively, west of the depot, and both are approach-lighted, color-light signals of the search-light type. When the track governed by signal 29225 is occupied that signal displays two staggered red lights, indicating, "Stop; then proceed at restricted speed". When the track between signals 249 and 29225 is occupied, signal 249 displays red-over-red-over-red, indicating "Stop"; however, if the leverman has operated the lever controlling this signal, the restricted speed aspect is
