REPORT NO. 3687

THE NEW YORK CENTRAL RAILROAD COMPANY

IN RE ACCIDENT

AT QUINCY, OHIO, ON

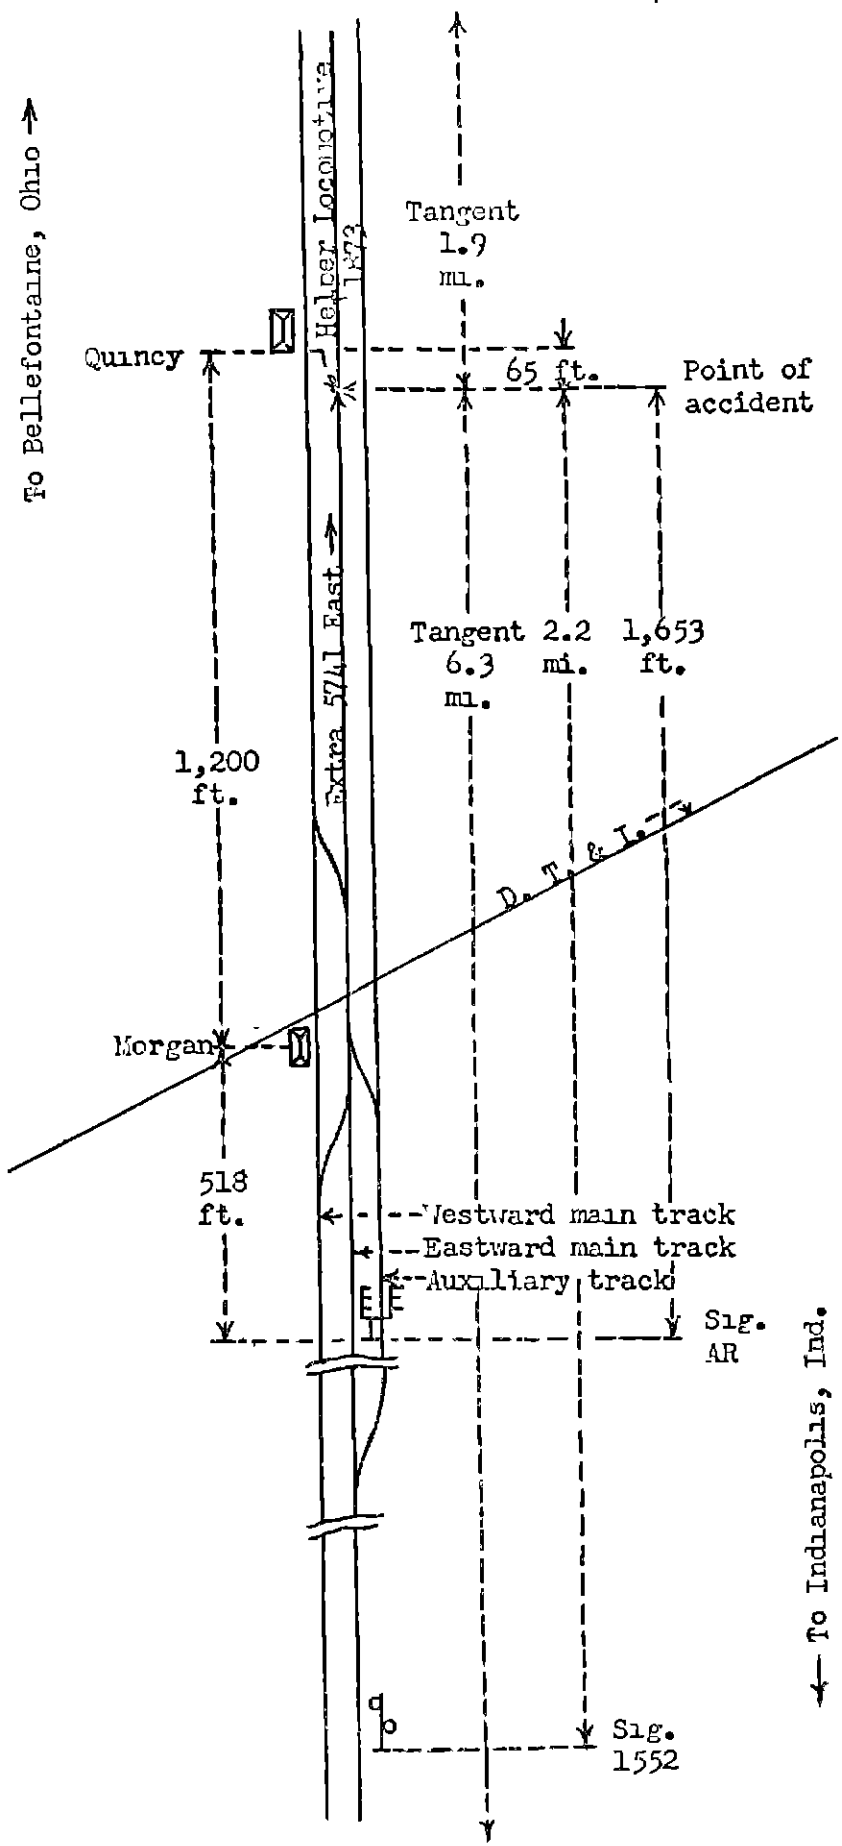
- Bellefontaine, Ohio 9.6 mi.
- DeGraff 2.9 mi.
- Quincy (Point of accident) 0.2 mi.
- Morgan 3.3 mi.
- Pemberton 2.5 mi.
- Mix 22.2 mi.
- Versailles 8.2 mi.
- Winchester 18.2 mi.
- Ansonia, Ohio 21.7 mi.
- Muncie, Ind. 3.1 mi.
- Hart 16.0 mi.
- South Anderson 29.1 mi.
- Eastwood 0.8 mi.
- Brightwood Yard 5.2 mi.
- Indianapolis, Ind.

← To Indianapolis, Ind.
