REPORT NO. 3621
THE NEW YORK CENTRAL RAILROAD COMPANY
IN RE ACCIDENT
NEAR SCHODACK LANDING, N. Y , ON
APRIL 2, 1955

Accident near Schodack Landing, N. Y., on April 2, 1955,
caused by a rock slide.

Report No. 3621
New York Central Railroad
Schodack Landing, N. Y.
April 2, 1955

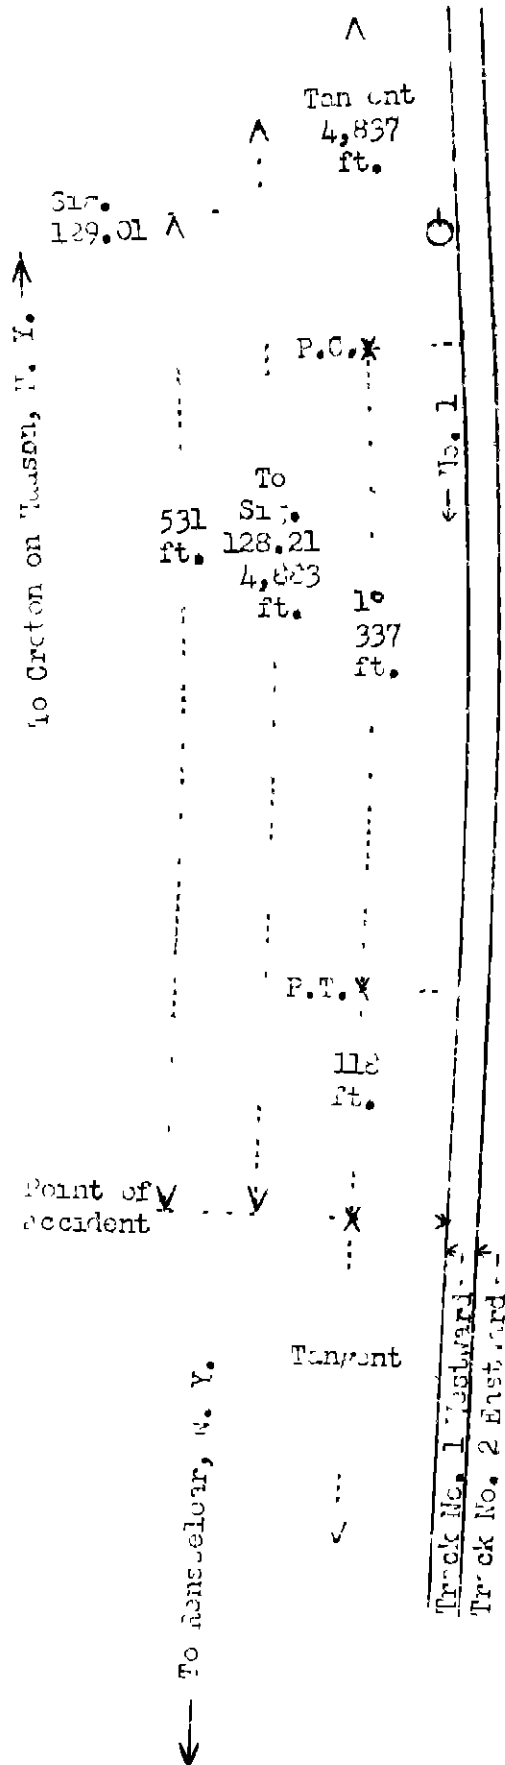
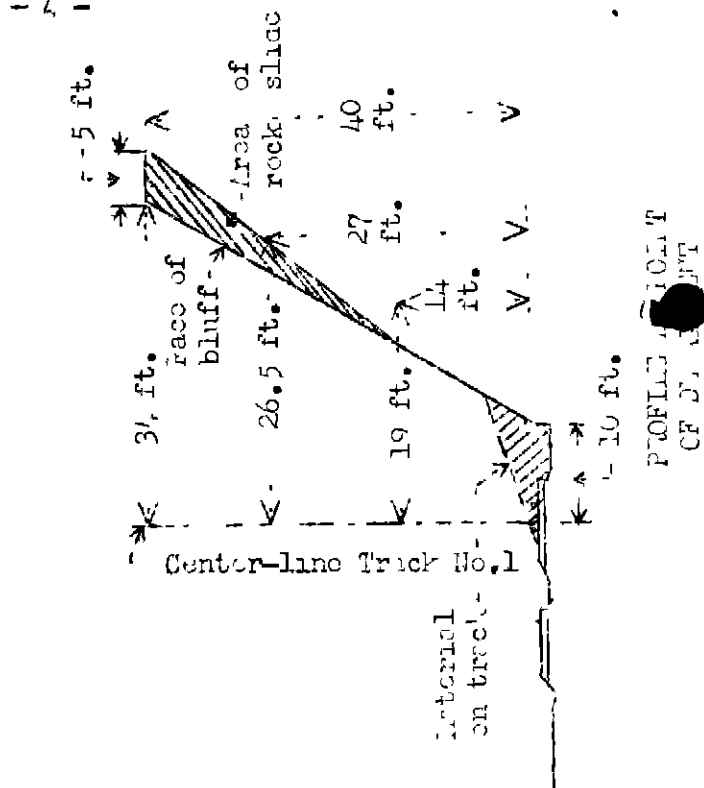
- Croton on Hudson, N. Y.
39.14 mi.
- SS 90 Stayvesant
5.37 mi.
- Point of accident
1.27 mi.
- Schodack Landing
11.97 mi.
- Rensselaer, N. Y.

This accident occurred on that part of the Hudson Division extending between Croton on Hudson and Rensselaer, N. Y., 107.75 miles. In the vicinity of the point of accident this is a double-track line, over which trains are operated by signal indications supplemented by an intermittent inductive automatic train-stop system. This division of the railroad follows the general course of the Hudson River, which flows southward. Timetable directions are east and west, and these directions are used in this report. The main tracks from south to north are designated as No. 2, eastward, and No. 1, westward. The accident occurred on track No. 1 at a point 94.51 miles west of Croton on Hudson and 1.27 miles east of the station at Schodack Landing. From the east on track No. 1 there are, in succession, a tangent 4,837 feet in length, a 1° curve to the right 337 feet, and a tangent 118 feet to the point of accident and a considerable distance westward. The grade is level.

Automatic signals 128.21 and 129.01, governing west-bound movements on track No. 1, are located, respectively, 4,883 feet and 531 feet east of the point of accident.
