REPORT NO. 3638

THE NEW YORK CENTRAL RAILROAD COMPANY

Accident at Syracuse, N. Y., on June 28, 1955, caused by
failure to operate the freight train in accordance
with signal indications.

Report No. 3638
 New York Central Railroad
 Syracuse, N. Y.
 June 28, 1955

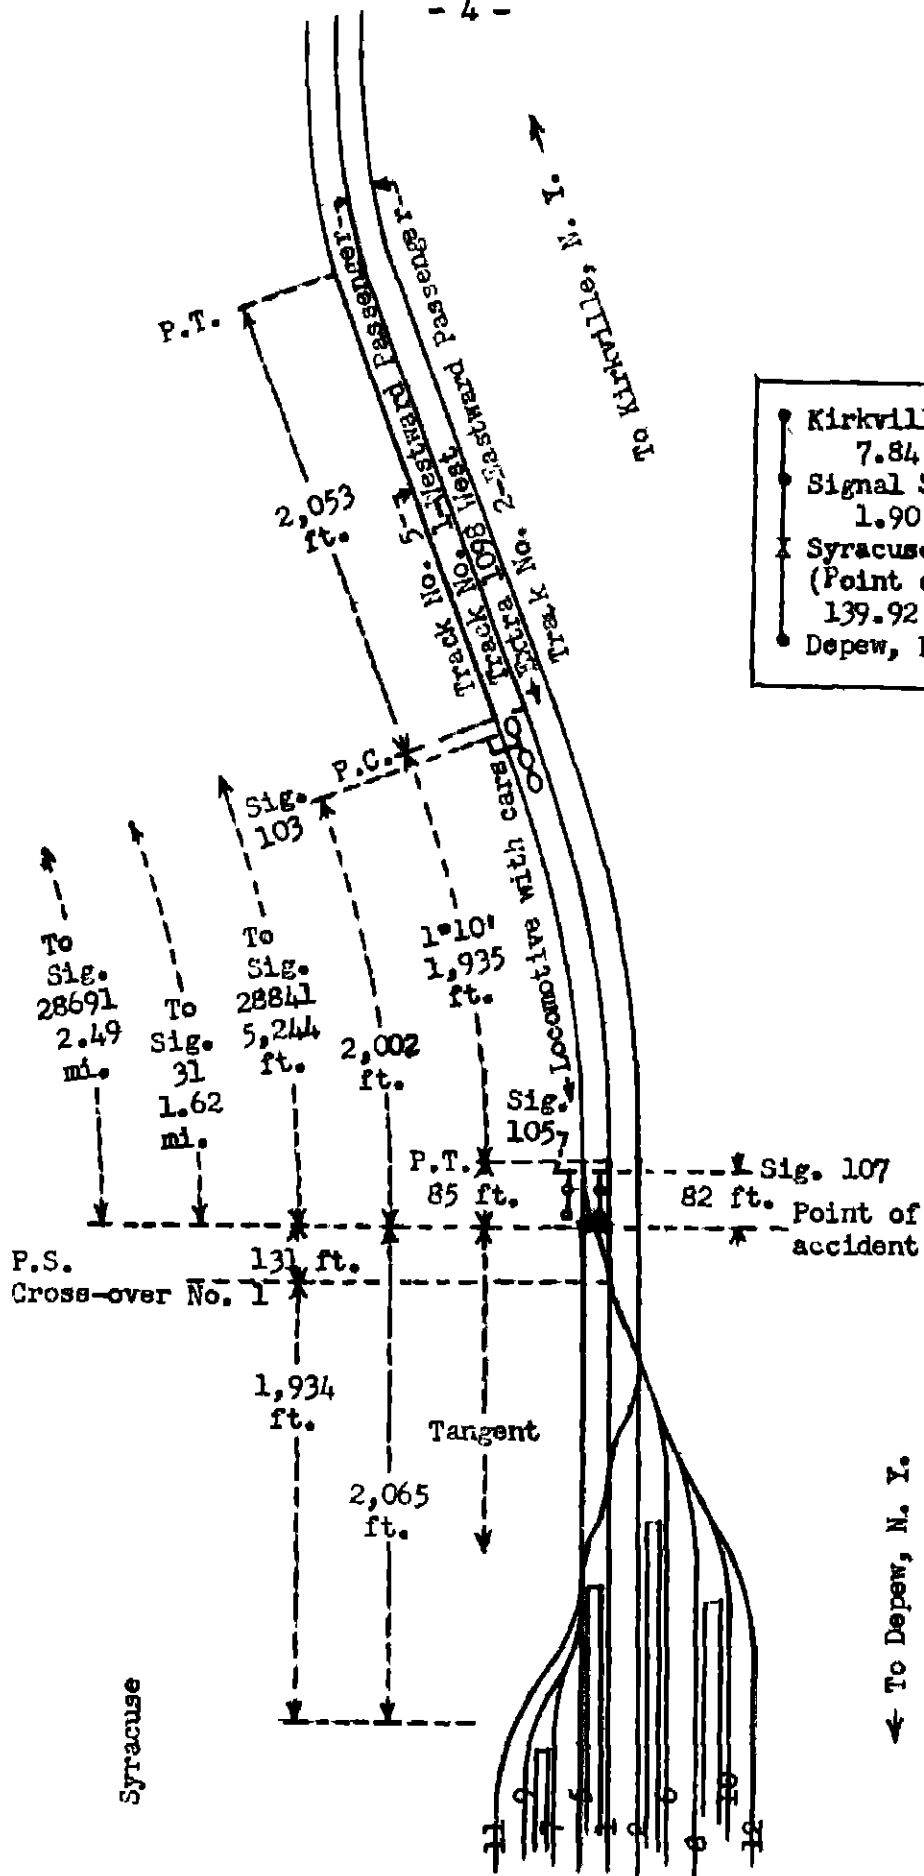
•	Kirkville, N. Y.
•	7.84 mi.
•	Signal Station 48
•	1.90 mi.
•	Syracuse
•	(Point of accident)
•	139.92 mi.
•	Depew, N. Y.
