**RAILROAD ACCIDENT INVESTIGATION**

**Report No 3774**

THE NEW YORK CENTRAL RAILROAD COMPANY

Accident at Syracuse, N Y , on August 25, 1957, caused by a broken journal

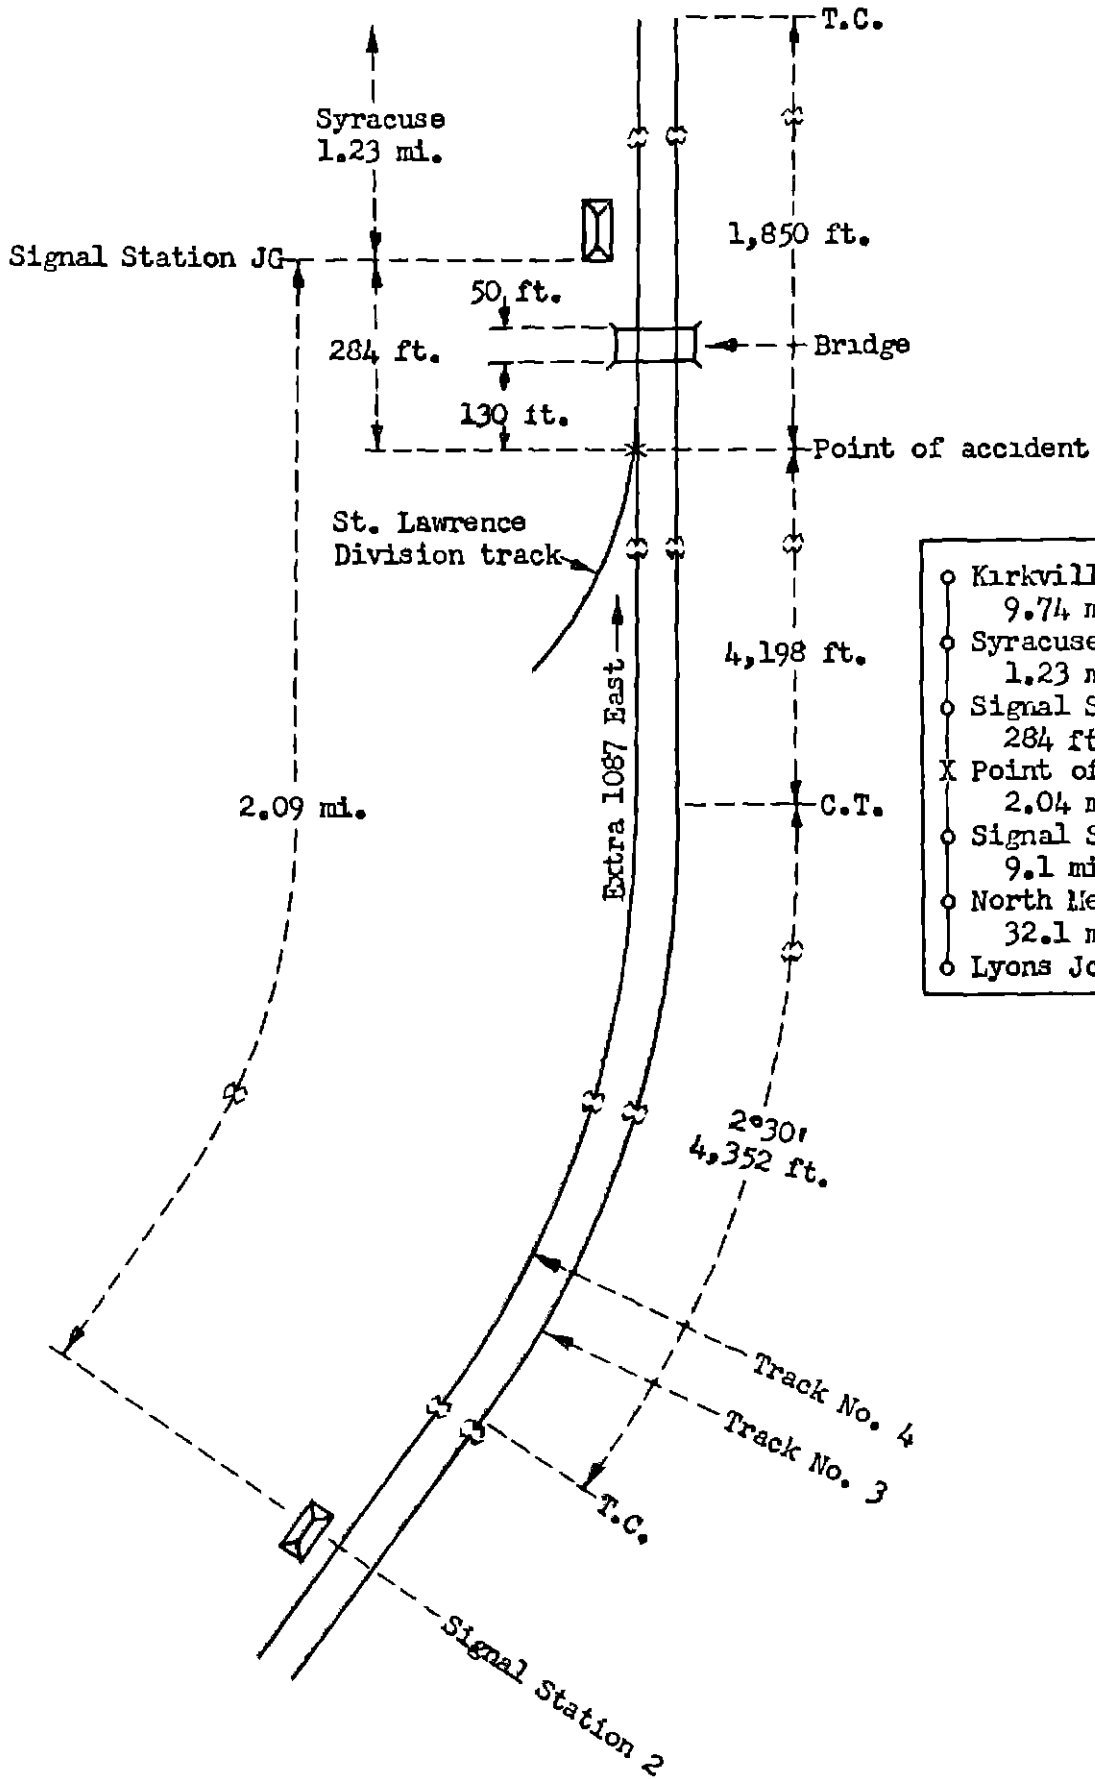
The New York Central Railroad  
 Syracuse, N. Y.  
 August 1957

- Kirkville, N. Y. 9.74 mi.
- Syracuse 1.23 mi.
- Signal Station JG 284 ft.
- X Point of accident 2.04 mi.
- Signal Station 2 9.1 mi.
- North Memphis 32.1 mi.
- Lyons Jct., N. Y.
