INVESTIGATION NO. 2716
THE NEW YORK, CHICAGO & ST. LOUIS
RAILROAD COMPANY

REPORT IN RE ACCIDENT

NEAR ALBANY, IND., ON

AUGUST 3, 1943

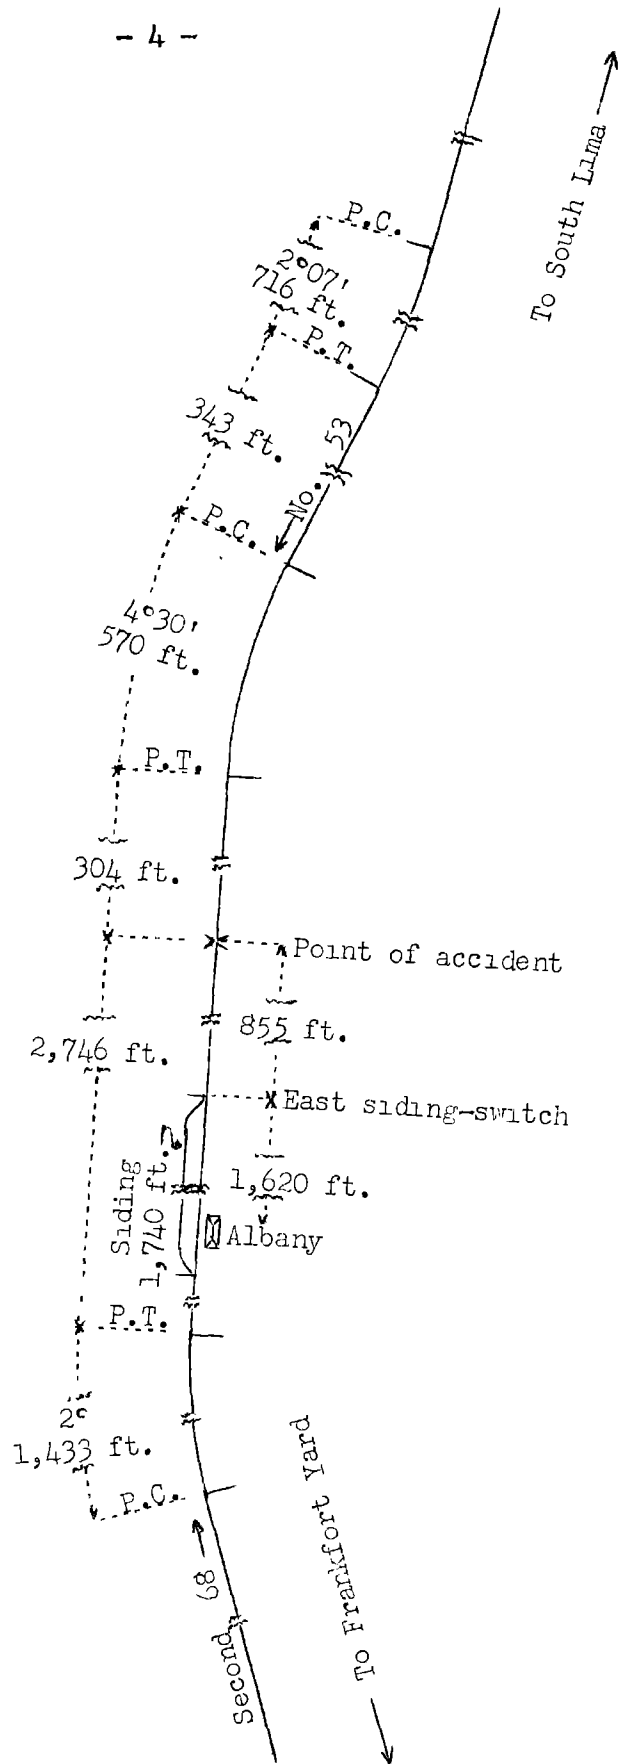
Inv-2716
 New York, Chicago & St. Louis Railroad
 Albany, Ind.
 August 1943

- o South Lima, Ohio
55.50 mi.
- o Portland, Ind.
10.90 mi.
- o Red Key
4.60 mi.
- o Hiles
0.73 mi.
- X Point of accident
0.47 mi.
- o Albany
11.20 mi.
- o Tuncie
2.50 mi.
- o Vernon
158.50 mi.
- o Frankfort Yard, Ind.
