INVESTIGATION NO. 2890
THE NEW YORK, CHICAGO AND ST. LOUIS
RAILROAD COMPANY
REPORT IN RE ACCIDENT
AT CAYUGA, IND., ON
MAY 22, 1945

Accident at Cayuga, Ind., on May 22, 1945, caused by failure of the New York, Chicago and St. Louis Railroad Company properly to enforce its operating rules applicable to the movement of the trains involved.

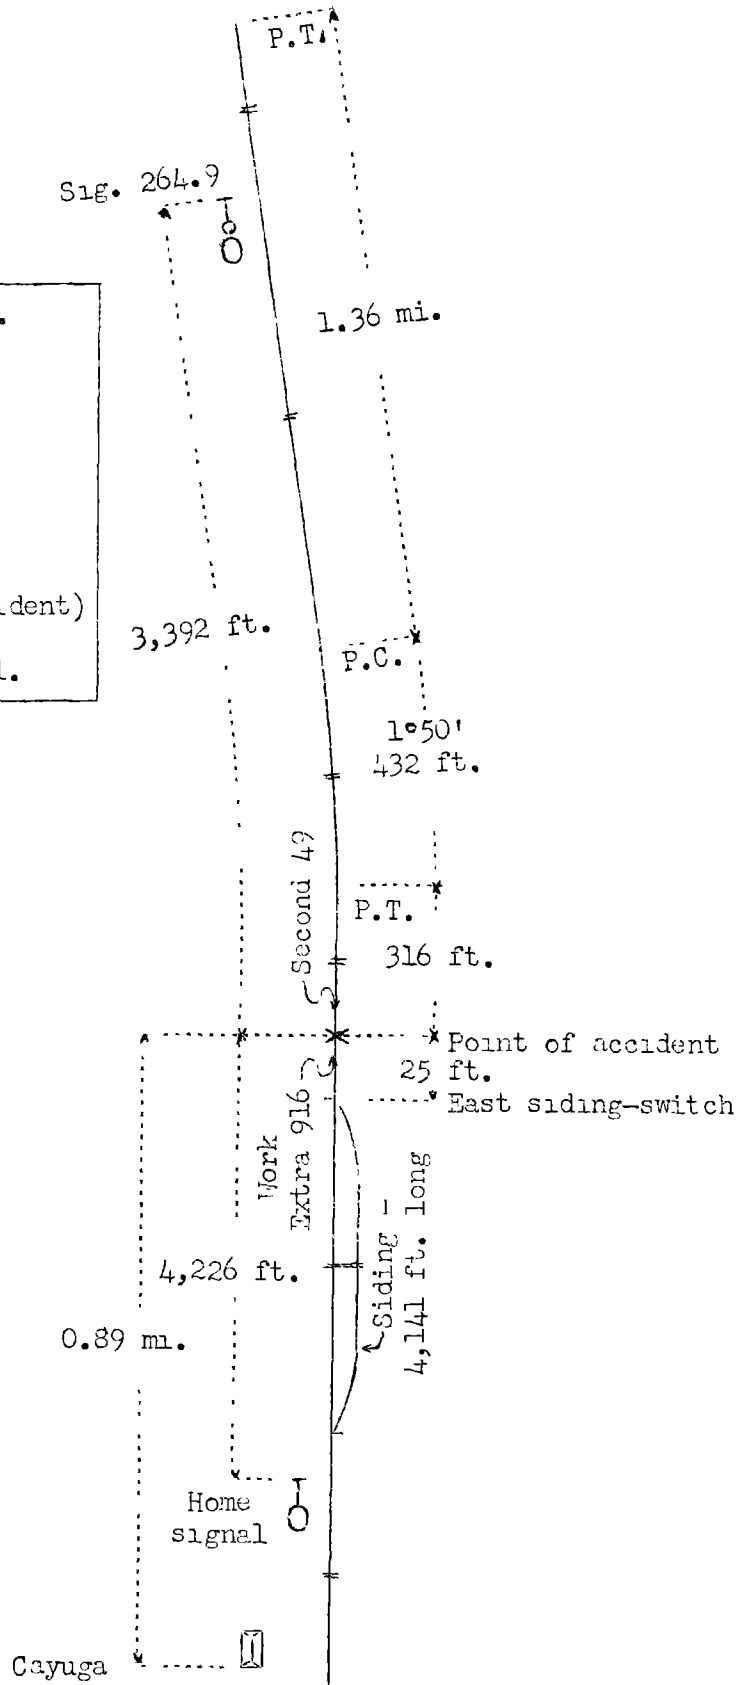
Inv. No. 2890
 New York, Chicago and St. Louis R. R.
 Cayuga, Ind.
 May 22, 1945

- Frankfort, Ind. 22.3 mi.
- Linden 20.6 mi.
- Veedersburg 9.4 mi.
- Cates 8.0 mi.
- X Cayuga, Ind. (Point of accident) 52.5 mi.
- Charleston, Ill.

Location of Accident and Method of Operation
