INVESTIGATION NO. 2517  
THE NEW YORK, CHICAGO & ST. LOUIS RAILROAD  
COMPANY

REPORT IN RE ACCIDENT  
AT CONNEAUT YARD, OHIO, ON  
AUGUST 13, 1941

-----  
Accident at Conneaut Yard, Ohio, on August 13, 1941, caused by  
failure properly to control speed of east-bound train  
moving within yard limits and approaching end of double  
track.

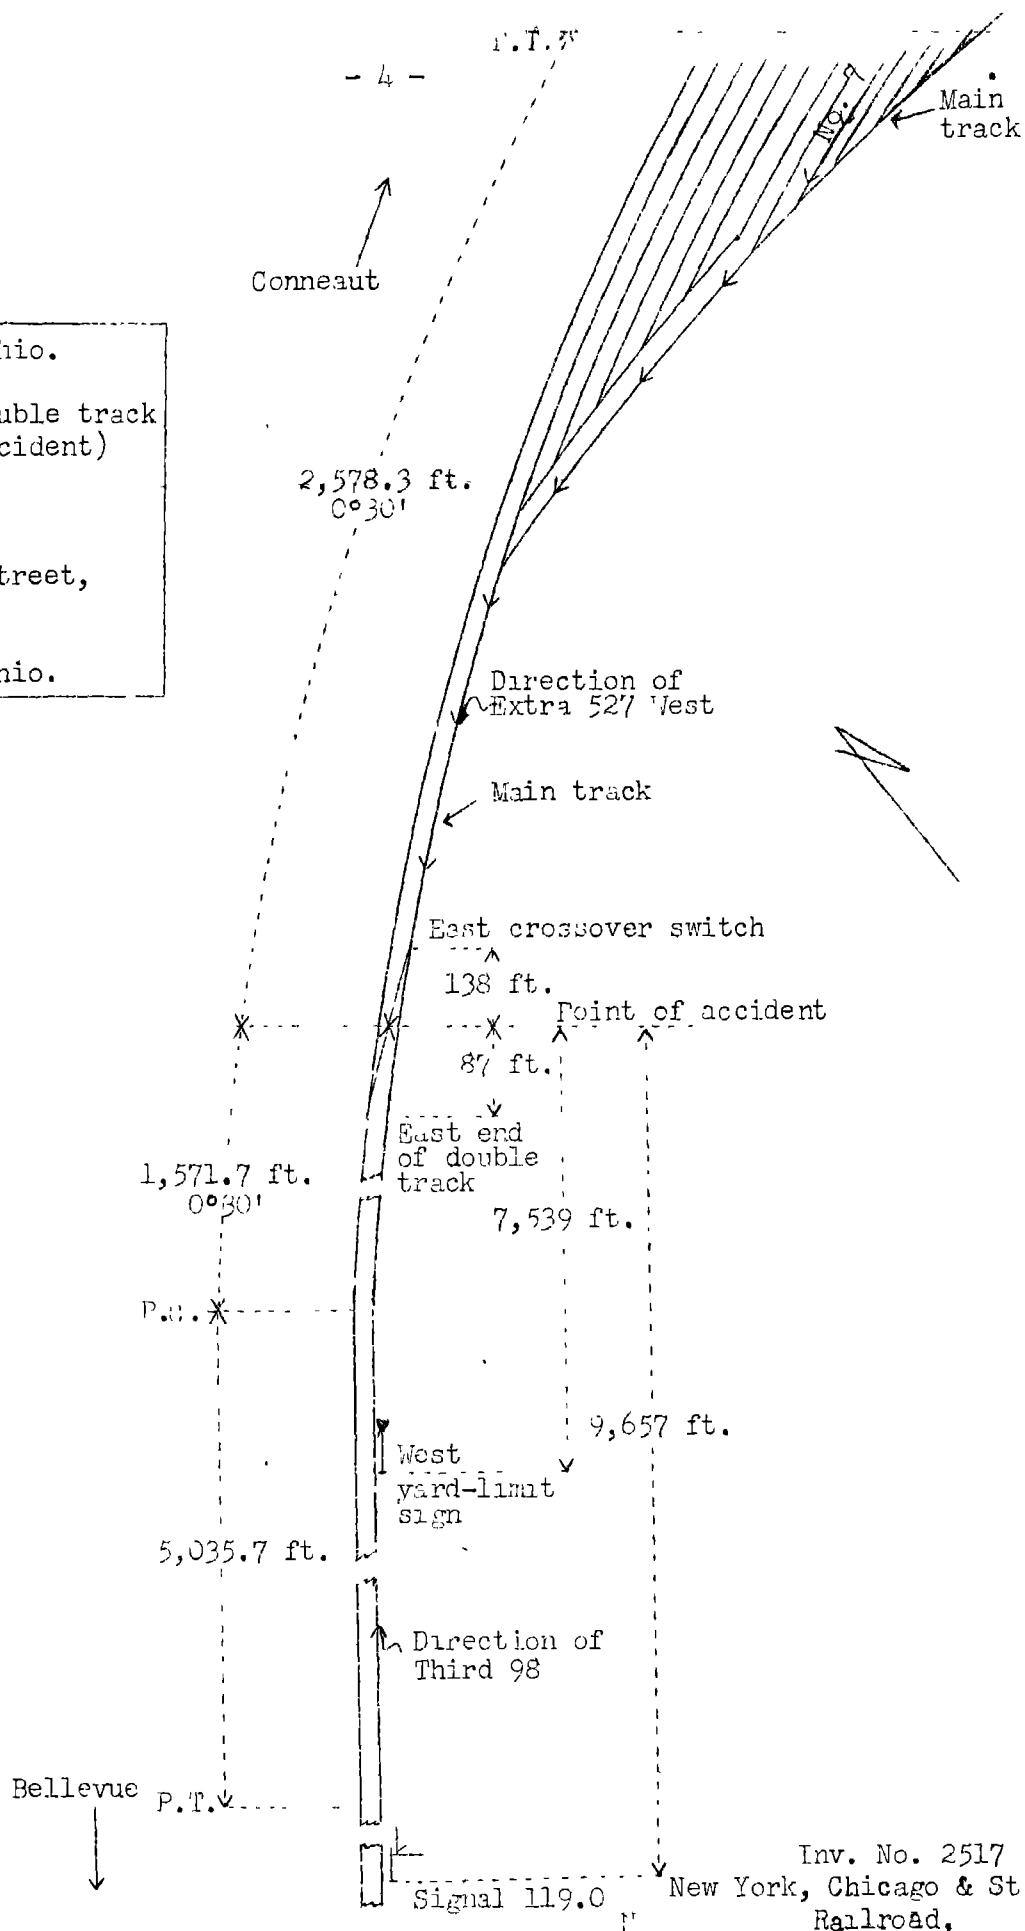
Inv. No. 2517  
New York, Chicago & St. Louis  
Railroad,  
Conneaut Yard, Ohio,  
August 13, 1941

- o Conneaut, Ohio.  
1.1 mi.
- X East end double track  
(Point of accident)  
12.3 mi.
- o NP Tower  
52.6 mi.
- o East 75th Street,  
(Cleveland)  
66.2 mi.
- o Bellevue, Ohio.

There was no condition of the engine of this train that distracted the attention of the crew or obscured their vision. Because of track curvature and telegraph poles adjacent to the track, the view from the right side of an east-bound engine of the point where the accident occurred was restricted to a distance of 1,950 feet.

The left side of the fifth and sixth cars of Extra 527 West were scraped and the rear truck of the sixth car was derailed. The seventh to tenth cars, inclusive, were derailed and stopped, badly damaged, in various positions on the crossover. The front truck of the eleventh car was derailed. Engine 629 was derailed and stopped, headed north, on its right side across the crossover and at right angles to it. This engine stopped on top of the tenth car of Extra 527 and 120 feet east of the point of collision. The pilot, engine truck, and left cylinder were demolished. The cab was crushed and shifted forward on the boiler. The tender was derailed and stopped, headed south, on its left side, across the main track and just west of the engine. The first car was derailed to the left but remained upright. The second car was derailed but remained upright and in line with the track. Both of these cars were badly damaged. The rear coupler and the end-sill of the eighteenth car were torn off and the center-sill was buckled. The nineteenth car was derailed and demolished. The twentieth car was derailed and stopped, badly damaged, on top of the wreckage of the nineteenth car.
