REPORT NO. 5417

THE NEW YORK, CHICAGO AND ST. LOUIS
RAILROAD COMPANY

IN RE ACCIDENT

AT FAIRVIEW, PA., ON

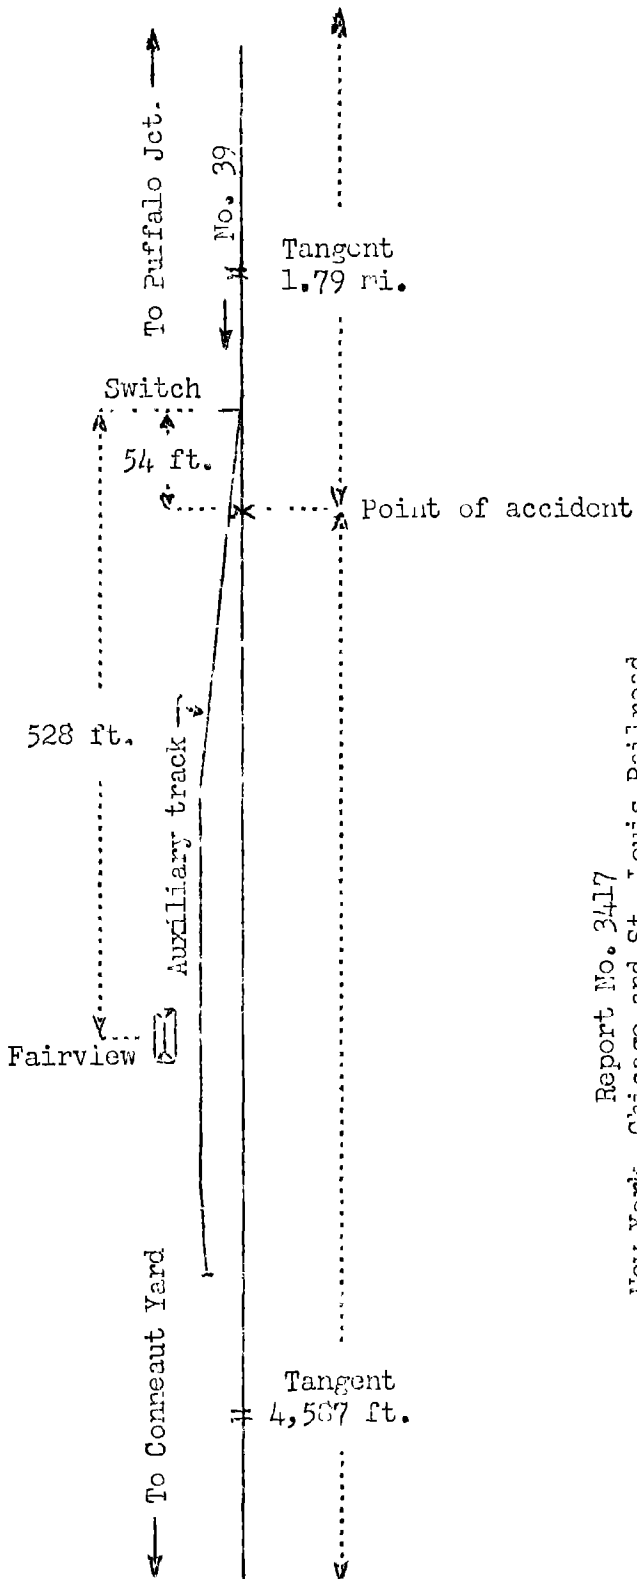
Report No. 3417
 New York, Chicago and St. Louis Railroad
 Fairview, Pa.
 July 8, 1951
