REPORT NO. 3660
THE NEW YORK, CHICAGO AND ST. LOUIS
RAILROAD COMPANY
IN RE ACCIDENT
AT WILLOUGHBY, OHIO, ON
OCTOBER 14, 1955

Accident at Willoughby, Ohio, on October 14, 1955, caused
by failure to provide adequate protection for the
movement of a track motor-car.

On October 14, 1955, there was a rear-end collision between a track motor-car and a locomotive with caboose on the New York, Chicago and St. Louis Railroad at Willoughby, Ohio, which resulted in the death of one signal helper. This accident was investigated in conjunction with a representative of the Public Utilities Commission of Ohio.

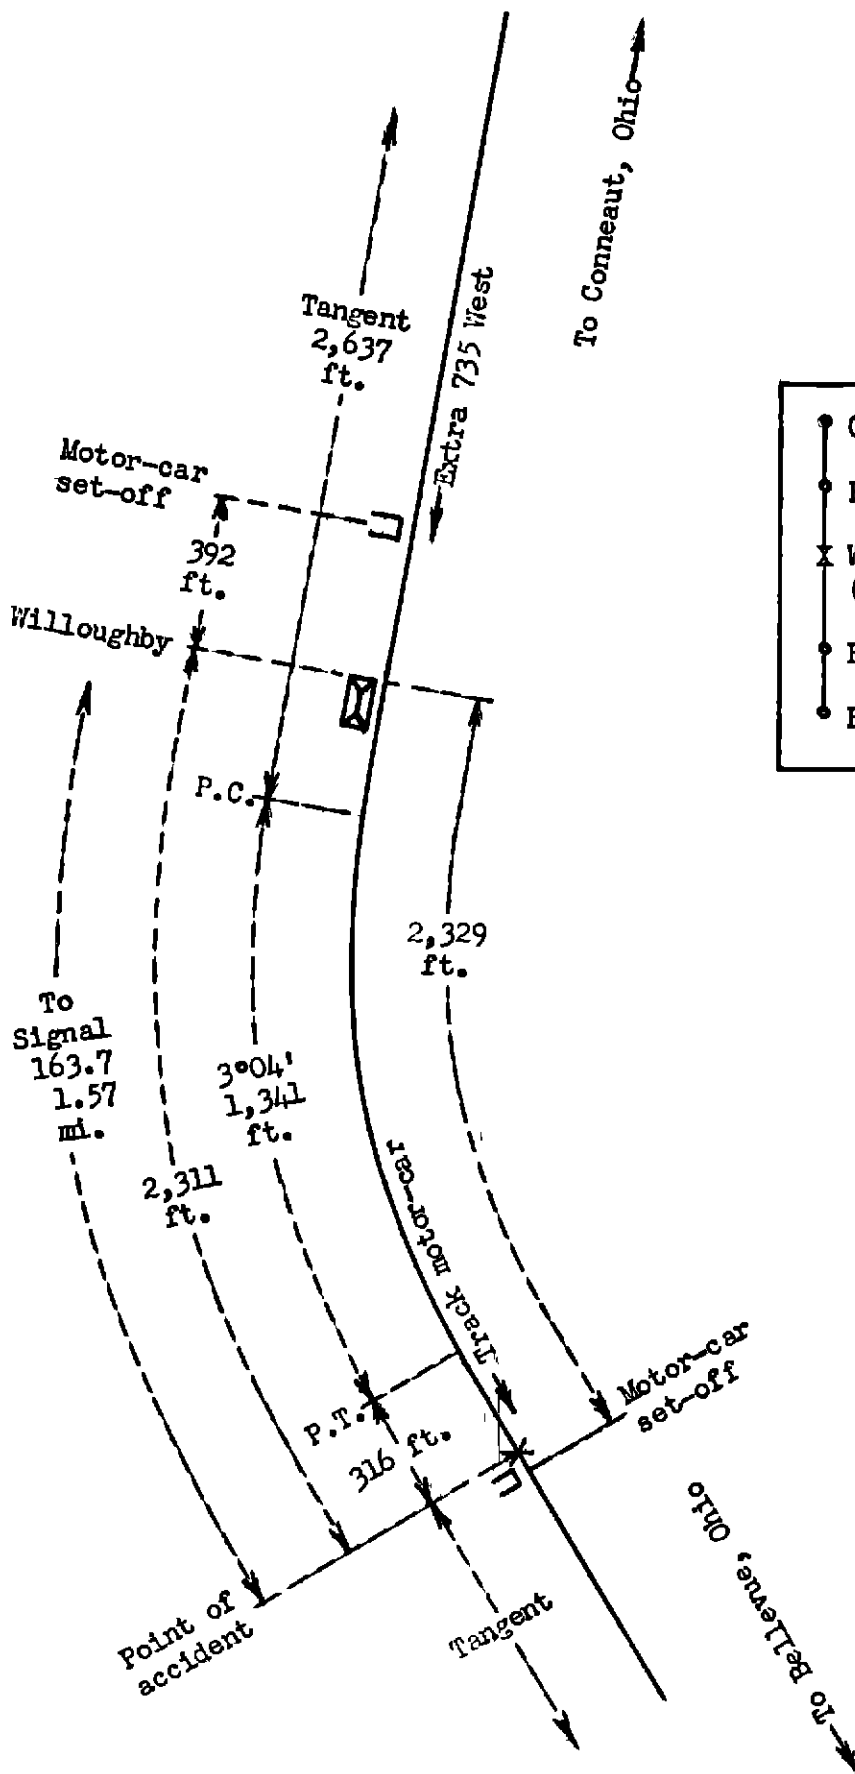
Report No. 3660
 New York, Chicago and St. Louis Railroad
 Willoughby, Ohio
 October 14, 1955

•	Conneaut, Ohio
•	39.3 mi.
•	PE Tower
•	9.8 mi.
X	Willoughby
	(Point of accident)
•	8.4 mi.
•	Euclid
•	74.7 mi.
•	Bellevue, Ohio
