INVESTIGATION NO 2763
THE NEW YORK, NEW HAVEN AND HARTFORD
RAILROAD COMPANY
REPORT IN RE ACCIDENT
AT DARIEN, CONN., ON
JANUARY 14, 1944

Accident at Darien, Conn., on January 14, 1944, caused by
failure properly to control the speed of the following
train in accordance with signal indications.

Inv. No. 2763
 N. Y., N. H. & H. R.R.
 Darien, Conn.
 January 14, 1944

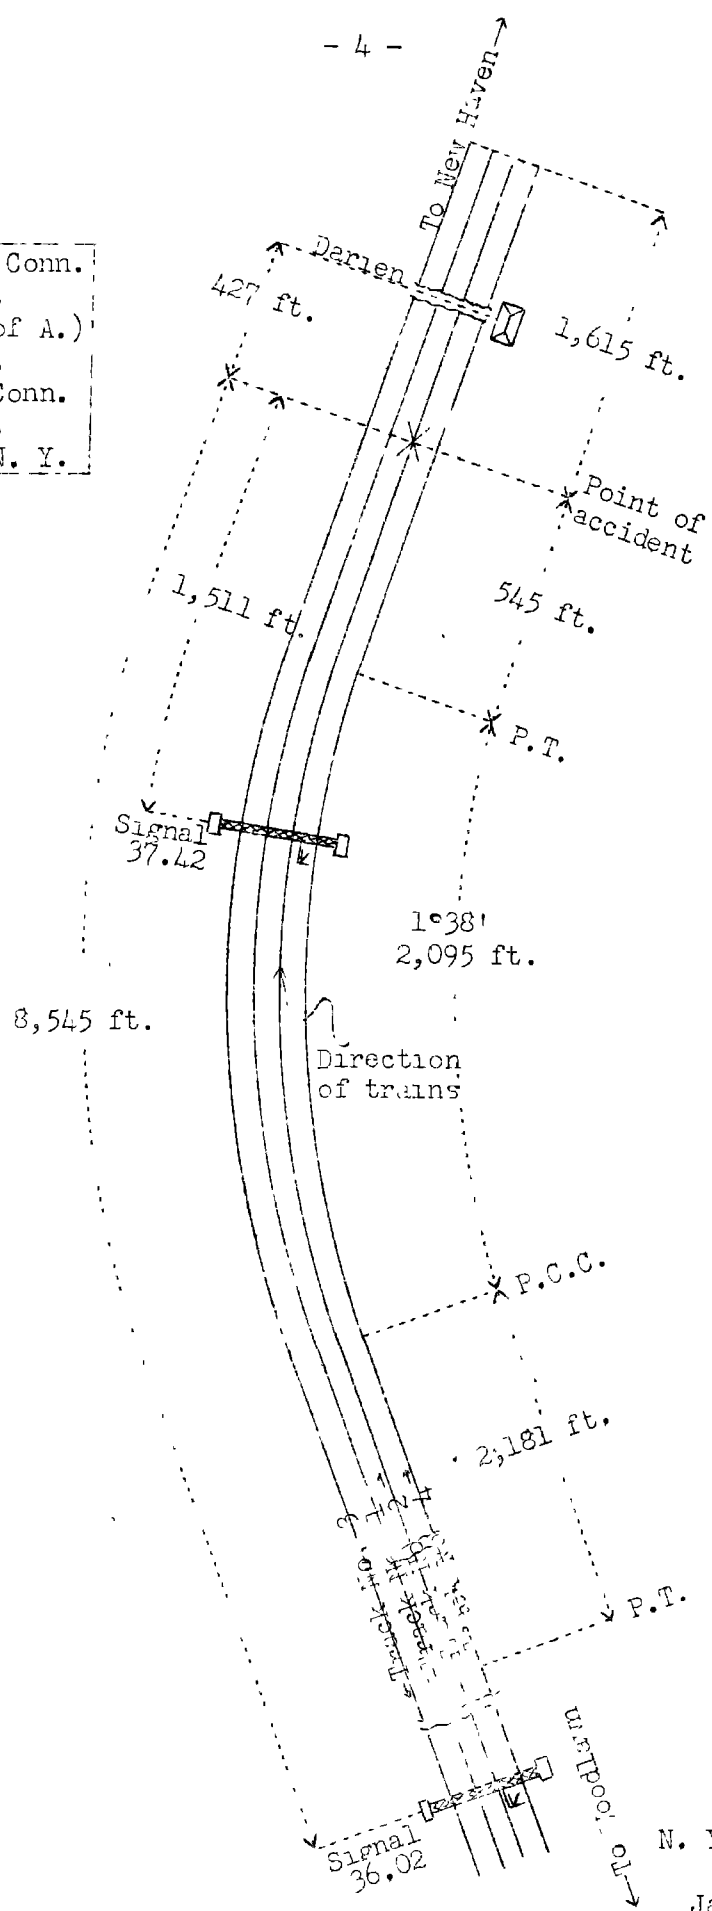
- o New Haven, Conn.
34.54 mi.
- X Darien (P. of A.)
4.69 mi.
- o Stamford, Conn.
21.29 mi.
- o Woodlawn, N. Y.

Location of Accident and Method of Operation

As No. 382 was approaching Darien the flagman dropped a lighted 5-minute fusee on track No. 2 about 700 feet west of signal 37.42. As No. 382 was departing from Darien the flagman saw the reflection of the headlight of the following train about 1,500 feet distant. He gave stop signals with a lighted white lantern from the side door of the rear car, then jumped off just before the collision occurred. After the accident occurred, the remains of a burned fusee were found where the flagman said he dropped the lighted fusee.
