REPORT OF THE DIRECTOR OF THE BUREAU OF SAFETY CONCERNING AN
ACCIDENT ON THE NEW YORK, NEW HAVEN & HARTFORD RAILROAD
AT NEW HAVEN, CONN., ON JUNE 6, 1933.

Inv. No. 1831
New York, New Haven & Hartford R.R.
New Haven, Conn.
June 6, 1933.

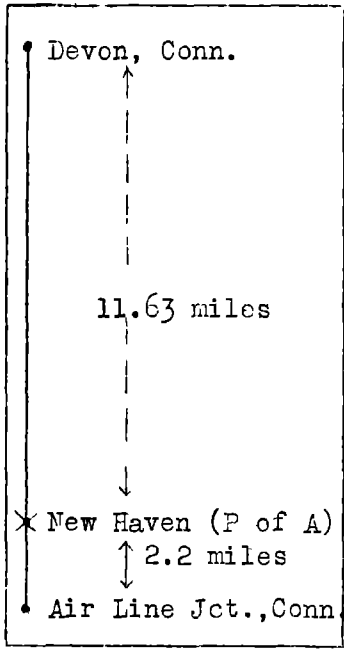
This accident occurred on that part of the New Haven Division extending between Air Line Junction and Devon, Conn., a distance of 13.83 miles; this is a four-track line over which trains are operated by time-table, train orders and an automatic block-signal system. The accident occurred within yard and interlocking limits, at a point 1,951 feet east of the passenger station at New Haven or 89 feet east of Signal Station 78, at a crossover switch located between Water Street bridge and Fair Street bridge; these are overhead bridges located about 400 feet apart. Approaching this point from the west there are 10 station tracks, most of which, together with various other tracks, converge into the four main-line tracks. These tracks curve gradually to the left, then there is a short tangent under Water Street bridge, following which the tracks curve gradually to the right, this curve extending beyond tower 78, and is followed by tangent track. The accident occurred at the west switch of crossover 24, connecting main tracks 2 and 4, about 85 feet west of tower 78. The grade is level.

Tower 78 is located south of the tracks; the interlocking is an electric plant with 47 working levers, and the crossovers and signals involved are operated from this signal station. The signal directly involved in this accident is west-bound dwarf signal 9L, which gives 2 indications, purple for stop and yellow for proceed at slow speed, located 431 feet east of the west switch of crossover 24, a trailing-point switch for westbound movements.

just east of dwarf signal 9L was reached, where the motor was stopped and the controls reversed from the east end to the west end of the motor, it being intended to return westward with the motor to the storage tracks located west of New Haven station. Electric motor 0305 started westward and passed dwarf signal 9L, the indication of which is in dispute, ran through the west switch of crossover 24 which was lined for a crossover movement, and collided with engine 1390 while traveling at a speed estimated to have been from 5 to 8 miles per hour.

Steam engine 1390, in charge of Engineman Newton and Fireman Burke, was detached from train no. 29 on arrival of that train at New Haven station from Boston, and was making a back-up movement eastward en route to the Cedar Hill roundhouse. The route was from station track 2 via crossover 24 to main track 2 and thence to main track 1; this route was lined and signals displayed for the movement and engine 1390 passed dwarf signal 3Ra, but at a point 470 feet beyond that signal the tender collided with motor 0305 while traveling at a speed estimated to have been from 5 to 15 miles per hour.

Signal Maintainer Gilhuly was in tower 78 at the time of the accident; immediately after its occurrence he examined the machine and found the route properly lined for steam engine 1390, with the lever for dwarf signal 9L in stop position. He then left the signal station and went to dwarf signal 9L and observed that it was displaying a stop indication. He also checked crossover 24 and found three of the switch rods of the west switch bent as a result

of the switch having been run through by motor 0305; the east switch was reversed, as it should have been for the intended movement of engine 1390. He had also looked over the plant about 2 hours prior to the accident and found all lights in proper condition.
