INTERSTATE COMMERCE COMMISSION

REPORT NO. 3642

THE NEW YORK, NEW HAVEN AND HARTFORD RAILROAD COMPANY

Accident at Bridgeport, Conn., on July 14, 1955, caused
by excessive speed on a curve.

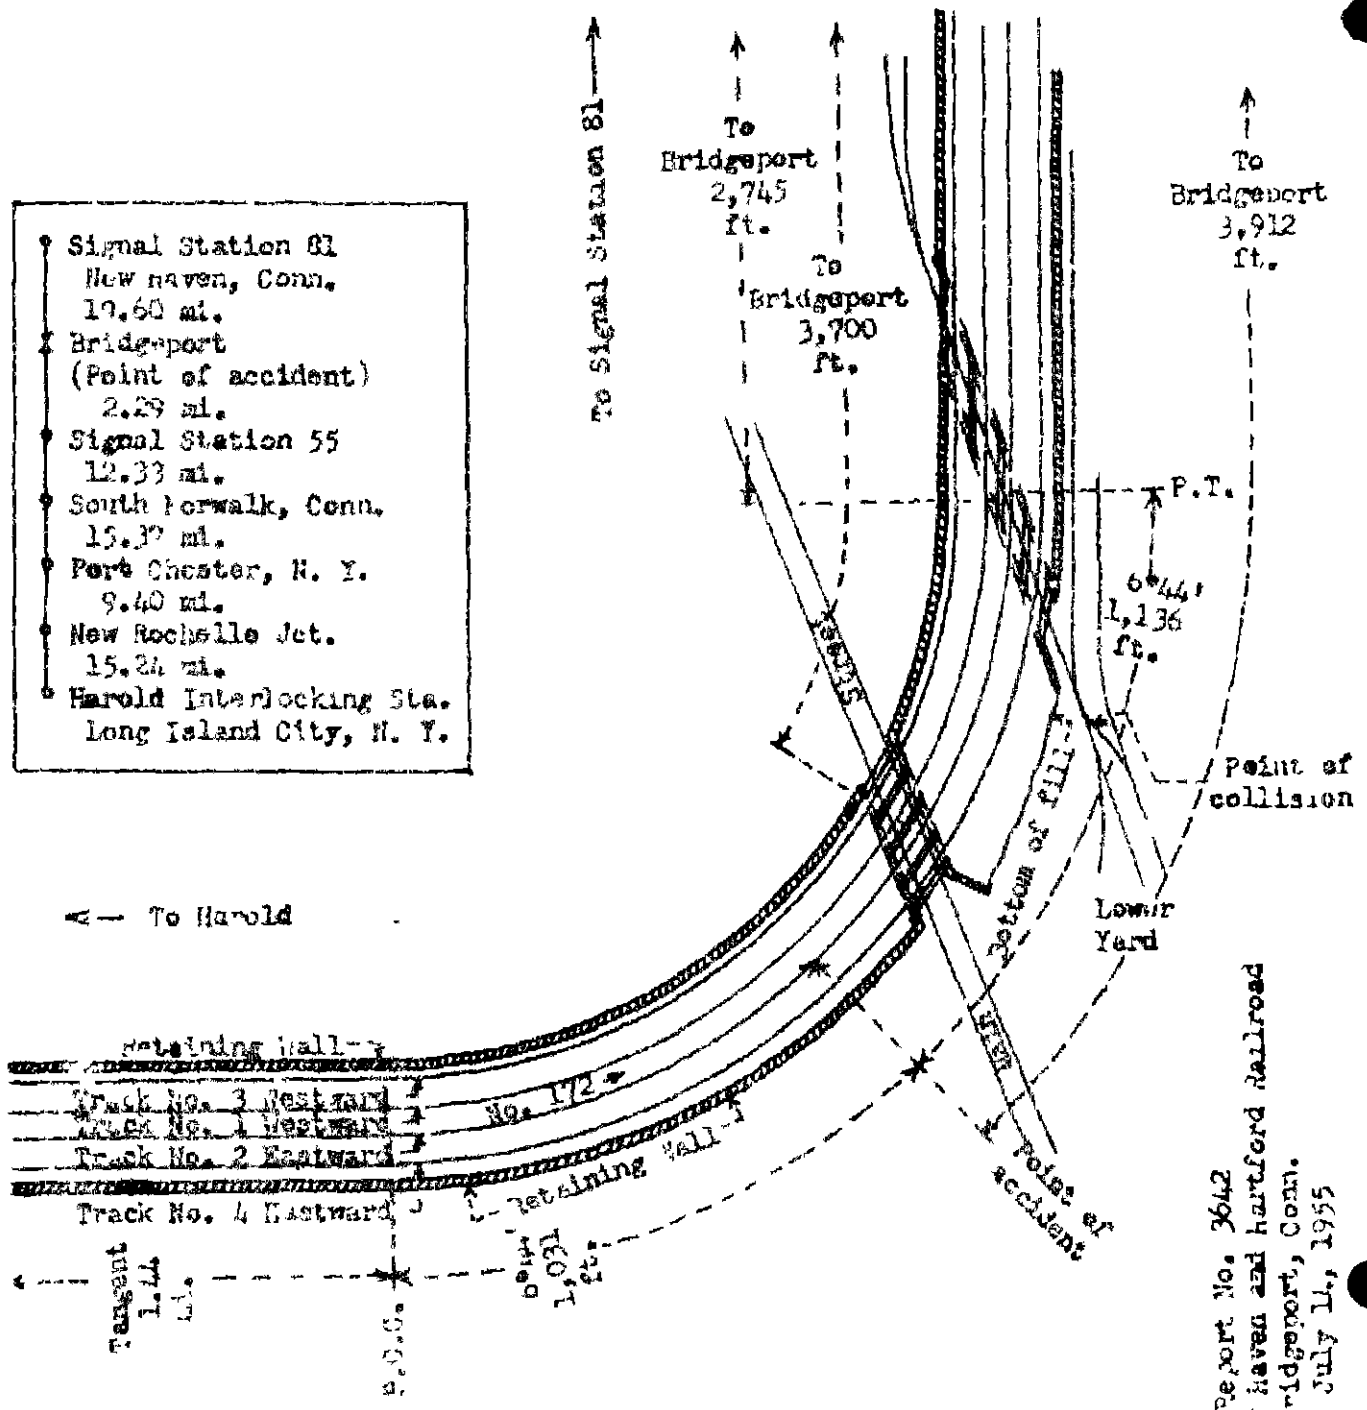
Report No. 3642
New Haven and Hartford Railroad
Bridgeport, Conn.
July 11, 1955

- Signal Station 81
New Haven, Conn.
19.60 mi.
- Bridgeport
(Point of accident)
2.29 mi.
- Signal Station 55
12.33 mi.
- South Norwalk, Conn.
15.37 mi.
- Port Chester, N. Y.
9.40 mi.
- New Rochelle Jct.
15.24 mi.
- Harold Interlocking Sta.
Long Island City, N. Y.

← To Harold

Location of Accident and Method of Operation

This accident occurred on that part of the New Haven Division extending between Harold Interlocking Station, Long Island City, N. Y., and Signal Station 81, New Haven, Conn., 74.23 miles. In the vicinity of the point of accident this is a four-track line, over which trains moving with the current of traffic are operated by signal indications. A catenary system for the electric propulsion of trains is provided. The main tracks from north to south are designated as Nos. 3 and 1, westward, and Nos. 2 and 4, eastward. The accident occurred on track No. 2 at a point 53.89 miles east of Harold and 3,912 feet west of the station at Bridgeport. From the west on track No. 2 there is a tangent 1.44 miles in length and a compound curve to the left, having a maximum curvature of $6^{\circ}44'$, 1,031 feet to the point of accident and 1,135 feet eastward. Throughout a distance of more than 1 mile immediately west of the point of accident the grade for east-bound trains on track No. 2 varies between level and 0.08 percent descending, and it is 0.08 percent descending at that point.
