REPORT NO. 3726

THE NEW YORK, NEW HAVEN AND HARTFORD
RAILROAD COMPANY

IN RE ACCIDENT

DECEMBER 15, 1956

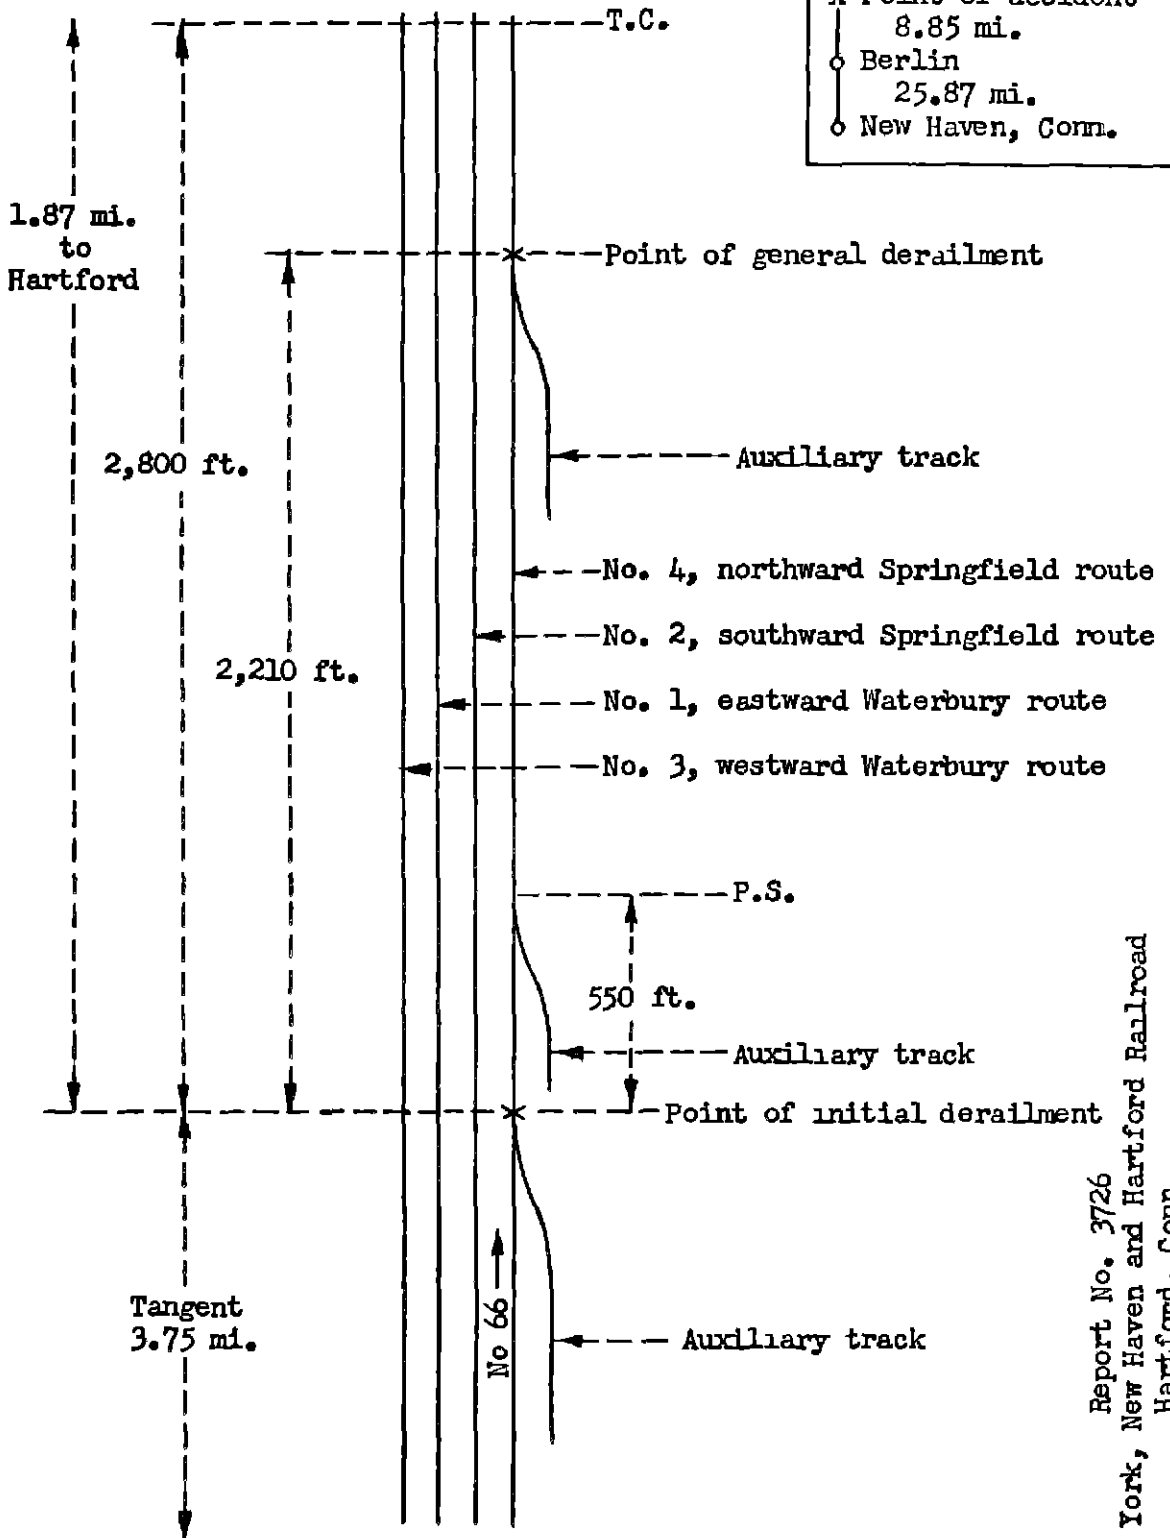
Report No. 3726
The New York, New Haven and Hartford Railroad
Hartford, Conn.
December 15, 1956

→ To Springfield →

← To New Haven ←

- Springfield, Mass. 25.39 mi.
- Hartford, Conn 1.87 mi.
- X Point of accident 8.85 mi.
- Berlin 25.87 mi.
- New Haven, Conn.
