INVESTIGATION NO. 2898
NORFOLK AND WESTERN RAILWAY COMPANY
REPORT IN RE ACCIDENT
AT BEDFORD, VA., ON
JUNE 11, 1945

Railroad: Norfolk and Western
Date: June 11, 1945
Location: Bedford, Va.
Kind of accident: Collision
Train involved: Freight : Cut of freight cars
Train number: Extra 1253 East :
Engine number: 1233 :
Consist: 59 cars, caboose : 8 cars
Estimated speed: 25 m. p. h. : Standing
Operation: Timetable, train orders and automatic block-signal system; yard limits
Track: Double; tangent; vertical curve
Weather: Clear
Time: 12:48 p. m.
Casualties: 1 killed; 2 injured
Cause: Failure properly to control speed of train moving within yard limits

Accident at Bedford, Va., on June 11, 1945, caused by
failure properly to control the speed of a train
moving within yard limits.

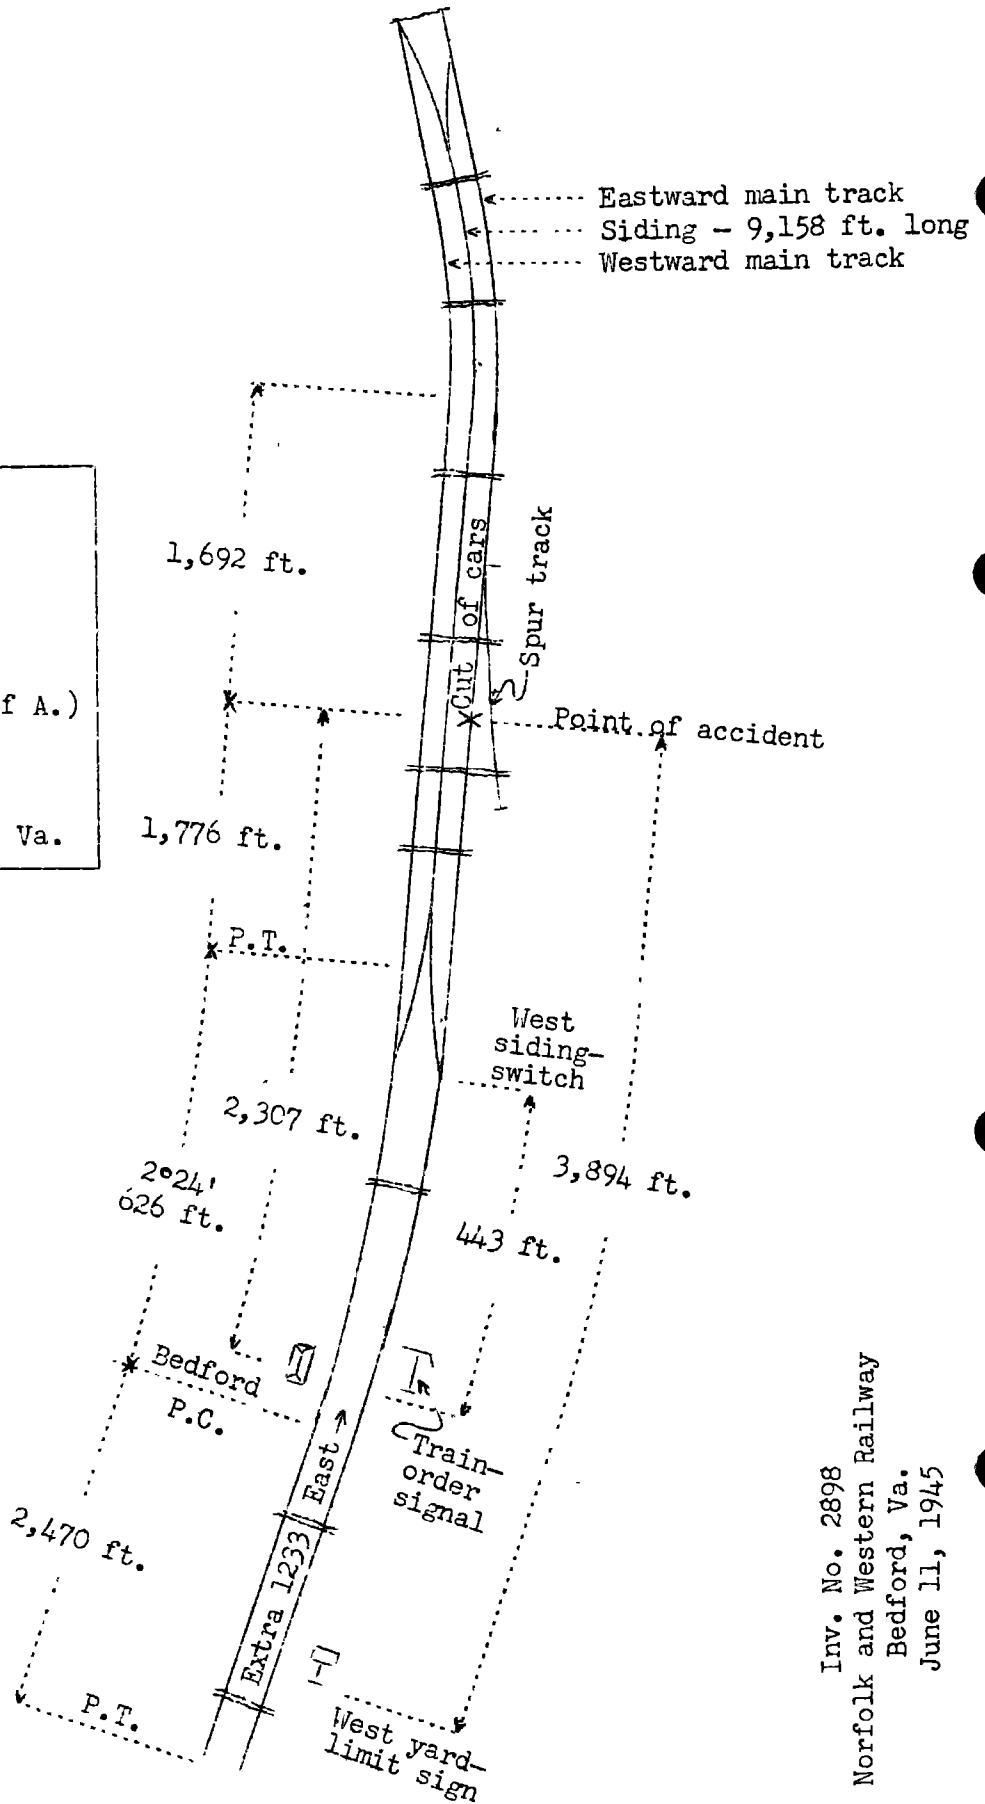
Inv. No. 2898
 Norfolk and Western Railway
 Bedford, Va.
 June 11, 1945

↑ To Crewe

- Crewe, Va. 87.11 mi.
- Goode 2.67 mi.
- Lowry 5.66 mi.
- X Bedford (P. of A.) 5.08 mi.
- Thaxton 24.40 mi.
- West Roanoke, Va.

← To West Roanoke

Location of Accident and Method of Operation
