REPORT NO. 3319

NORFOLK AND WESTERN RAILWAY COMPANY

IN RE ACCIDENT

AT KIMBALL, W. VA., ON

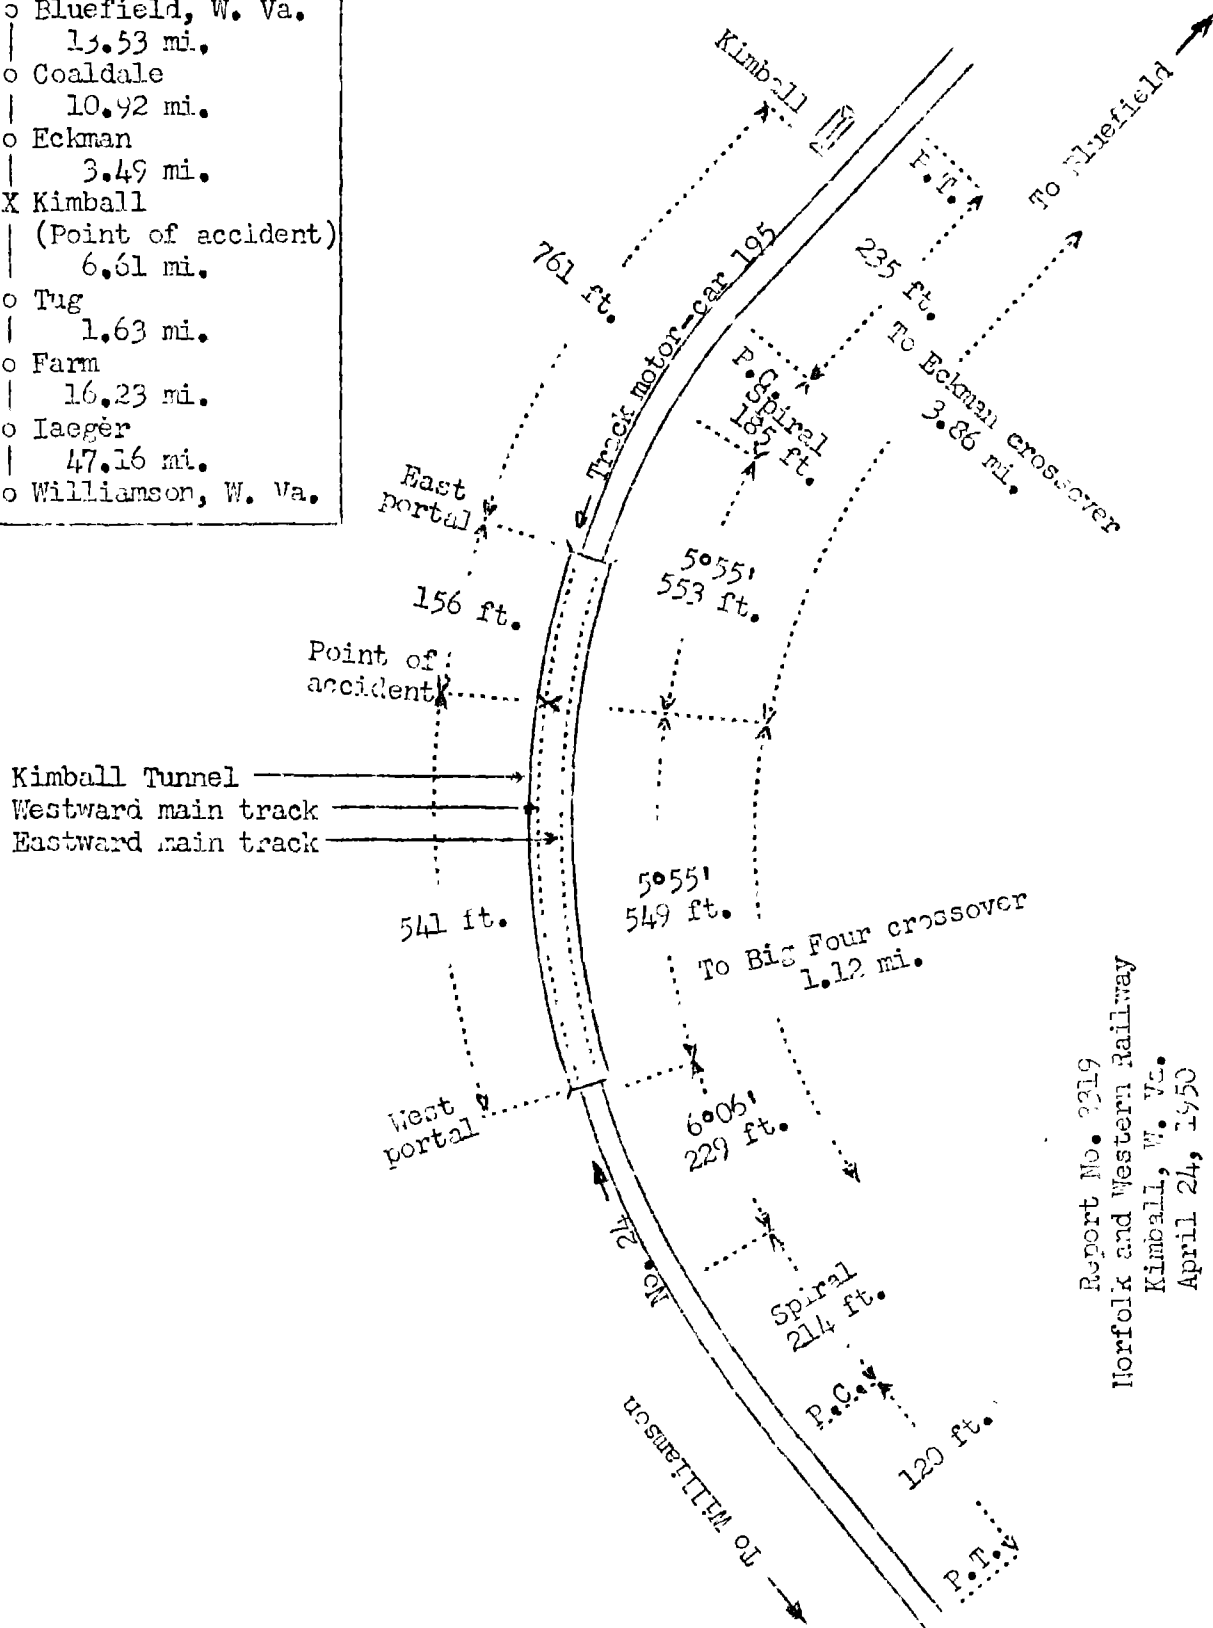
Location of Accident and Method of Operation

o	Bluefield, W. Va.
	13.53 mi.
o	Coaldale
	10.92 mi.
o	Eckman
	3.49 mi.
X	Kimball
	(Point of accident)
	6.61 mi.
o	Tug
	1.63 mi.
o	Farm
	16.23 mi.
o	Jaeger
	47.16 mi.
o	Williamson, W. Va.

Report No. 2319  
Norfolk and Western Railway  
Kimball, W. Va.  
April 24, 1950
