INVESTIGATION NO. 2613

THE NORTHERN PACIFIC RAILWAY COMPANY

REPORT IN RE ACCIDENT

NEAR WATAB, MINN., ON

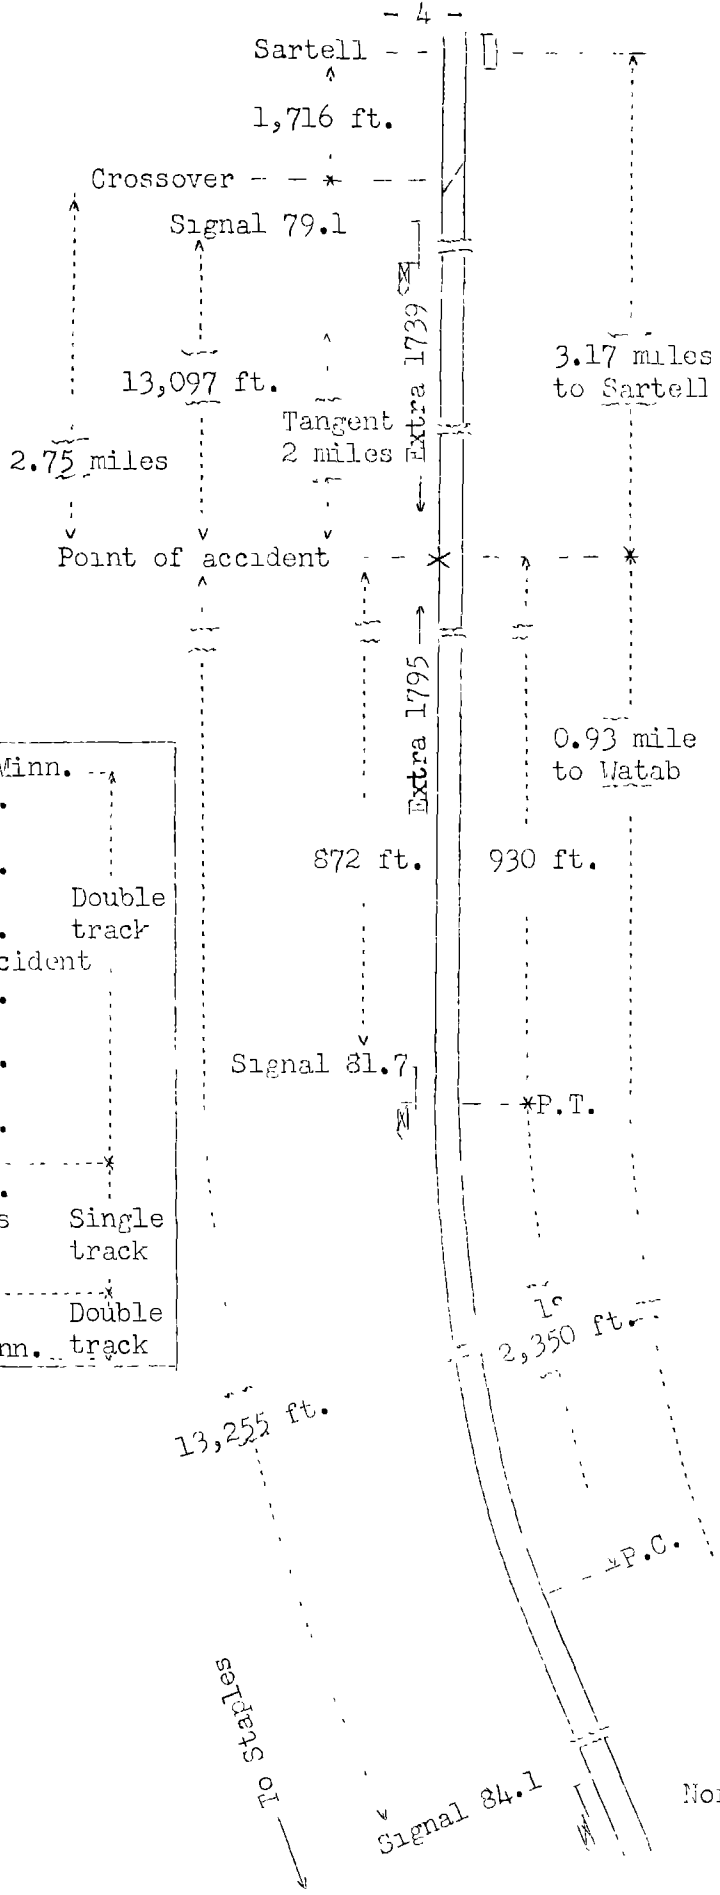
Inv-2613  
 Northern Pacific Railway  
 Watab, Minn.  
 August 9, 1942

- o Northtown, Minn. --- 61.50 mi.
- o St. Cloud --- 4.30 mi.
- o Sartell --- 3.17 mi. Double track
- X Point of accident --- 0.93 mi.
- o Watab --- 12.40 mi.
- o Royalton --- 8.00 mi.
- o Gregory --- 2.80 mi.
- o Little Falls --- 27.6 mi. Single track
- o Philbrook --- 6.3 mi. Double track
- o Staples, Minn. --- track
