INVESTIGATION NO. 2507

THE NORTHERN PACIFIC RAILWAY COMPANY

REPORT IN RE ACCIDENT

Accident near Athol, Idaho, on June 13, 1941, caused by  
excessive speed on sharp curve.

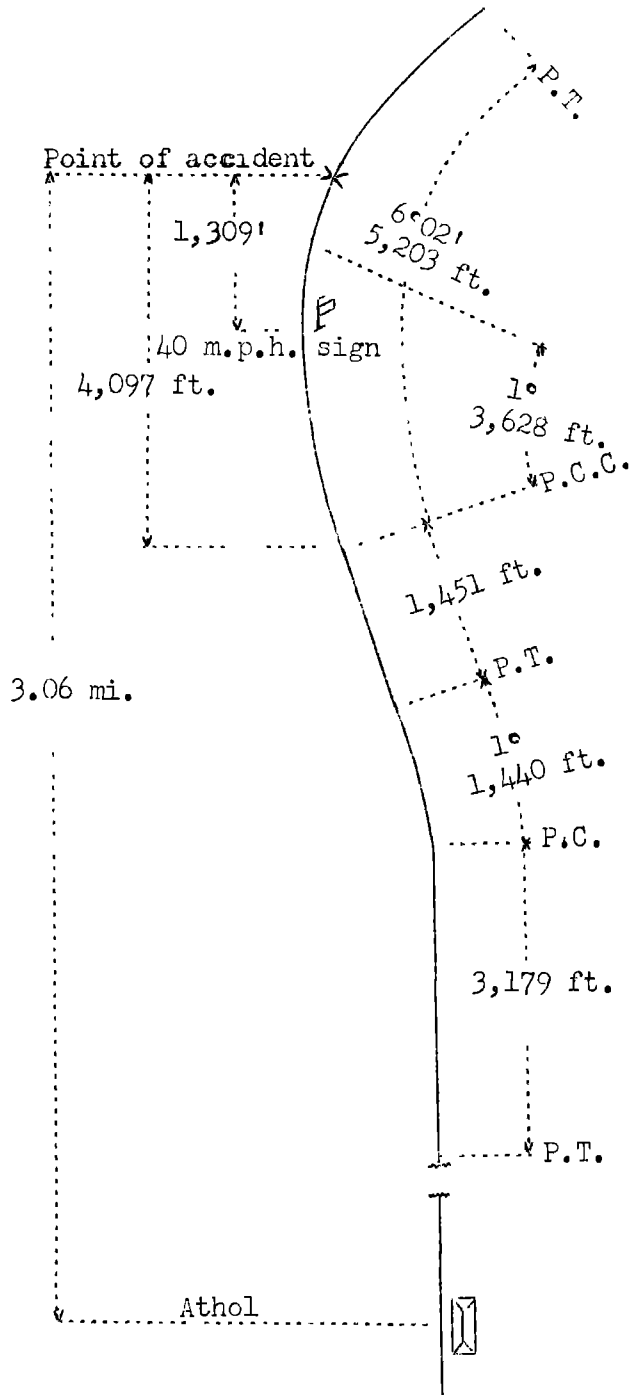
Inv-2507  
Northern Pacific Railway  
Athol, Idaho  
June 13, 1941

- o Paradise, Mont.  
144.34 mi.
- X Point of accident  
3.06 mi.
- o Athol, Idaho  
13.0 mi.
- o Rathdrum, Idaho  
23.5 mi.
- o Yardley, Wash.
