REPORT OF THE DIRECTOR

ACCIDENT ON THE
NORTHERN PACIFIC RAILWAY

AUBURN, WASH.

INVESTIGATION NO. 2028

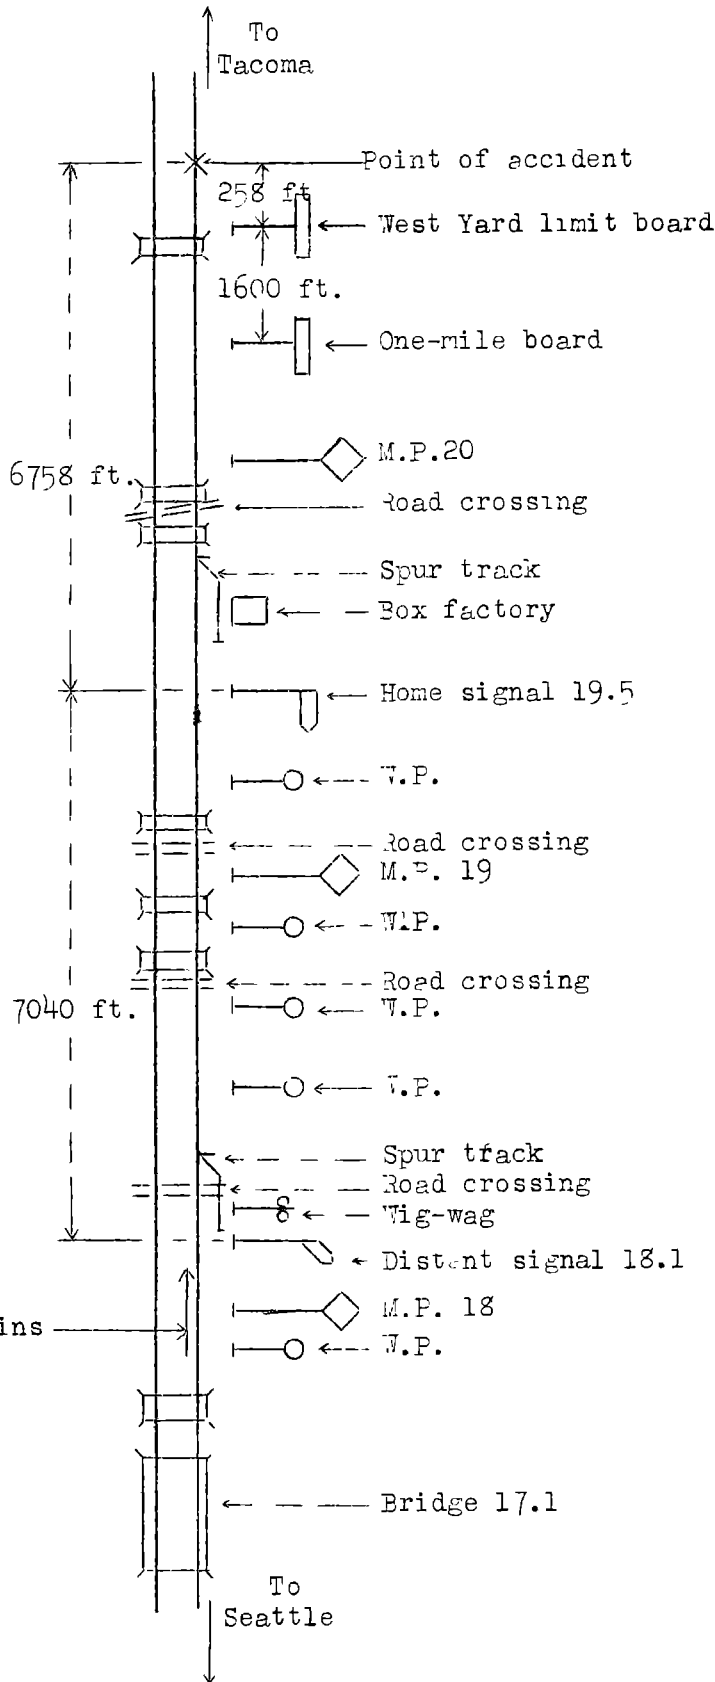
Inv. No. 2028
 Northern Pacific Ry.,
 Auburn, Wash.
 Dec. 19, 1935

• Tacoma, Wash.
18.8 mi.
• Auburn (P of A)
1.9 mi.
• Christopher
1.4 mi.
• Thomas
1.9 mi.
• Kent
16.3 mi.
• Seattle, Wash.

AUBURN

CHRISTOPHER

THOMAS

The automatic block signals are of the 3-position, upper-quadrant, semaphore type, approach-lighted. Night indications are red, yellow, and green, for stop and then proceed at restricted speed, approach, and proceed, respectively. Signal 19.5 is located 6,758 feet west of the point of accident, while signal 18.1 is located 7,040 feet west of signal 19.5. The station one-mile board is located 1,600 feet west of the west yard-limit board. In addition to the above signals and markers, there are numerous landmarks in this vicinity by which members of a train crew can determine the location of their train. One of these is bridge 17.1, located 3 miles west of the point of accident, which consists of a steel span 181 feet in length over White River, while its total length including the approaches is 1,801 feet; between this bridge 17.1 and the point of accident, a distance of 3 miles, an east-bound train passes 3 mile posts, 4 public road crossings, 1 of which is protected by an electric crossing bell and a wig-wag signal; 2 trailing-point spur-track switches; 7 small culverts; 5 whistling posts, and a box factory. All of the signals and markers, as well as the box factory, are located on the engineman's side of the track.
