REPORT NO. 3497
NORTHERN PACIFIC RAILWAY COMPANY
IN RE ACCIDENT
AT BASSETT JUNCTION, WASH., ON
DECEMBER 27, 1952

Date: December 27, 1952
Railroad: Northern Pacific
Location: Bassett Junction, Wash.
Kind of accident: Derailment
Train involved: Freight
Train number: Extra 1567 West
Engine number: 1567
Consist: 26 cars, caboose
Estimated speed: 20 m. p. h.
Operation: Timetable and train orders
Track: Single; tangent; 0.40 percent
descending grade westward
Weather: Clear
Time: 4:05 a. m.
Casualties: 3 killed
Cause: Defective switch

Accident at Bassett Junction, Wash., on December 27, 1952,
caused by a defective switch.

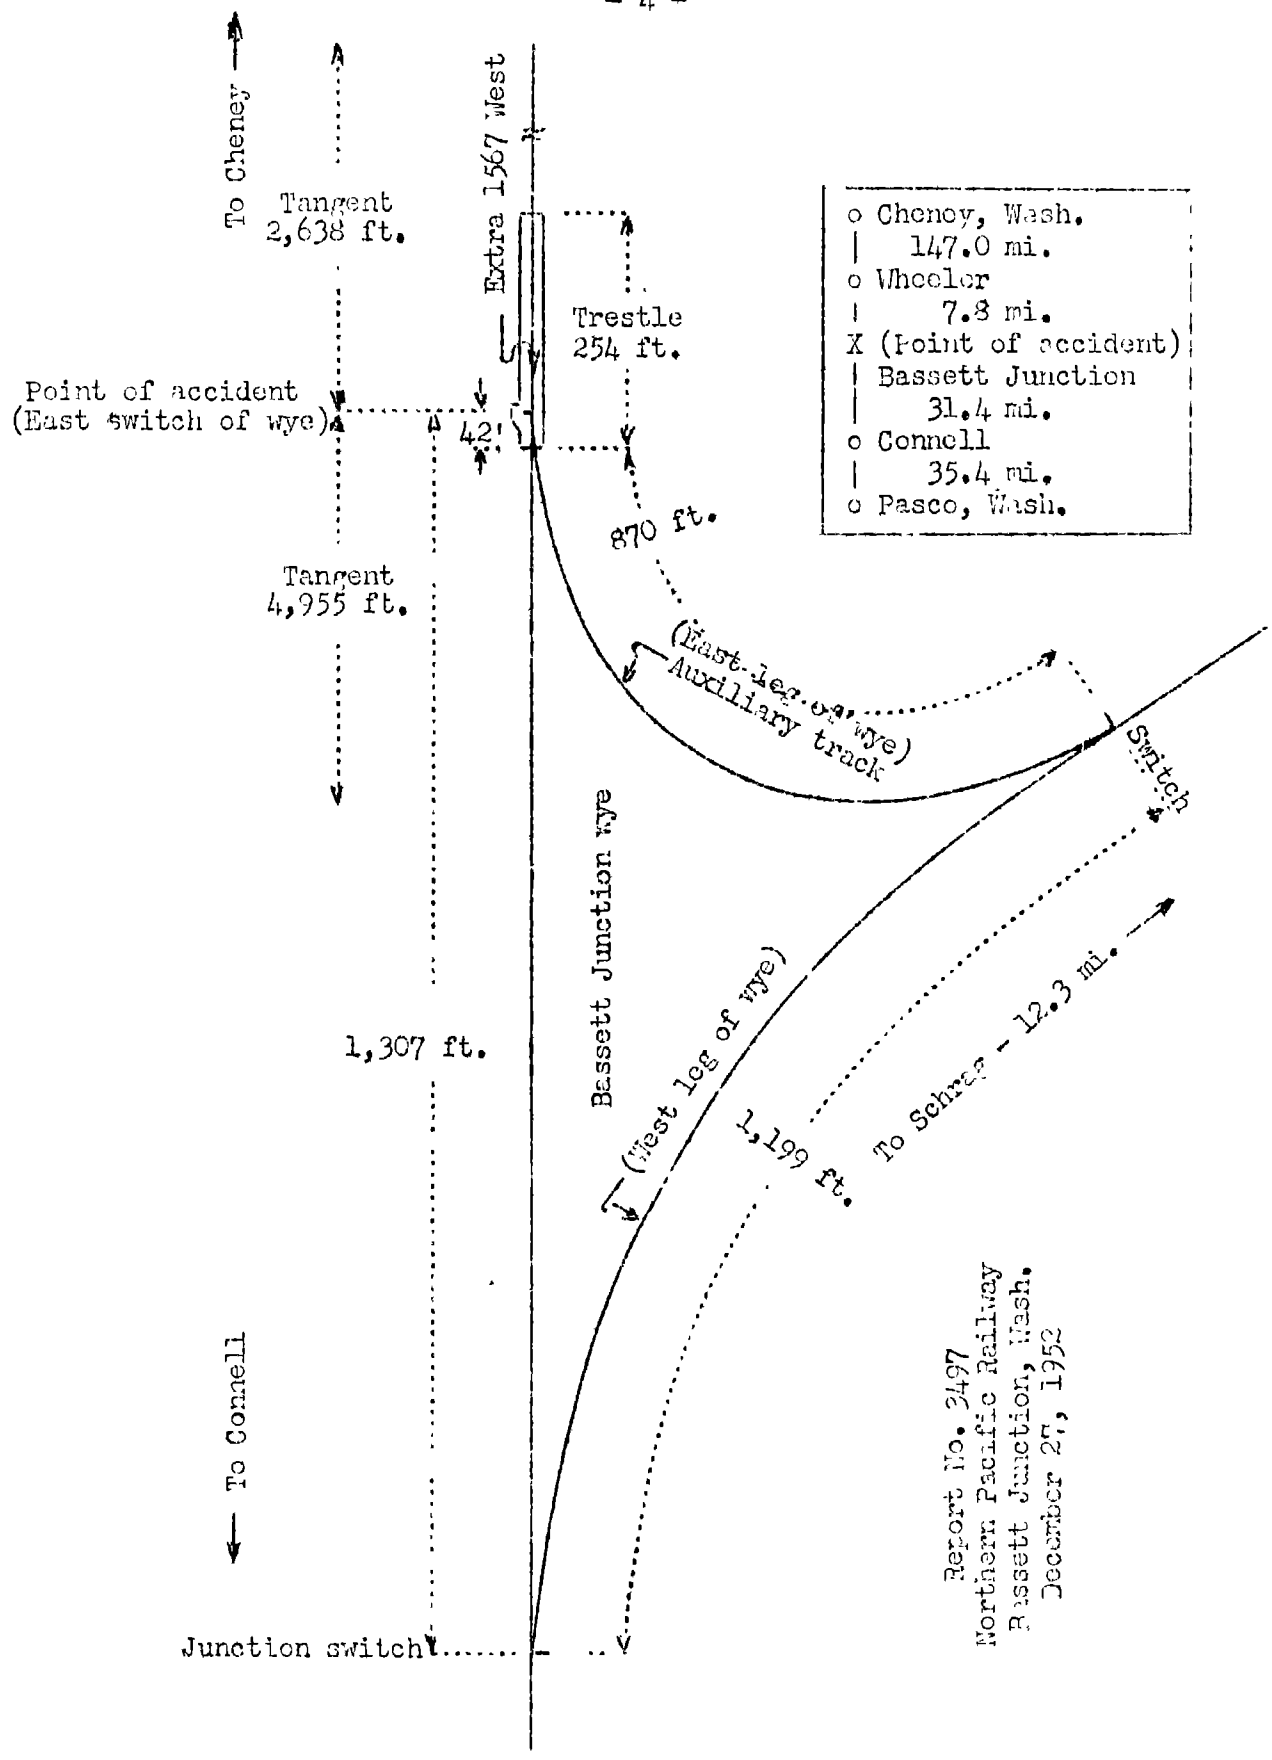
Report No. 3497
 Northern Pacific Railway
 Bassett Junction, Wash.
 December 27, 1952

| o Cheney, Wash. |
| 147.0 mi. |
| o Wheeler |
| 7.8 mi. |
| X (Point of accident) |
| Bassett Junction |
| 31.4 mi. |
| o Connell |
| 35.4 mi. |
| o Pasco, Wash. |
