ACCIDENT ON THE
NORTHERN PACIFIC RAILWAY

BUCODA, WASH.

APRIL 27, 1939

INVESTIGATION NO. 2346

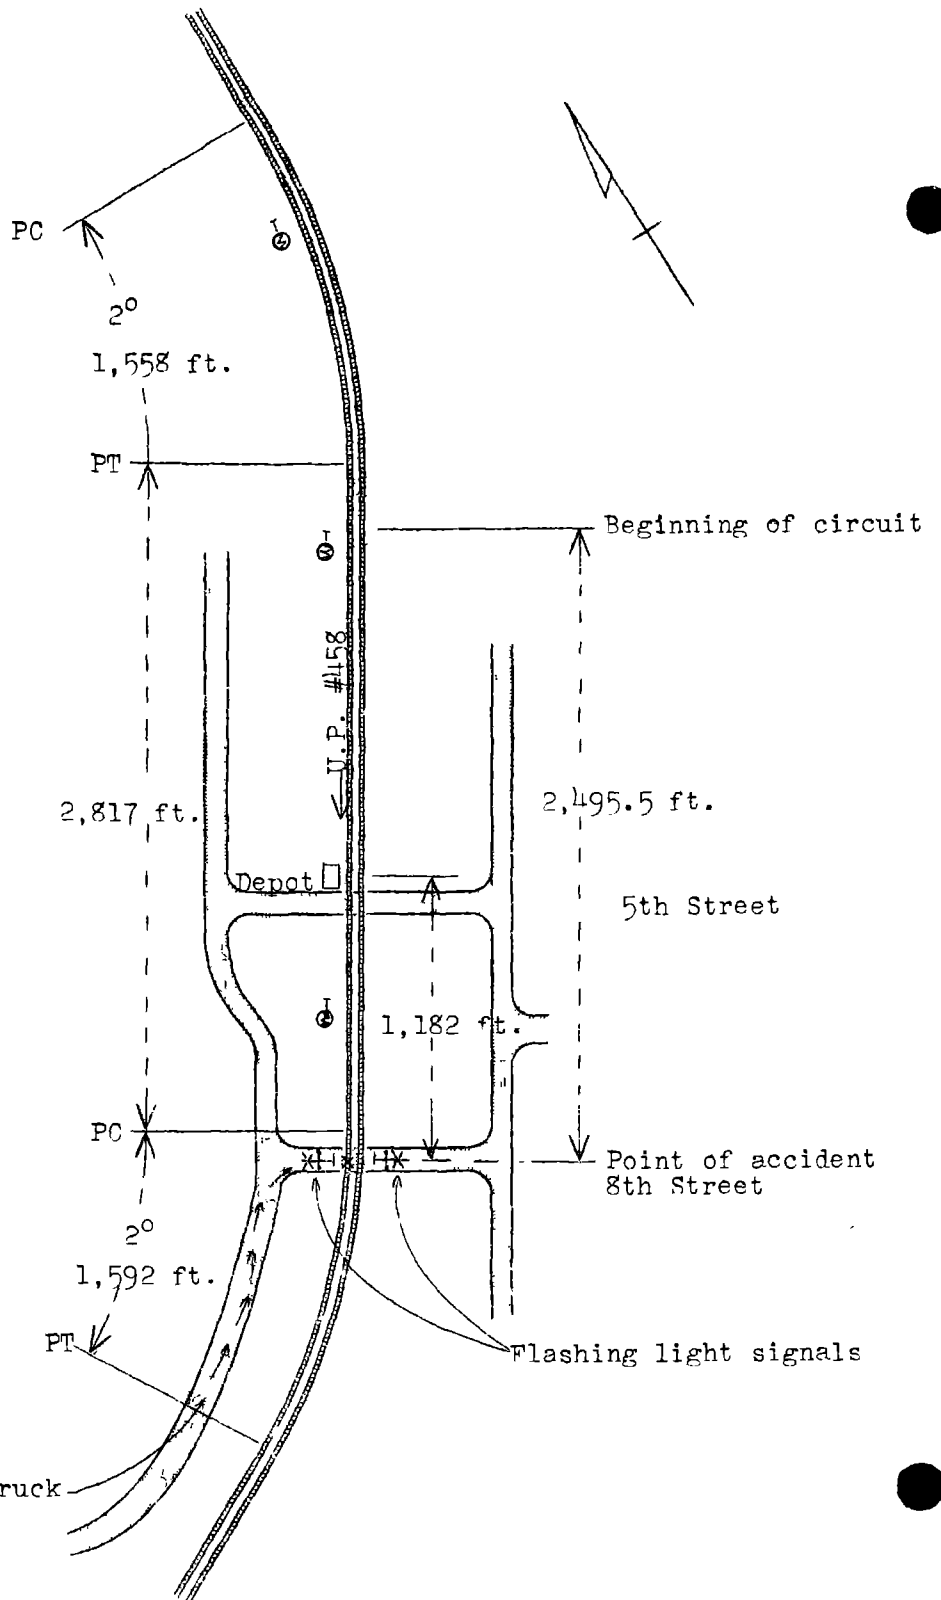
Inv. No. 2746
 Northern Pacific Ry.
 Bucoda, Wash.
 April 27, 1939

o	Tacoma, Wash.
	28.2 mi.
o	St. Clair
	6.7 mi.
o	East Olympia
	8.1 mi.
o	Tenino
	3.7 mi.
X	Bucoda (P of A)
	89.7 mi.
o	Vancouver, Wash.

This accident occurred on that part of the Tacoma Division designated as the Third Sub-Division which extends between Tacoma and Vancouver, Wash., a distance of 136.4 miles. In the vicinity of the point of accident this is a double-track line over which trains are operated by timetable, train orders, and an automatic block-signal system. This track is used jointly by the Northern Pacific, the Union Pacific, and the Great Northern. The Northern Pacific is the operating company; the train involved was manned by Union Pacific employees.

Thurston County highway parallels the railroad on the west, the center-line of the highway being 68.5 feet from the center-line of the track at the point where 8th Street connects with the highway and extends eastward therefrom. Approaching from the south on the highway the grade is descending about 1,300 feet to within about 100 feet of the crossing, then from the right-angle turn at 8th Street the grade is about 4 percent ascending to the crossing, and level over the tracks. The highway is a hard-surfaced black-top road, and is maintained in good condition; 8th Street is hard-surfaced and the crossing, which is planked and well

The crossing is protected by standard grade-crossing flashing-light signals mounted on diamond-shaped concrete islands $7\frac{1}{2}$ feet long by $4\frac{1}{2}$ feet wide by 2 feet high; the signals are located in the center of 8th Street, one on each side of the crossing and 14 feet 4 inches from the center line of the adjacent track; four lights are visible to automobile drivers from both directions. The flashing lights are located 7 feet 10 inches above the surface of the street. On each island there are two foundation yellow marker lights located near the outer edges of the concrete islands. The crossing signal control circuit for south-bound trains extends a distance of 2,495.5 feet north of the crossing; after a train enters upon this circuit the lights flash until the train passes over the crossing. A cross-bar sign, reading "RAILROAD CROSSING," is mounted on the mast above the lights and beneath the lights there is another sign, reading "2 TRACKS."
