INVESTIGATION NO 2829  
THE NORTHERN PACIFIC RAILWAY COMPANY  
REPORT IN RE ACCIDENT  
AT CASTLE ROCK, WASH., ON  
SEPTEMBER 18, 1944

Kind of accident: Side collision

Accident at Castle Rock, Wash., on September 18, 1944,  
caused by a train fouling the main track immediately  
in front of a following train.

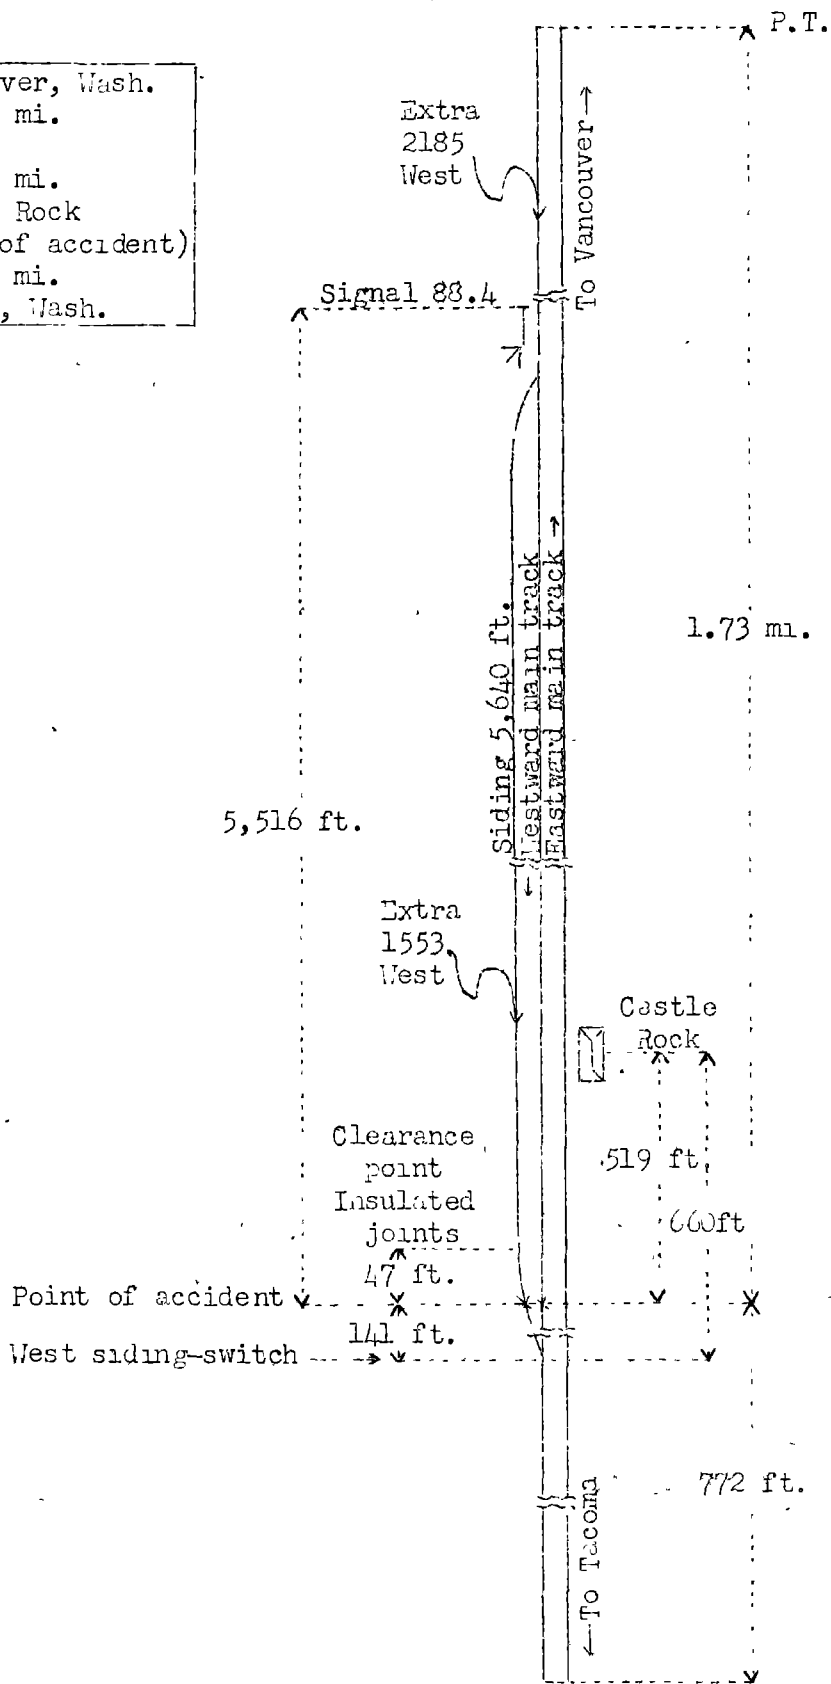
Inv. No. 2829  
 Northern Pacific Railway  
 Castle Rock, Wash.  
 September 18, 1944

o	Vancouver, Wash.	39.1 mi.
o	Kelso	9.9 mi.
X	Castle Rock (Point of accident)	87.4 mi.
o	Tacoma, Wash.
