INVESTIGATION NO. 2830
THE NORTHERN PACIFIC RAILWAY COMPANY
REPORT IN RE ACCIDENT
NEAR CASTLE ROCK, WASH., ON
SEPTEMBER 19, 1944

Kind of accident: Rear-end collision

Accident near Castle Rock, Wash., on September 19, 1944,
caused by failure of the Northern Pacific Railway
Company to provide adequate safeguards for the
movement of trains against the current of traffic.

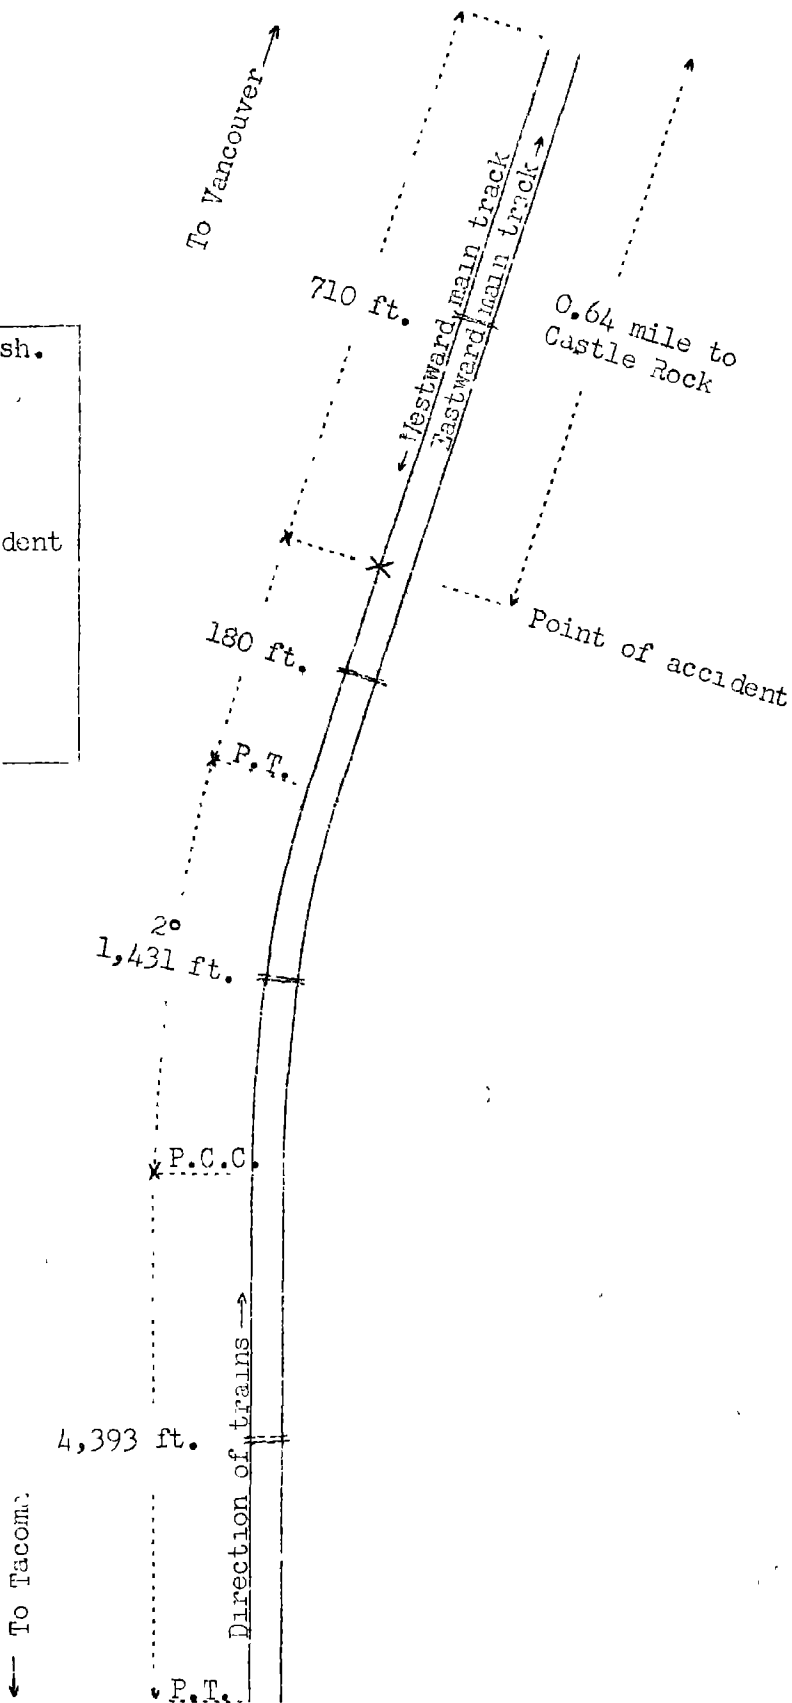
Inv-2830
 Northern Pacific Railway
 Castle Rock, Wash.
 September 19, 1944

o	Vancouver, Wash.	39.10 mi.
o	Kelso	9.90 mi.
o	Castle Rock	0.64 mi.
X	Point of accident	7.76 mi.
o	Vader Jct.	25.00 mi.
o	Centralia	54.00 mi.
o	Tacoma, Wash.

Location of Accident and Method of Operation
