REPORT OF THE DIRECTOR
BUREAU OF SAFETY

ACCIDENT ON THE
NORTHERN PACIFIC RAILWAY

CROW WING, MINN.

INVESTIGATION NO. 2427

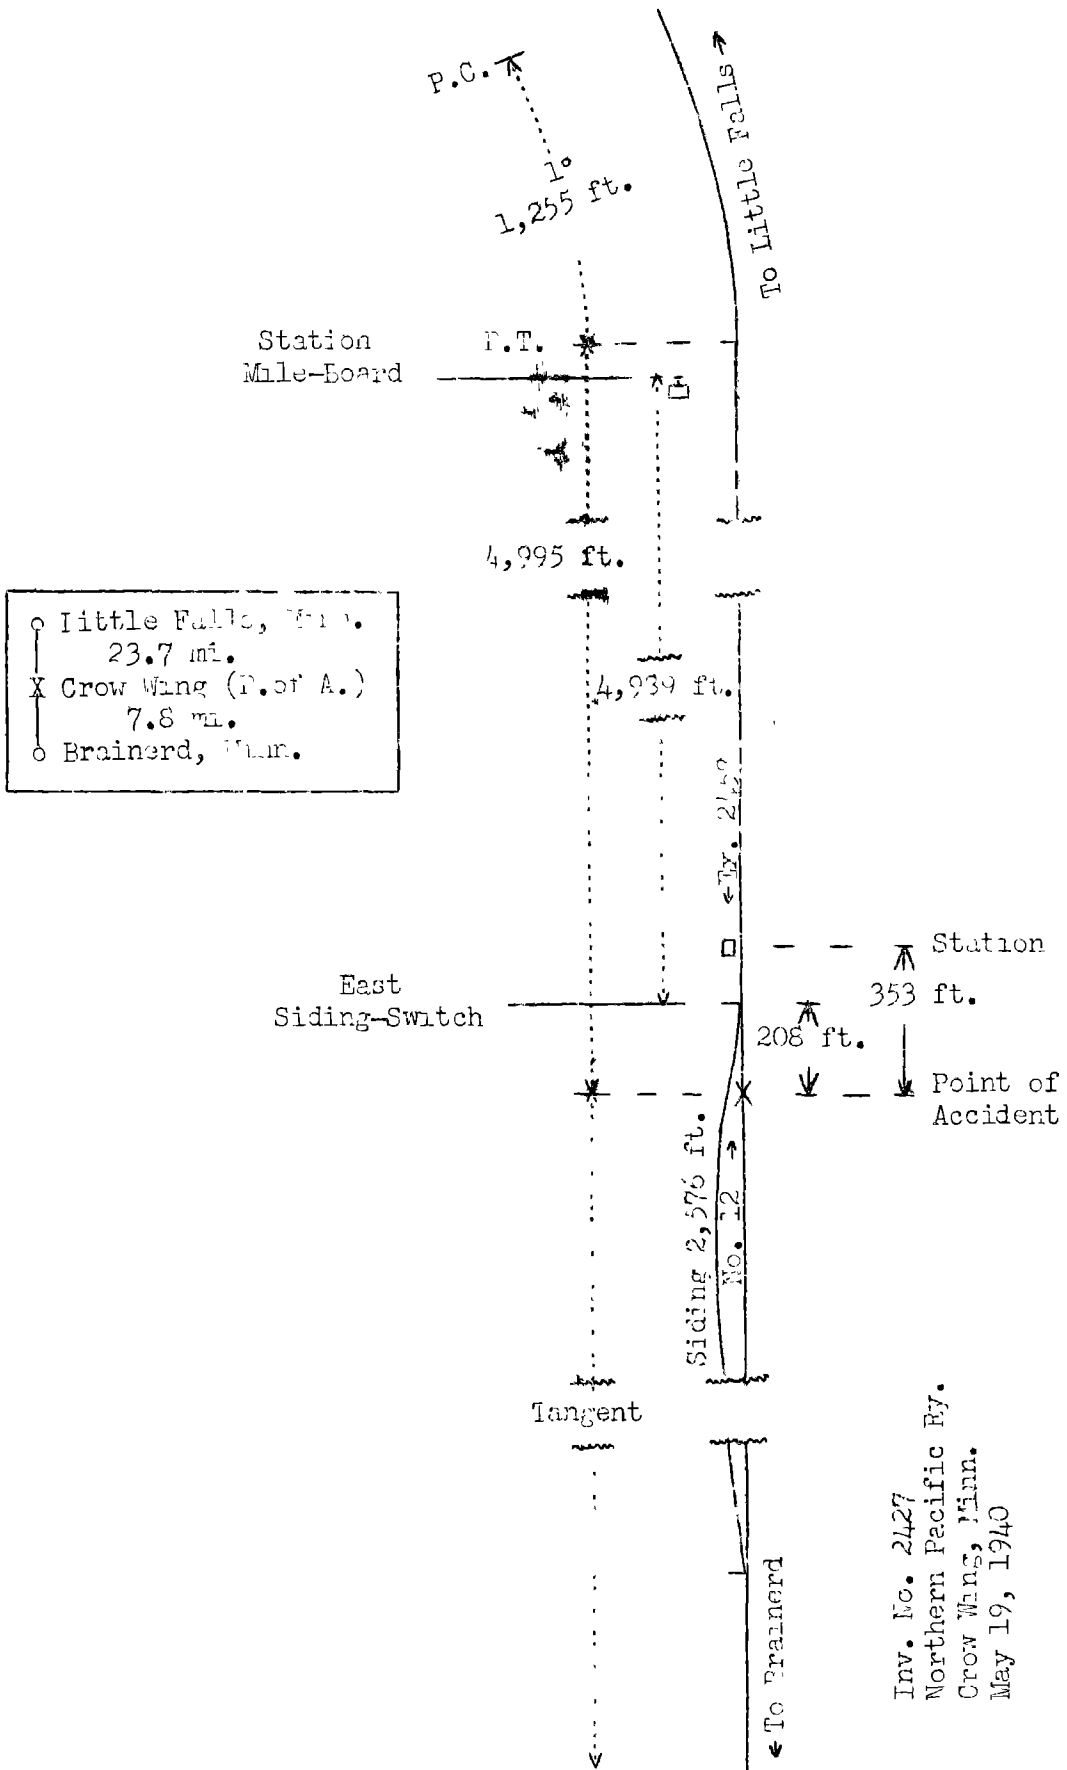
Inv. No. 2427
 Northern Pacific Ry.
 Crow Wing, Minn.
 May 19, 1940

This accident occurred on that part of the St. Paul Division designated as the Third Sub-Division which extends between Little Falls and Brainerd, Minn., a distance of 31.5 miles. In the vicinity of the point of accident this is a single-track line over which trains are operated by timetable and train orders; there is no block system in use. The accident occurred on the main track at a point 553 feet west of Crow Wing station. Approaching from the east there are, in succession, a 1° curve to the right, 1,255 feet in length, and a tangent extending 4,995 feet to the point of accident and more than 1 mile beyond. The grade is 0.278 percent ascending westward a distance of 1,802 feet to the point of accident.

A siding 2,576 feet in length parallels the main track on the north and its east switch is located 145 feet west of the station; the accident occurred at a point 208 feet west of this switch.

A station mile-board for west-bound trains is located 4,989 feet east of the east siding-switch.
