REPORT NO. 3512  
MISSOURI PACIFIC RAILROAD COMPANY  
IN RE ACCIDENT  
NEAR HALSEY, ILL., ON  
APRIL 1, 1953

Kind of accident: Head-end collision

Accident near Halsey, Ill., on April 1, 1953, caused by  
failure to provide adequate protection for the movement  
of a track motor-car.

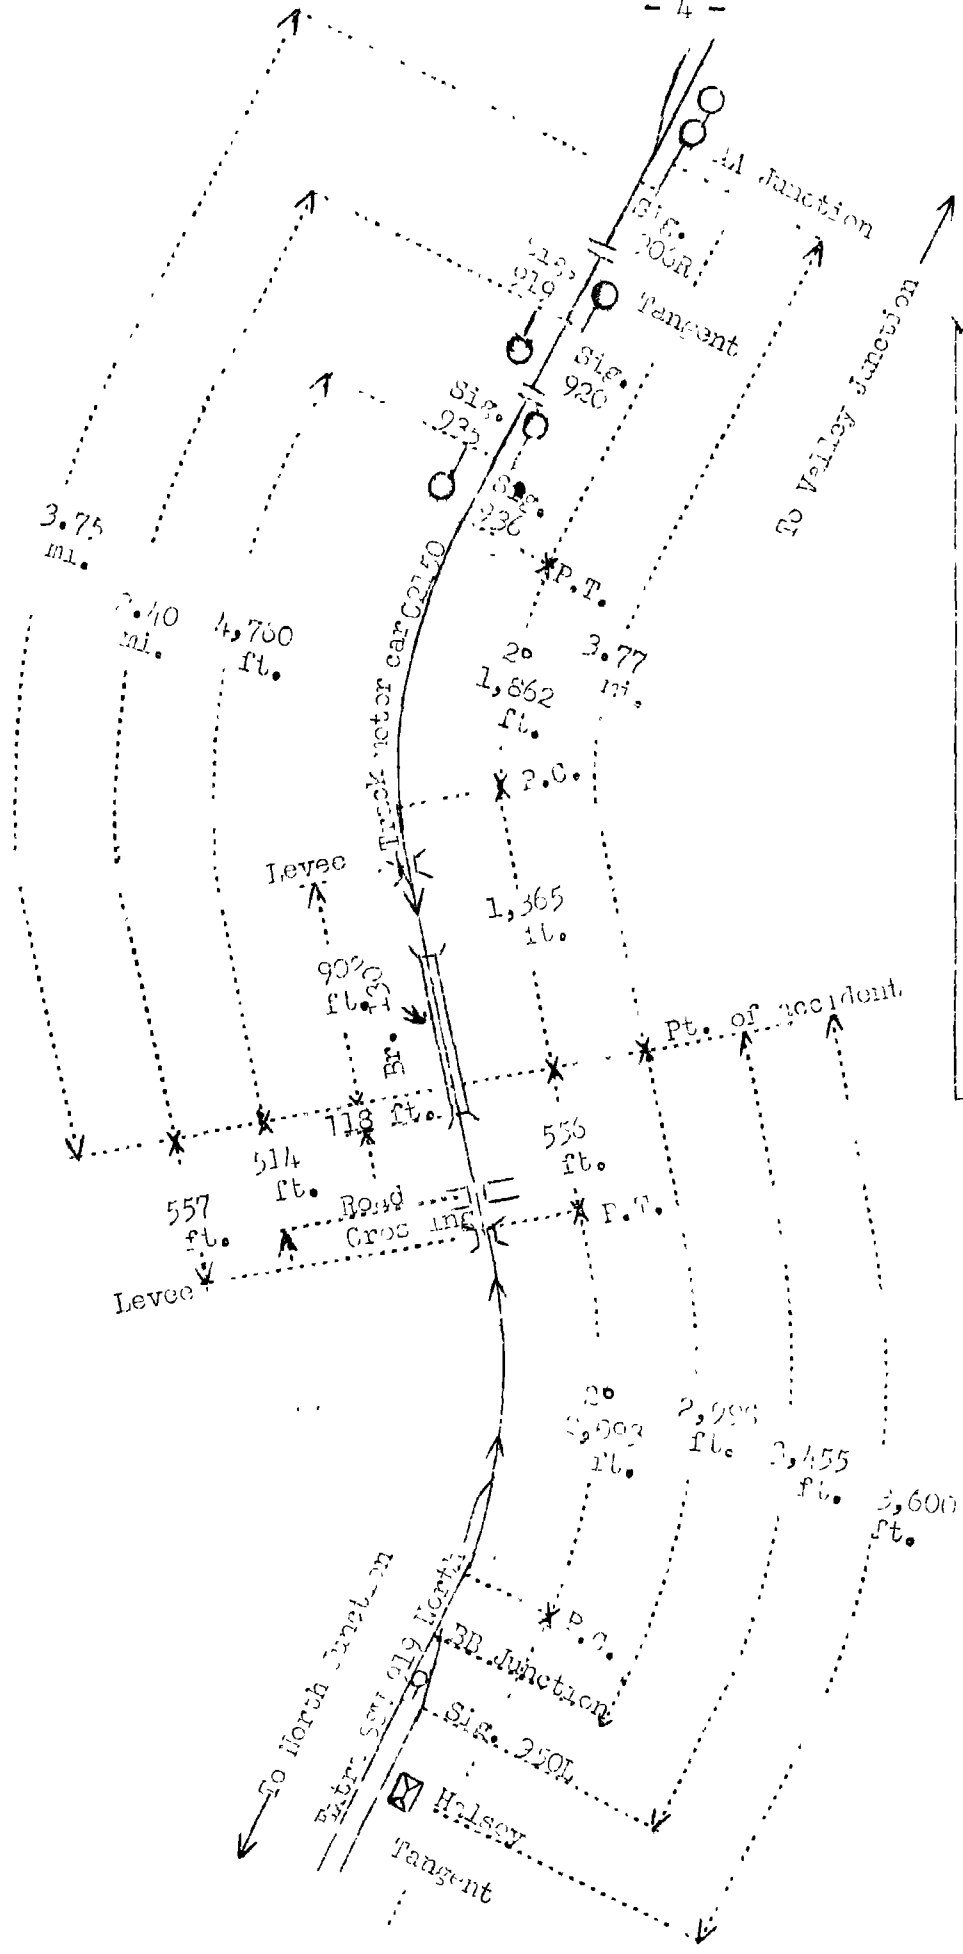
Report No. 3512  
 Missouri Pacific Railroad  
 Halsey, Ill.  
 April 1, 1953

- Valley Junction 40.17 mi.
- Flinton 12.39 mi.
- Chester 14.83 mi.
- Raddle Junction 7.82 mi.
- Gorham 6.41 mi.
- AA Junction 3.77 mi.
- ( Point of accident ) 0.57 mi.
- BR Junction 0.11 mi.
- Halsey 20.53 mi.
- JJ 1.93 mi.
- Gale 1.30 mi.
- North Junction
