REPORT NO. 3273

NORTHERN PACIFIC RAILWAY COMPANY

IN RE ACCIDENT

NEAR MELVIN, MINN., ON

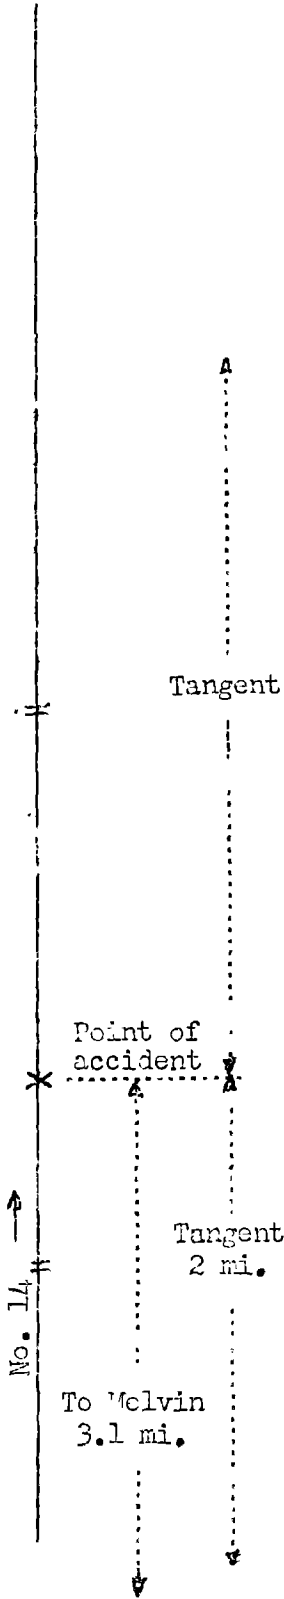
Report No. 3273  
 Northern Pacific Railway  
 Melvin, Minn.  
 August 19, 1949

To Manitoba →

o	Manitoba Jct., Minn.
	44.0 mi.
o	Fertile
	4.9 mi.
X	Point of accident
	3.1 mi.
o	Melvin
	15.2 mi.
o	Crookston
	26.7 mi.
o	East Grand Forks, Minn.

← To East Grand Forks
