INVESTIGATION NO. 2534

THE NORTHERN PACIFIC RAILWAY COMPANY

REPORT IN RE ACCIDENT

AT SENTINEL BUTTE, N. DAK., ON

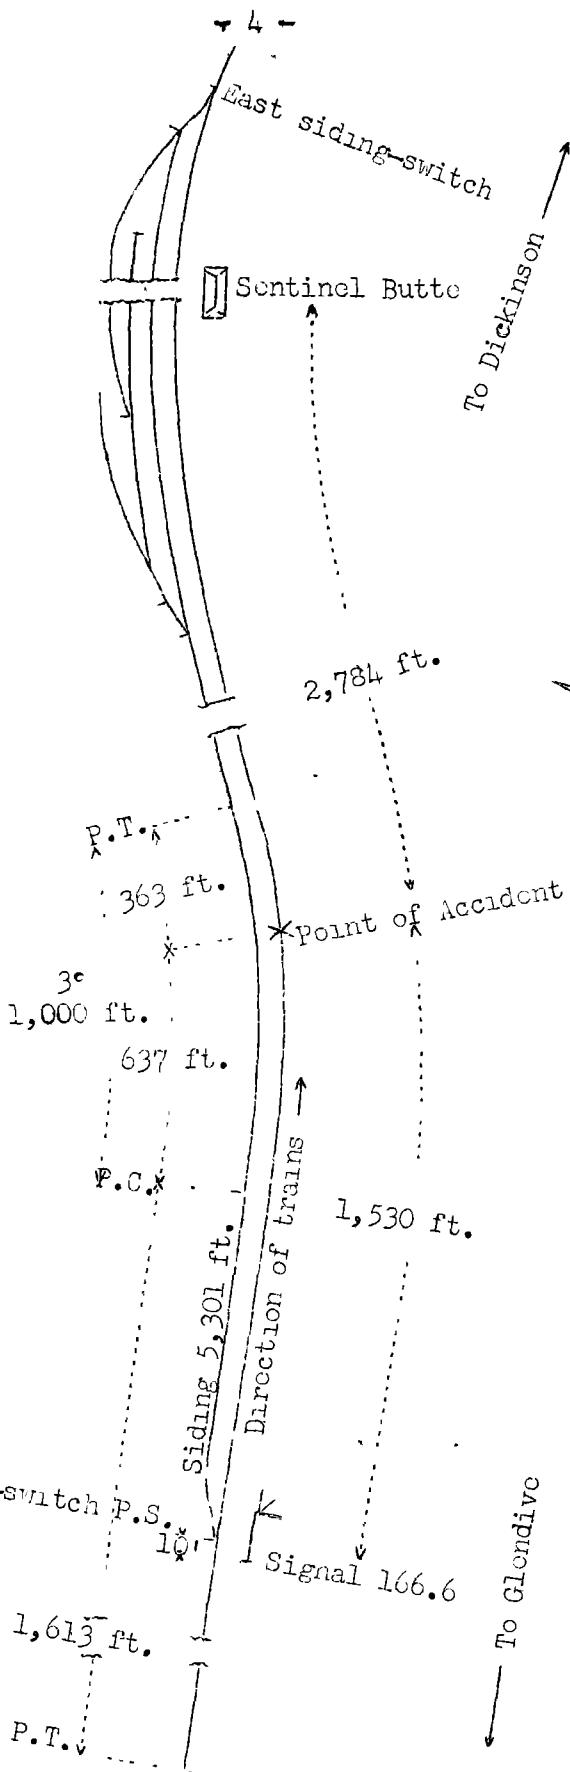
Inv-2534
 Northern Pacific Railway
 Sentinel Butte, N. Dak.
 October 3, 1941

Location of Accident and Method of Operation
