INVESTIGATION NO. 2805
THE OKLAHOMA RAILWAY COMPANY
REPORT IN RE ACCIDENT
AT BERRY, OKLA , ON
JUNE 17, 1944

Kind of accident: Rear-end collision

Accident at Berry, Okla., on June 17, 1944, caused by
failure of the Oklahoma Railway Company to provide
adequate safeguards for the movement of its trains.

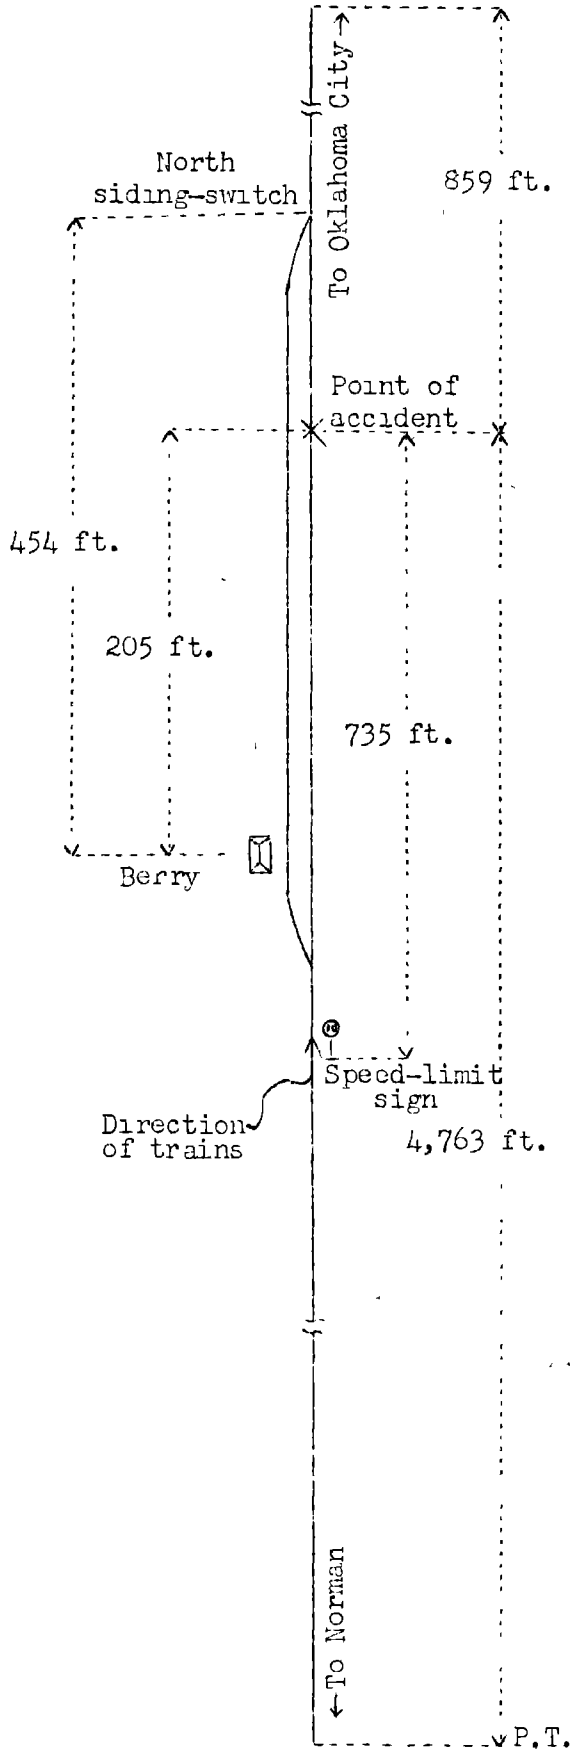
Inv. No. 2805
Oklahoma Railway
Berry, Okla.
June 17, 1944

- o Terminal Station,
Oklahoma City, Okla.
6.5 mi.
- x Berry (P. of A.)
7.3 mi.
- o Harvest
4.6 mi.
- o Norman, Okla.
