REPORT NO. 3508
PACIFIC ELECTRIC RAILWAY COMPANY
IN RE ACCIDENT
AT LOS ANGELES, CALIF., ON
JANUARY 26, 1953

Kind of accident: Rear-end collision

Cause: Failure properly to control speed
of following train in compliance
with instructions for operation
under fog conditions and failure of
the carrier to provide adequate
means of protection for the movement
of trains under heavy traffic and
adverse weather conditions

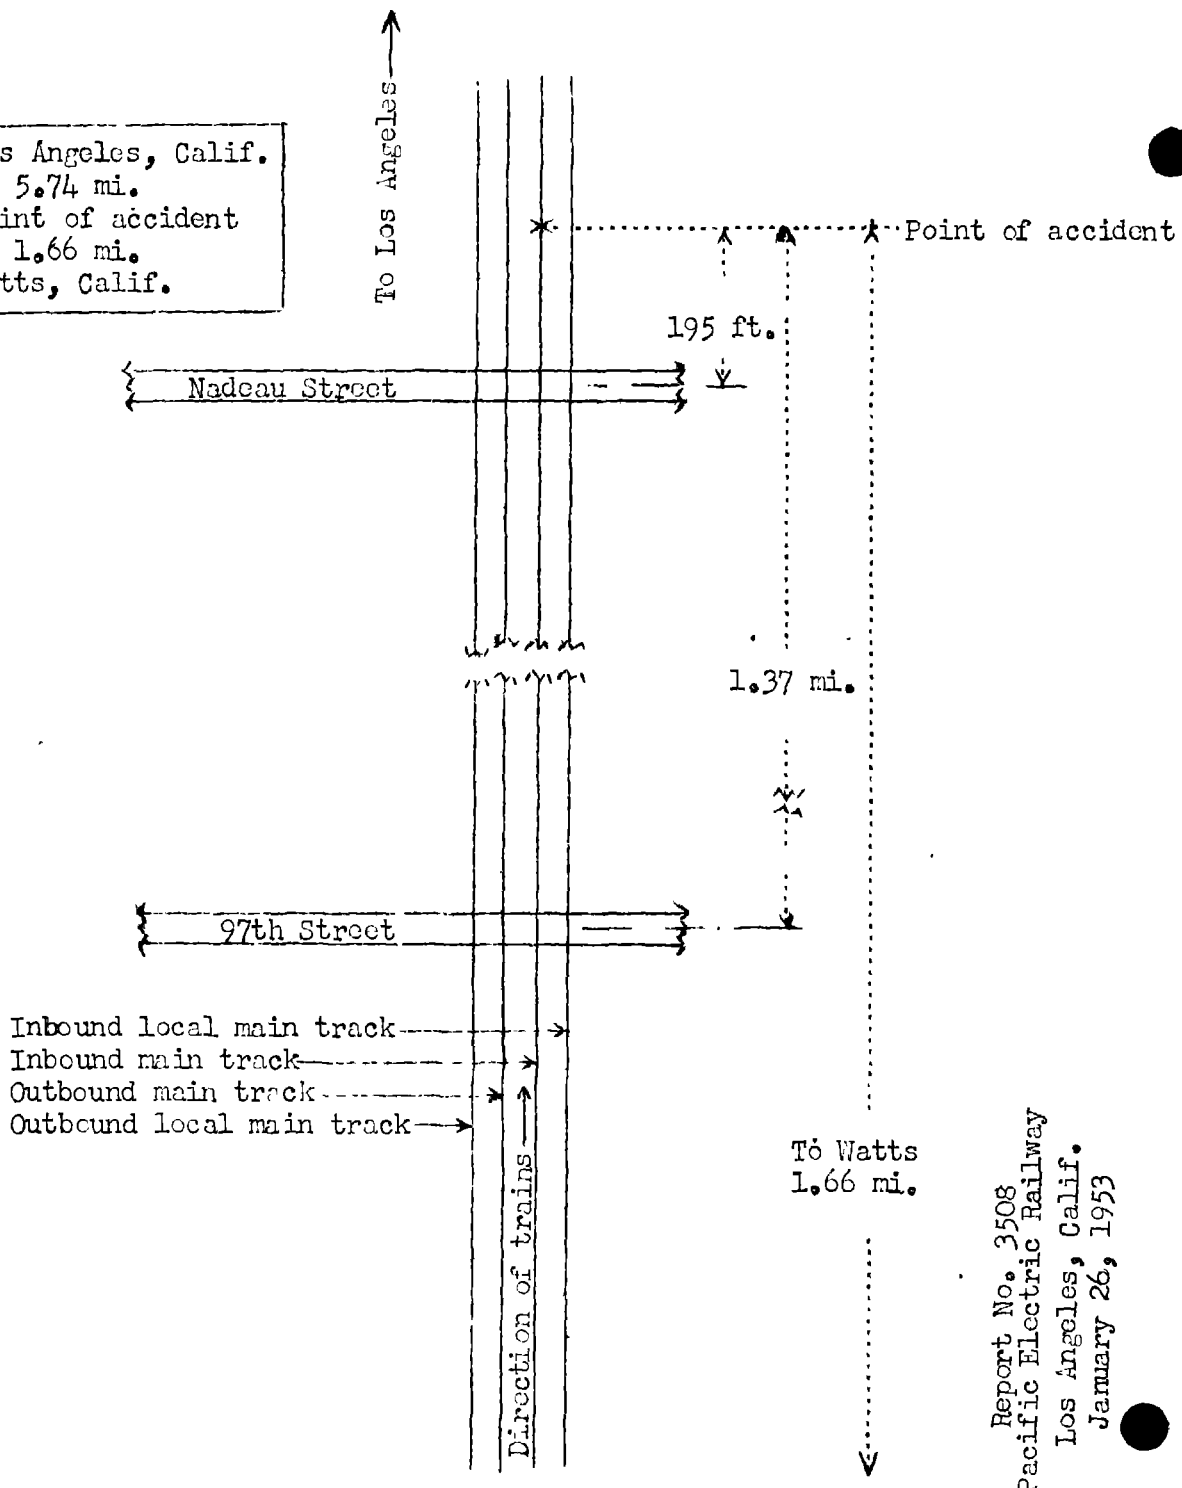
Report No. 3508
 Pacific Electric Railway
 Los Angeles, Calif.
 January 26, 1953

o Los Angeles, Calif.
 | 5.74 mi.
 X Point of accident
 | 1.66 mi.
 o Watts, Calif.
