INVESTIGATION NO. 2795  
THE PENNSYLVANIA RAILROAD COMPANY  
REPORT IN RE ACCIDENT  
NEAR ARDARA, PA., ON  
MAY 1, 1944

Accident near Ardara, Pa., on May 1, 1944, caused by  
derailed cars obstructing an adjacent main track  
immediately in front of an approaching train.

Inv-2795  
 Pennsylvania Railroad  
 Ardara, Pa.  
 May 1, 1944

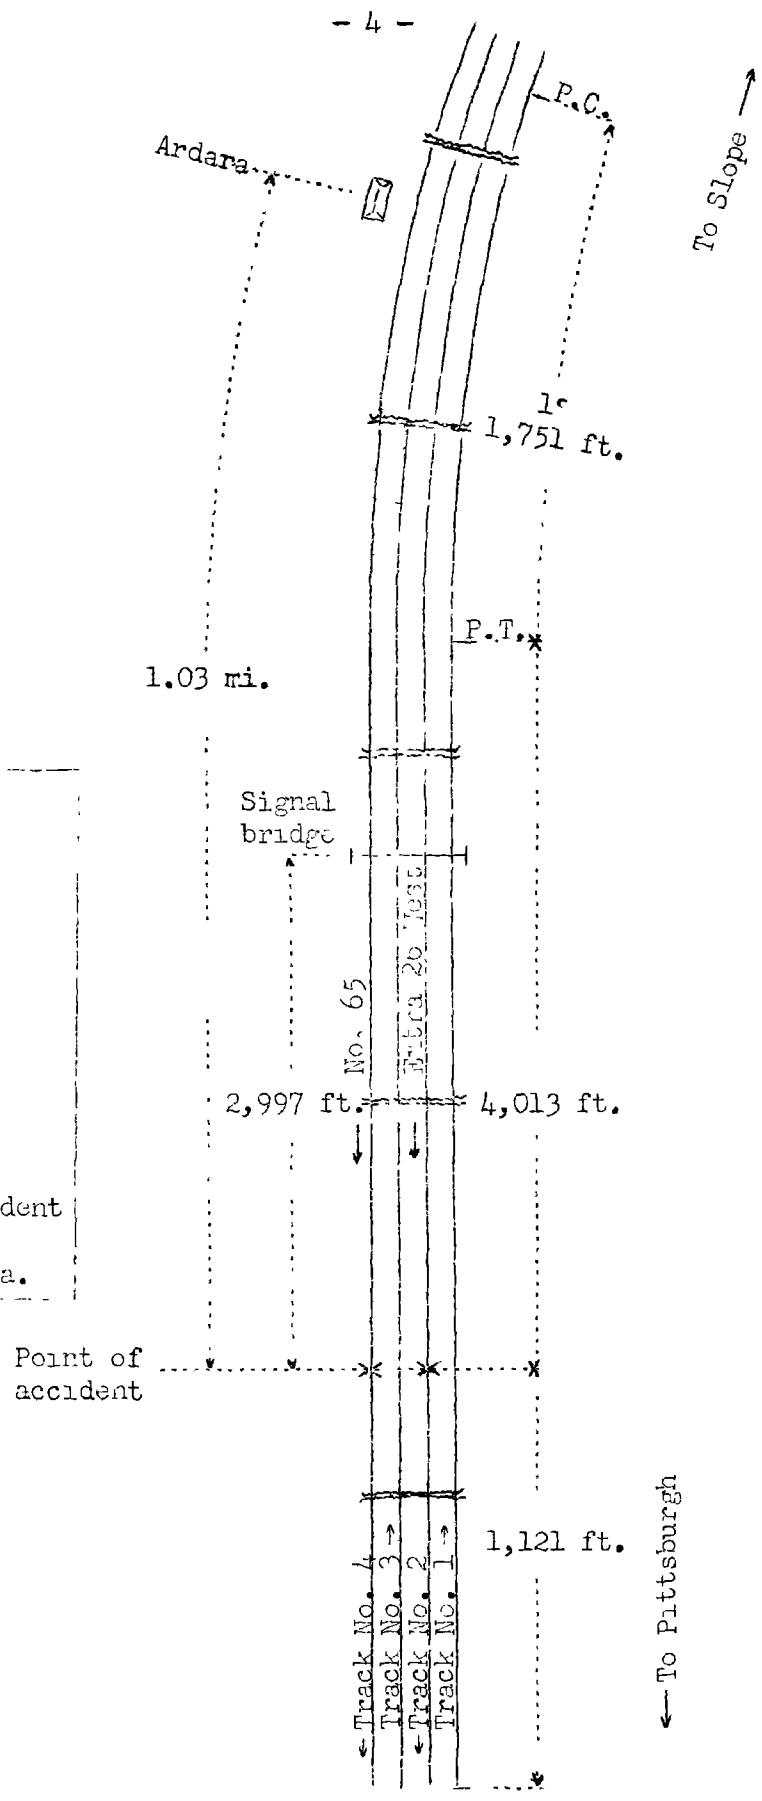
- o Slope, Pa. 34.10 mi.
- o Conemaugh 50.90 mi.
- o RG Tower 4.30 mi.
- o Manor 3.20 mi.
- o CP Tower 1.40 mi.
- o Ardara 1.03 mi.
- X Point of accident 17.97 mi.
- o Pittsburgh, Pa.

Location of Accident and Method of Operation

Signals governing west-bound movements on tracks No. 2 and No. 4 were mounted on a signal bridge 2,997 feet east of the point of accident.
