INVESTIGATION NO. 3234
THE PENNSYLVANIA RAILROAD COMPANY
REPORT IN RE ACCIDENT
AT BURGETTS, PA., ON
FEBRUARY 19, 1949

Accident at Burgetts, Pa., on February 19, 1949, caused
by failure to operate the following train in
accordance with signal indications.

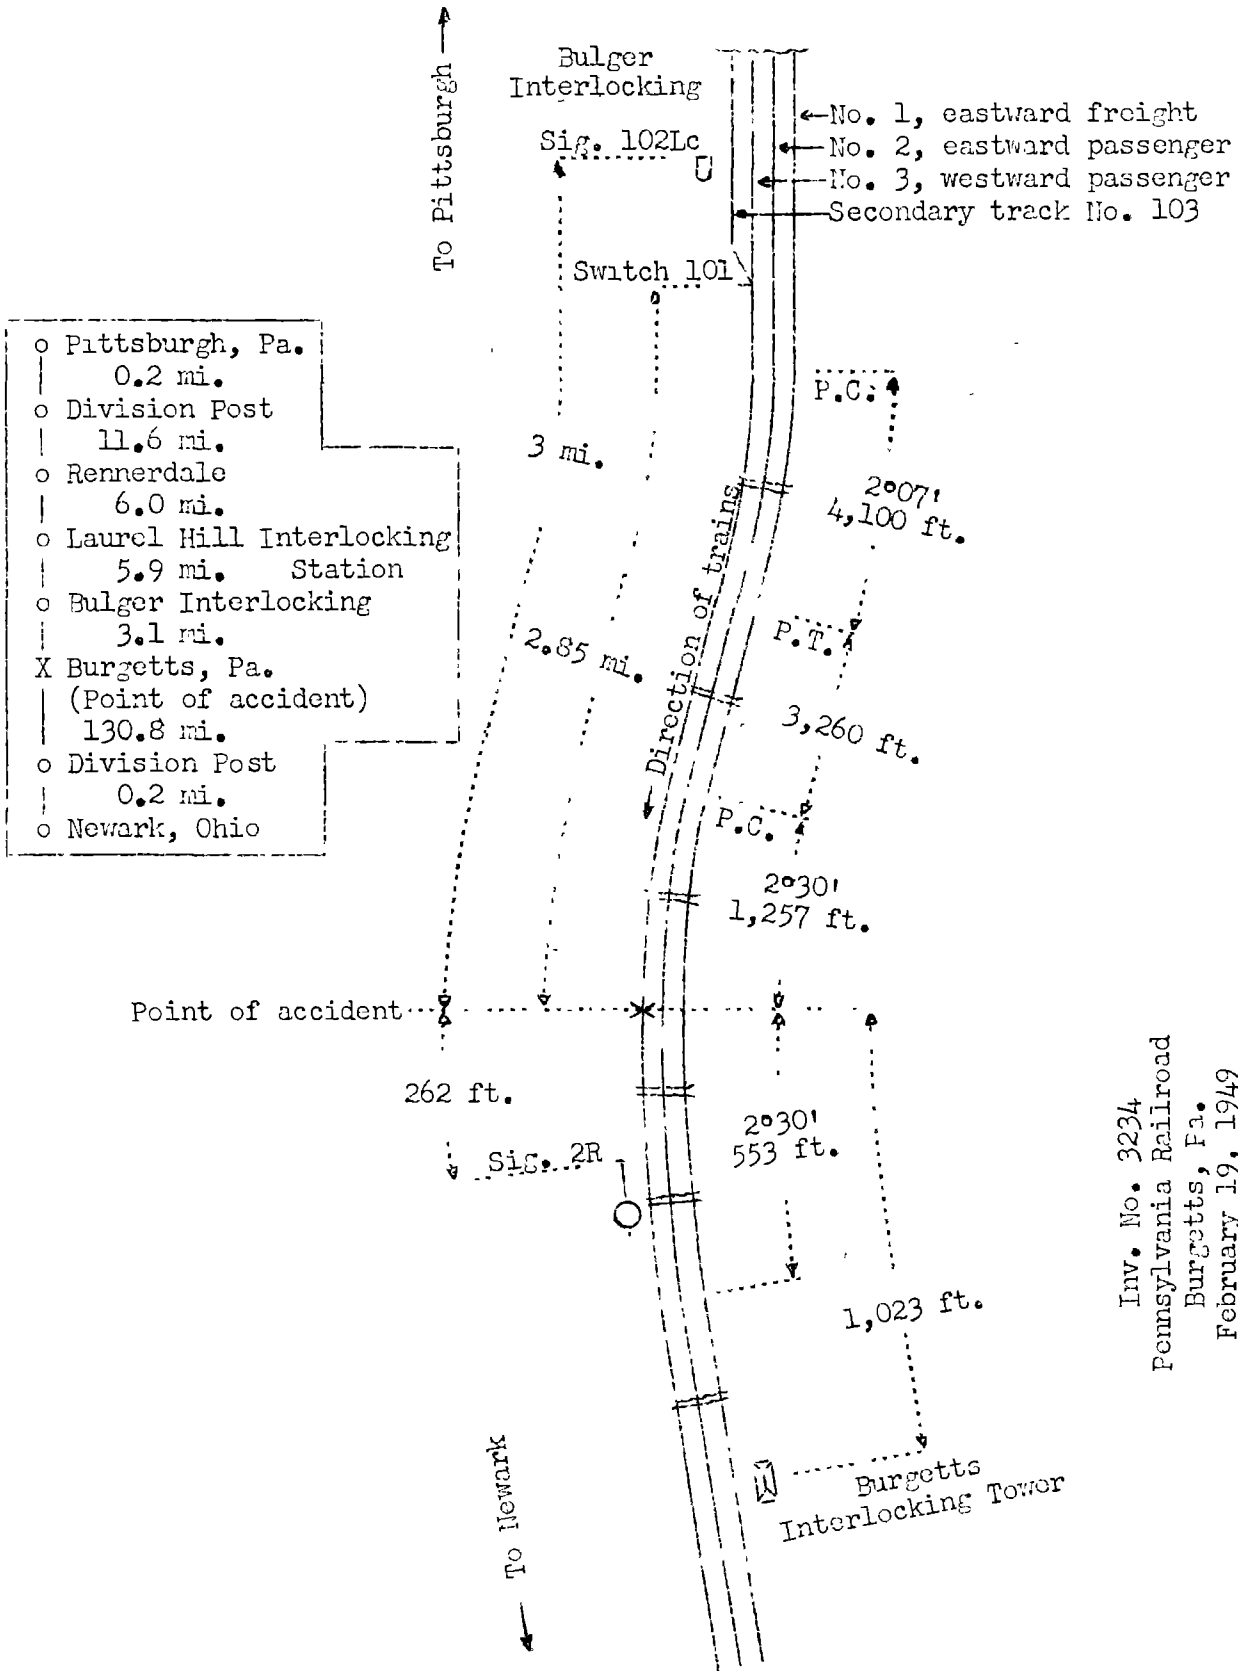
Inv. No. 3234
 Pennsylvania Railroad
 Burgetts, Pa.
 February 19, 1949

- o Pittsburgh, Pa. 0.2 mi.
- o Division Post 11.6 mi.
- o Rennerdale 6.0 mi.
- o Laurel Hill Interlocking Station 5.9 mi.
- o Bulger Interlocking 3.1 mi.
- X Burgetts, Pa. (Point of accident) 130.8 mi.
- o Division Post 0.2 mi.
- o Newark, Ohio

This accident occurred on that part of the Panhandle Division extending between Division Post, Pittsburgh, Pa., and Division Post, Newark, Ohio, 157.4 miles. In the vicinity of the point of accident, this is a three-track line, over which trains moving with the current of traffic are operated by automatic block-signal and cab-signal indications. The main tracks from south to north are designated as No. 1, eastward freight, No. 2, eastward passenger, and No. 3, westward passenger. Between Laurel Hill and Bulger interlocking stations, located, respectively, 17.8 and 23.7 miles west of Pittsburgh, secondary track No. 103, for west-bound movements, parallels the main tracks on the north. The east switch of this track connects with track No. 3 within the limits of Laurel Hill interlocking, and the west switch connects with track No. 3 within the limits of Bulger interlocking. Track No. 103 is not signaled. The accident occurred on track No. 3 at a point 26.6 miles west of Pittsburgh, and 1,023 feet east of Burgetts Interlocking Tower. From the east there are, in succession, a 2°07' curve to the right 4,100 feet in length, a tangent 3,260 feet and a 2°30' curve to the left 1,257 feet to the point of accident and 553 feet westward. The grade is 1 percent descending westward a distance of 2.82 miles to the point of accident and 173 feet beyond.
