INVESTIGATION NO. 2661
THE PENNSYLVANIA RAILROAD COMPANY
REPORT IN RE ACCIDENT
NEAR COLUMBIA CITY, IND., ON
DECEMBER 12, 1942

Railroad:	Pennsylvania
Date:	December 12, 1942
Location:	Columbia City, Ind.
Kind of accident:	Rear-end collision
Trains involved:	Freight : Passenger
Train numbers:	Extra 8393 West : 23
Engine numbers:	2303 : 5471-5357
Consist:	82 cars, caboose : 15 cars
Estimated speed:	2-5 m. p. h. : 25-50 m. p. h.
Operation:	Automatic block-signal system
Track:	Double; tangent; 0.38 percent ascending grade westward
Weather:	Hazy
Time:	About 11:05 a. m.
Casualties:	1 killed; 2 injured
Cause:	Accident caused by failure to provide adequate flag protection for preceding train, and by failure to operate following train in accordance with signal indications

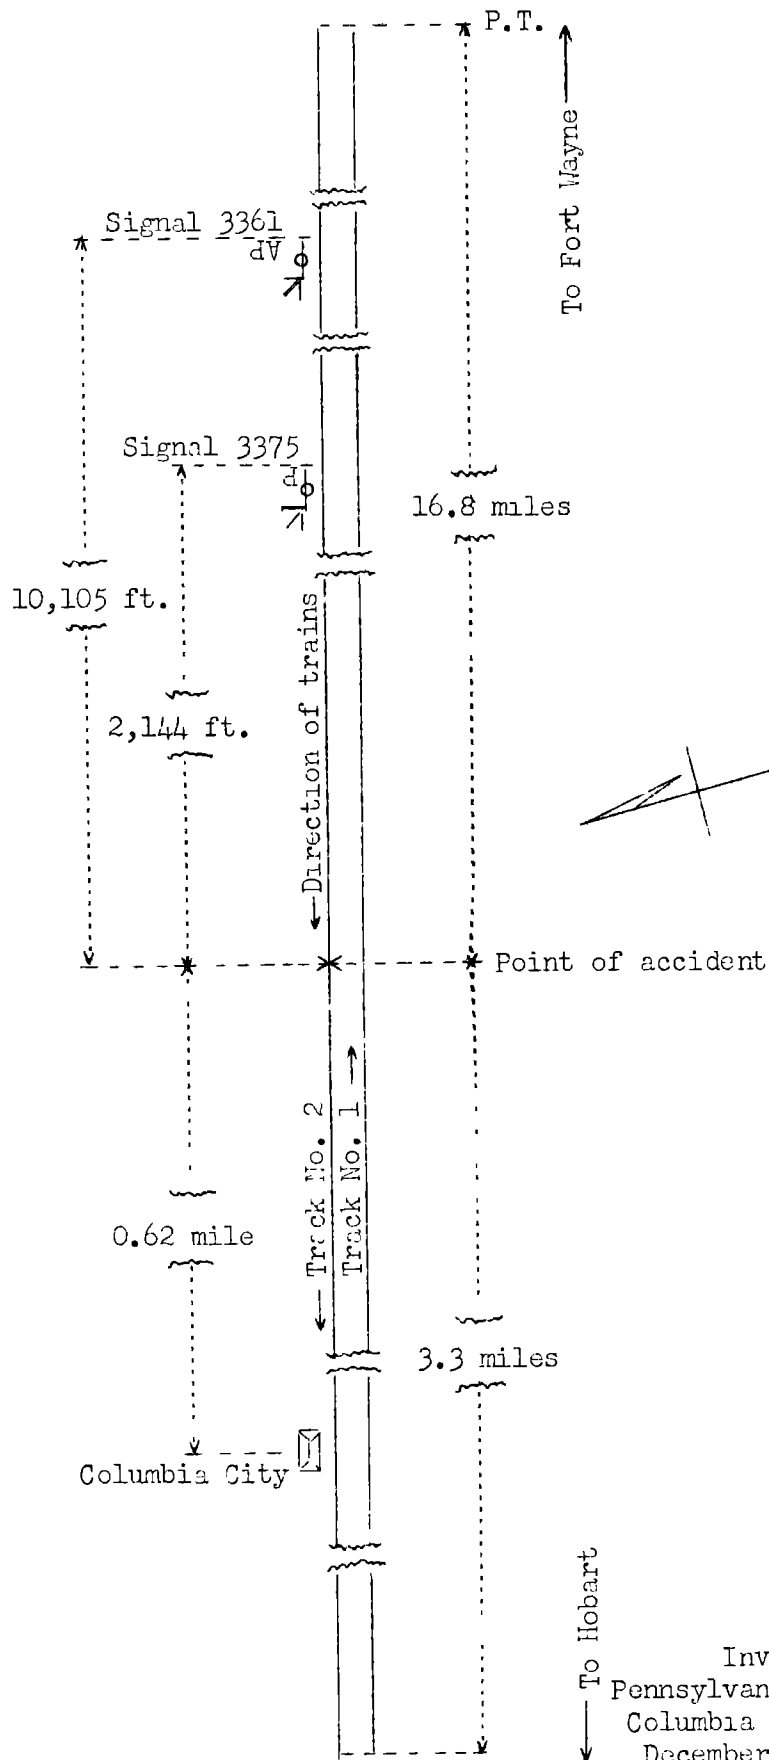
Inv-2661
 Pennsylvania Railroad
 Columbia City, Ind.
 December 12, 1942

○	Fort Wayne, Ind.
	1.40 mi.
○	Junction
	16.88 mi.
X	Point of accident
	0.62 mi.
○	Columbia City
	95.80 mi.
○	Hobart, Ind.
