INVESTIGATION NO. 2895  
THE PENNSYLVANIA RAILROAD COMPANY  
REPORT IN RE ACCIDENT  
NEAR CREIGHTON, PA., ON  
JUNE 6, 1945

Accident near Creighton, Pa., on June 6, 1945, caused by  
failure to control the speed of Extra 1487 East in  
accordance with signal indications.

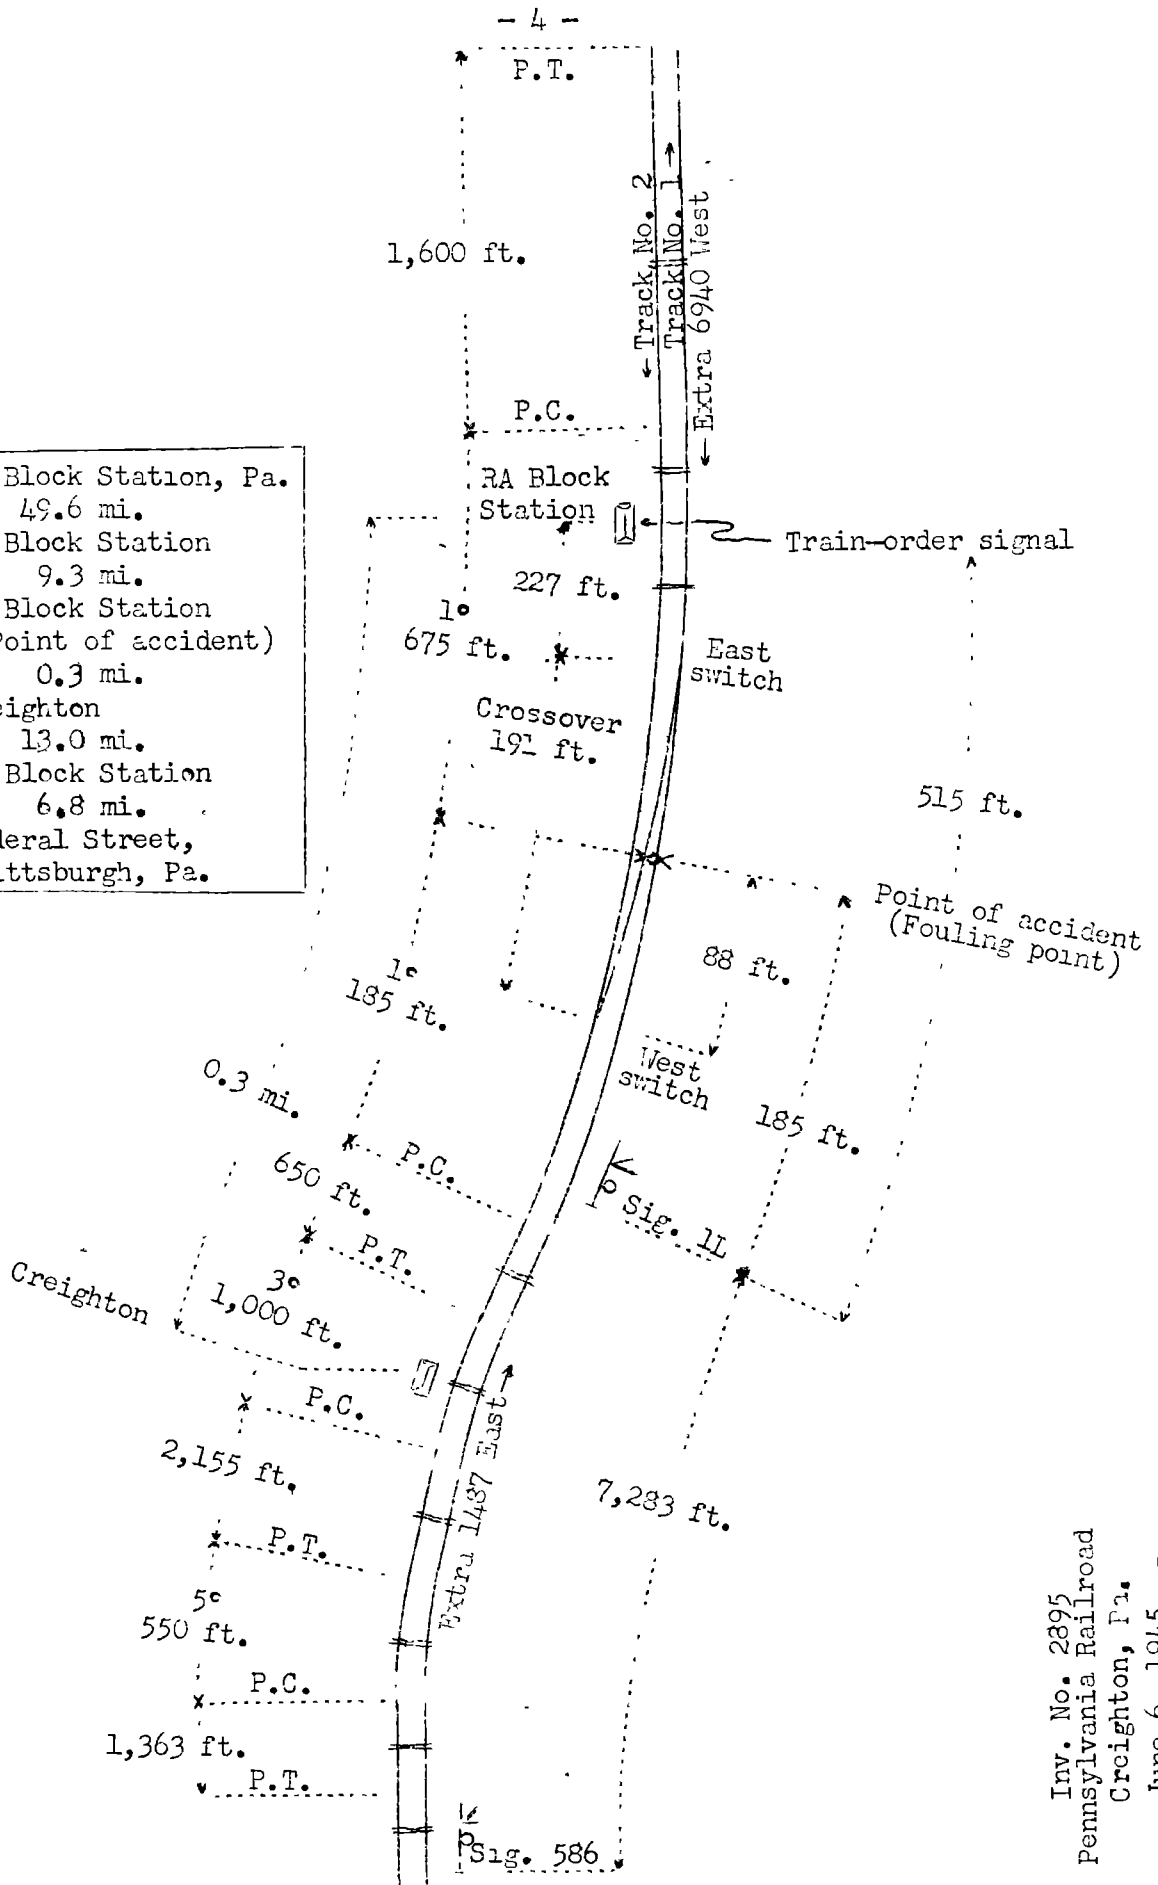
Inv. No. 2895  
 Pennsylvania Railroad  
 Creighton, Pa.  
 June 6, 1945

- o JD Block Station, Pa. 49.6 mi.
- o AJ Block Station 9.3 mi.
- X RA Block Station (Point of accident) 0.3 mi.
- o Creighton 13.0 mi.
- o UY Block Station 6.8 mi.
- o Federal Street, Pittsburgh, Pa.

Location of Accident and Method of Operation
