INVESTIGATION NO. 3049
THE PENNSYLVANIA RAILROAD COMPANY
REPORT IN RE ACCIDENT
NEAR DERRY, PA., ON
DECEMBER 17, 1946

Kind of accident: Rear-end collision

Accident near Derry, Pa., on December 17, 1946, caused
by failure to operate the following train in
accordance with signal indications.

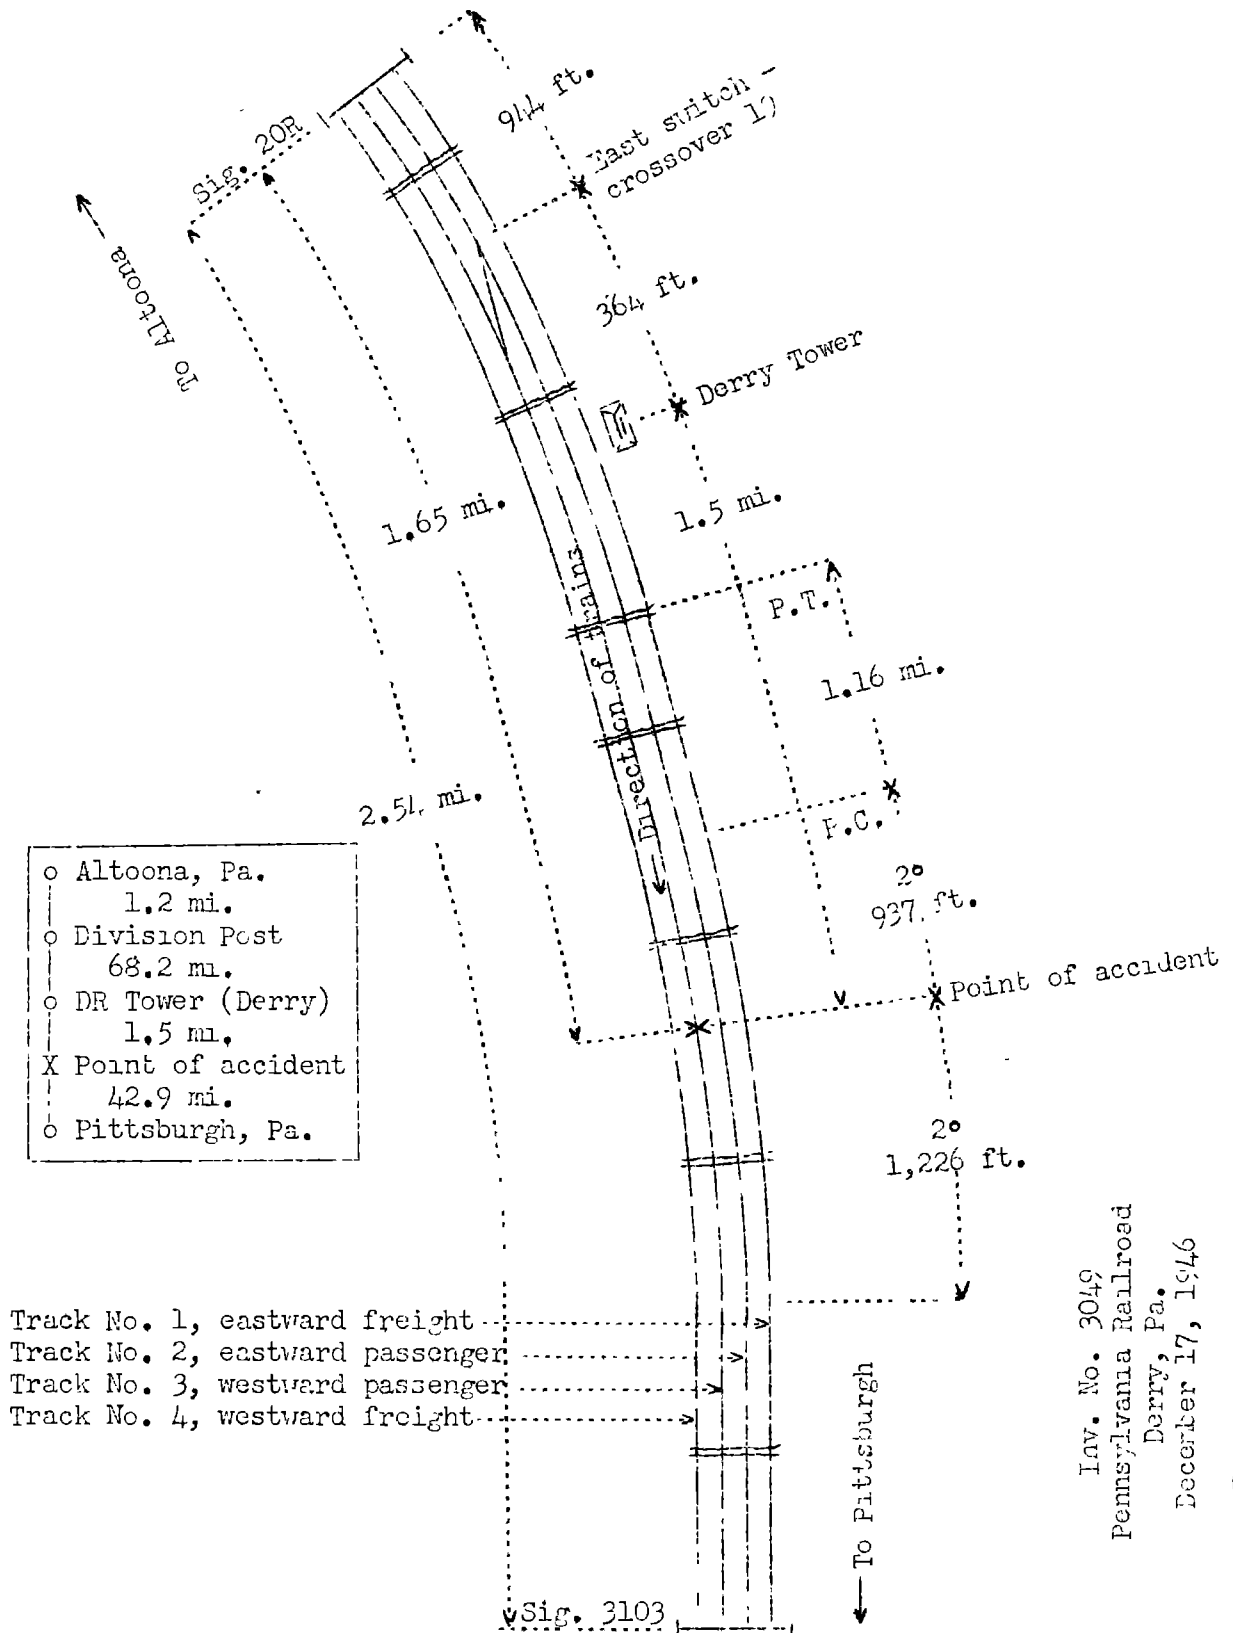
Inv. No. 3049
 Pennsylvania Railroad
 Derry, Pa.
 December 17, 1946

Location of Accident and Method of Operation
