INVESTIGATION NO. 3201
THE PENNSYLVANIA RAILROAD COMPANY
REPORT IN RE ACCIDENT
AT FRANK, OHIO, ON
SEPTEMBER 1, 1948

Accident at Frank, Ohio, on September 1, 1948, caused
by failure properly to control speed of train
moving on siding and approaching clearance point.

Inv. No. 3201
 Pennsylvania Railroad
 Frank, Ohio
 September 1, 1948

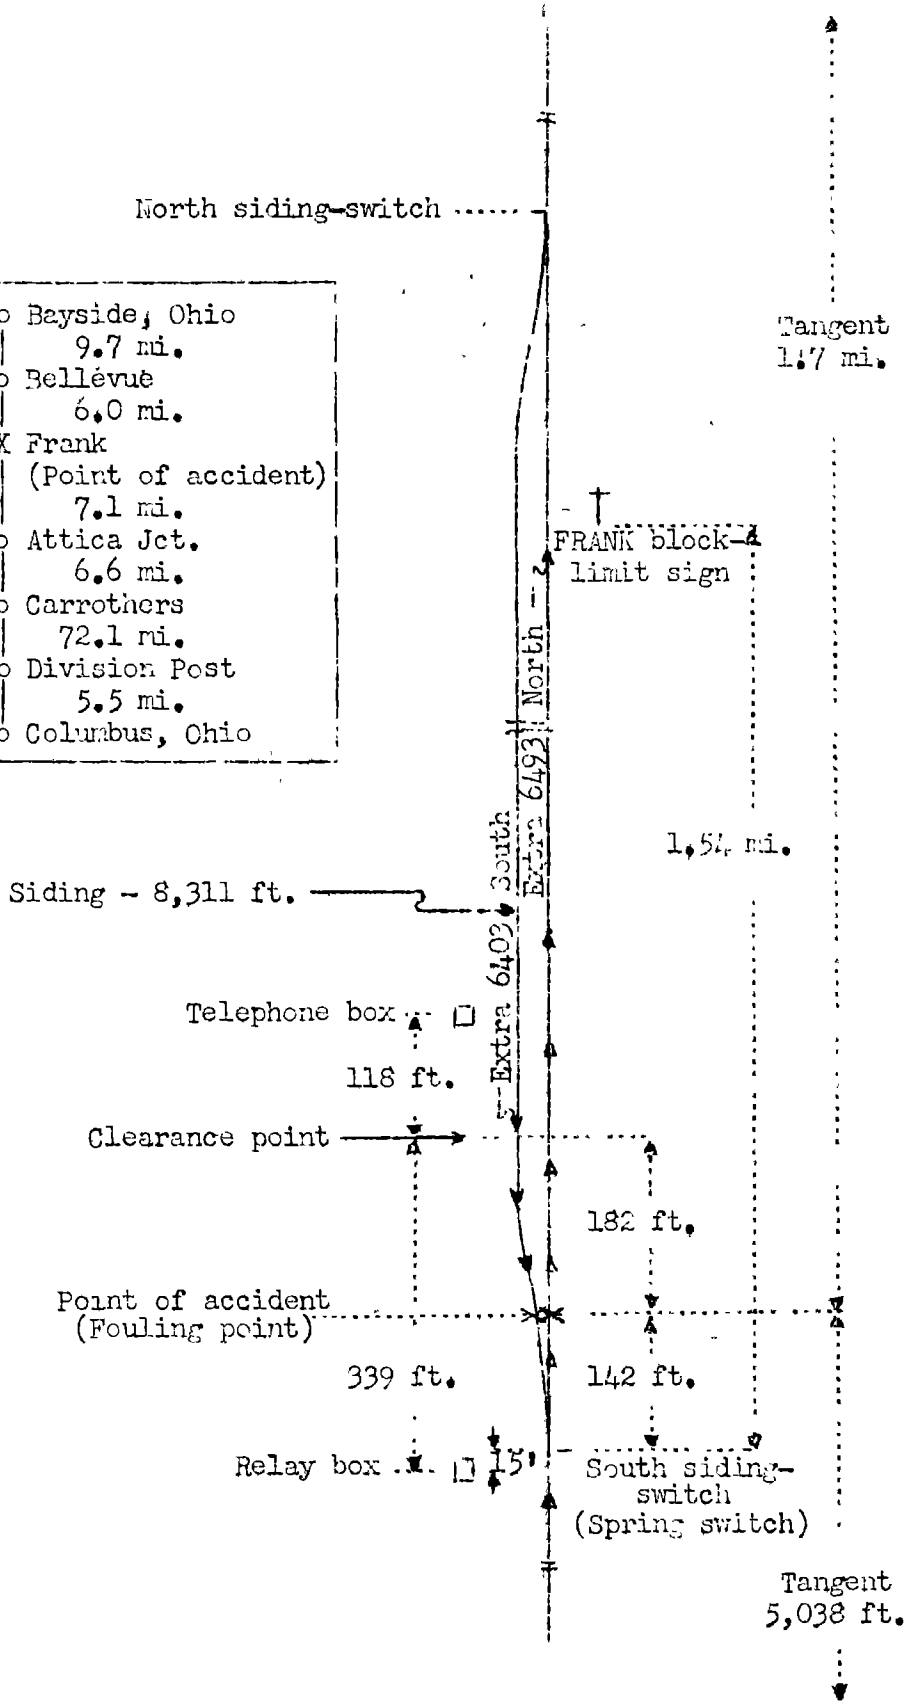
- o Bayside, Ohio
- | 9.7 mi.
- o Bellevue
- | 6.0 mi.
- X Frank
- | (Point of accident)
- | 7.1 mi.
- o Attica Jct.
- | 6.6 mi.
- o Carrothers
- | 72.1 mi.
- o Division Post
- | 5.5 mi.
- o Columbus, Ohio
