INVESTIGATION NO. 2999
THE PENNSYLVANIA RAILROAD COMPANY
REPORT IN RE ACCIDENT
NEAR TRAZEYSBURG, OHIO, ON
JUNE 26, 1946

Accident near Frazeytsburg, Ohio, on June 26, 1946, caused
by defective draft gear attachments.

Inv. No. 2999
 Pennsylvania Railroad
 Frazeysburg, Ohio
 June 26, 1946

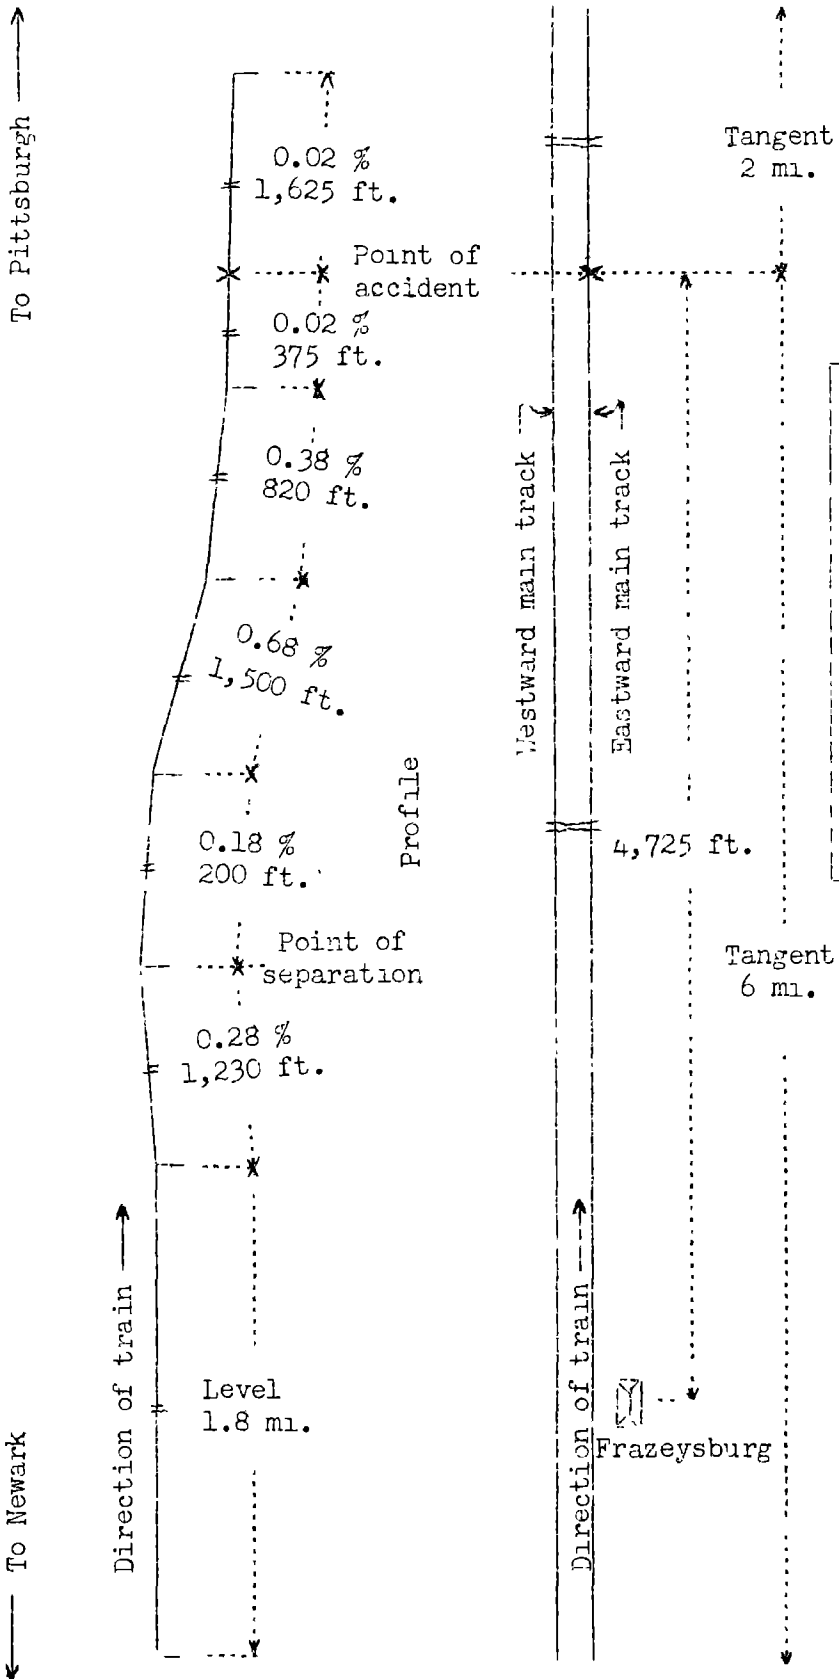
○	Pittsburgh, Pa.	0.20 mi.
○	Division Post	140.80 mi.
X	Point of accident	0.90 mi.
○	Frazeysburg, Ohio	0.90 mi.
○	Bricker	14.80 mi.
○	Division Post	0.20 mi.
○	Newark	33.10 mi.
○	Columbus, Ohio

Location of Accident and Method of Operation

This accident occurred on that part of the Panhandle Division extending between Division Post, near Newark, Ohio, and Division Post, near Pittsburgh, Pa., 157.4 miles, a double-track line in the vicinity of the point of accident, over which trains moving with the current of traffic are operated by signal indications. The accident occurred on the eastward main track, 16.61 miles east of Division Post, near Newark, at a point 4,725 feet east of the station at Frazeyburg. The main tracks are tangent throughout a distance of 6 miles immediately west of the point of accident and 2 miles eastward. The grade for east-bound trains is level throughout a distance of 1.8 miles, then it is, successively, 0.28 percent ascending 1,230 feet, 0.18 percent descending 200 feet, 0.68 percent descending 1,500 feet, 0.38 percent descending 620 feet and 0.02 percent descending 375 feet to the point of accident and 1,625 feet eastward.
