INVESTIGATION NO. 3005

THE PENNSYLVANIA RAILROAD COMPANY

REPORT IN RE ACCIDENT

NEAR GRAZIER, PA., ON

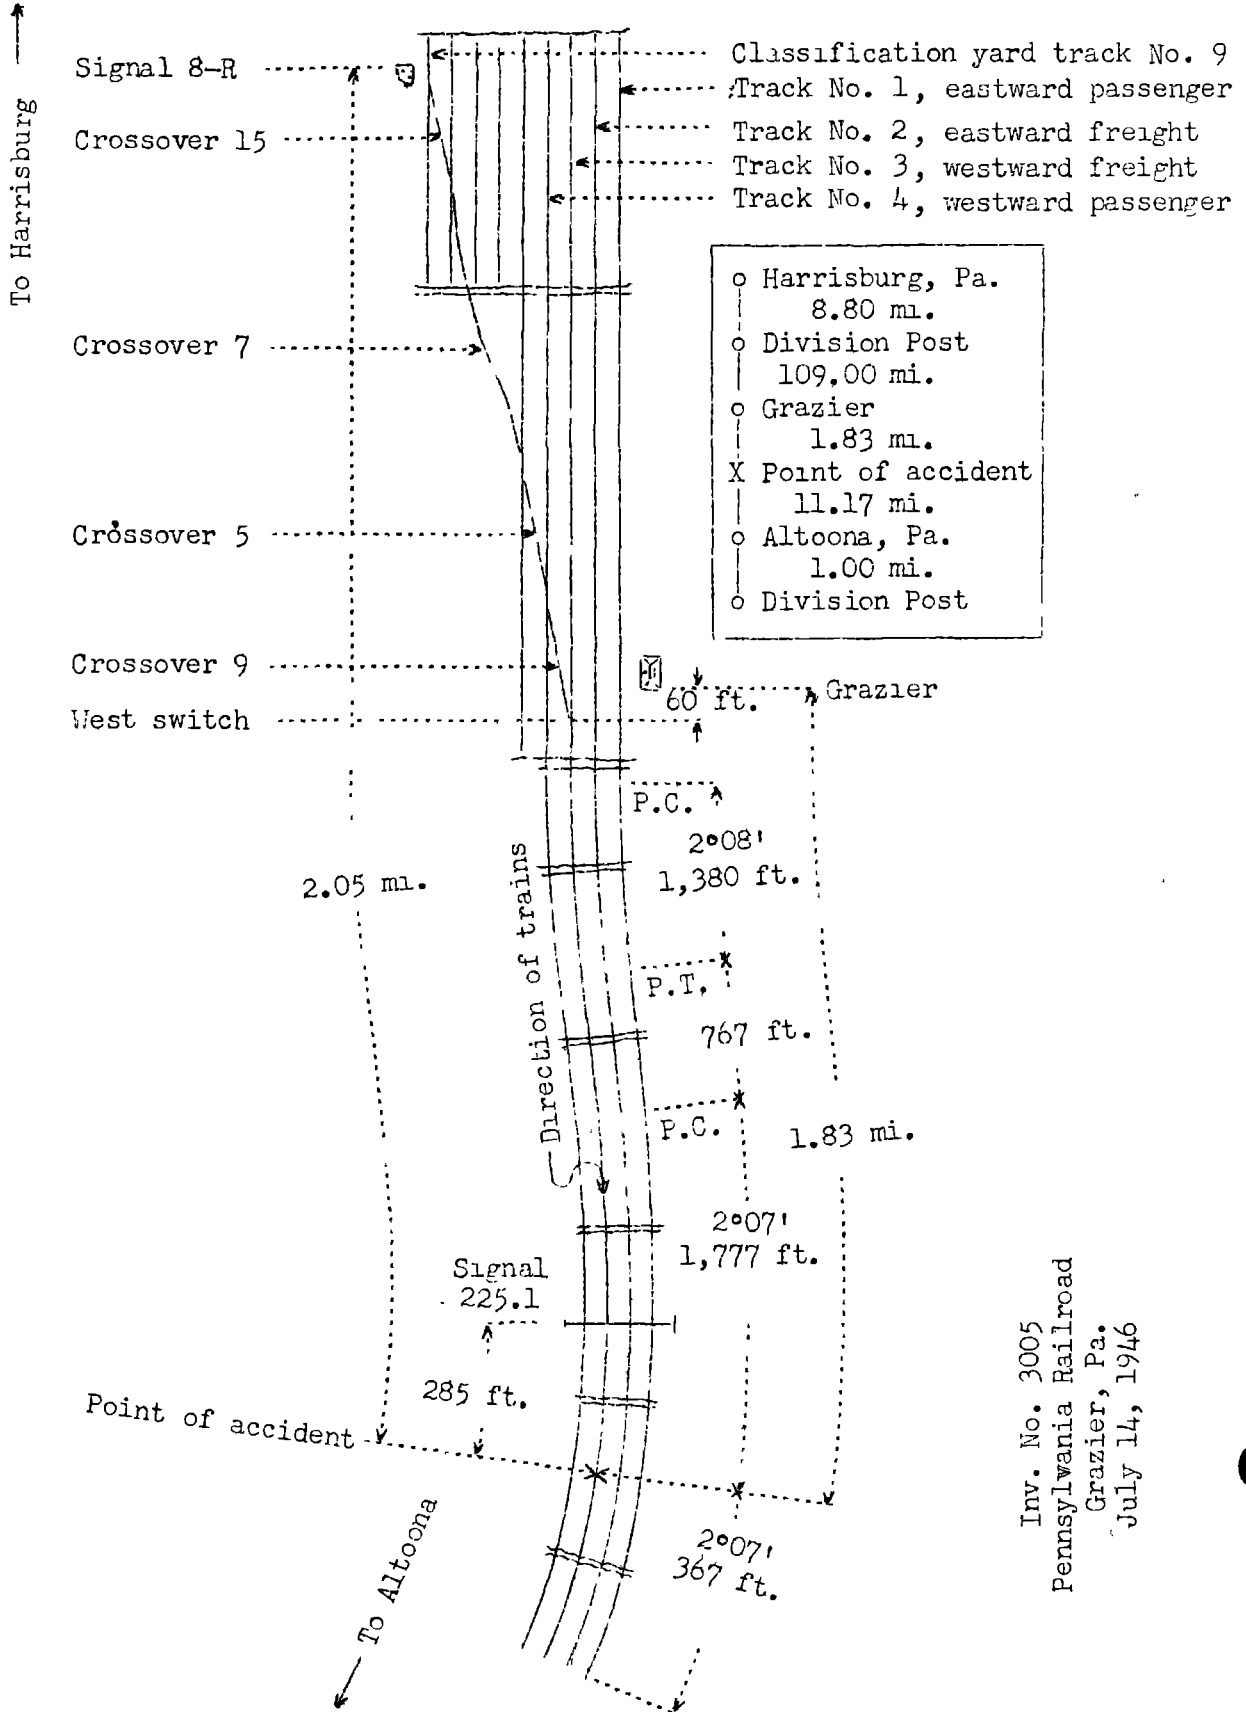
Inv. No. 3005
 Pennsylvania Railroad
 Grazier, Pa.
 July 14, 1946

Location of Accident and Method of Operation

This accident occurred on that part of the Middle Division extending between Division Post, near Harrisburg, and Division Post, near Altoona, Pa., 123 miles, a four-track line in the vicinity of the point of accident. The main tracks from south to north are designated as No. 1, eastward freight, No. 2, eastward passenger, No. 3, westward passenger, and No. 4, westward freight. Trains moving with the current of traffic on tracks Nos. 1, 2, 3 and 4 are operated by automatic block-signal and cab-signal indications. At Grazier, 117.8 miles west of Harrisburg, the tracks of a freight classification yard parallel the main tracks on the north. West-bound movements from yard track No. 9 to main track No. 4 and thence to track No. 3 are made through crossovers 15, 7, 5 and 9, the switches of which are controlled from the tower at Grazier. The west switch of crossover 9 is 60 feet west of the tower. The accident occurred on track No. 3 at a point 1.83 miles west of the tower at Grazier. From the east on track No. 3 there are, in succession, a 2°08' curve to the left 1,380 feet in length, a tangent 767 feet, and a 2°07' curve to the right 1,777 feet to the point of accident and 367 feet westward. The grade is 0.40 percent ascending westward.

The controlling circuits are so arranged that when a west-bound train is occupying track No. 3 in the block extending between a point 1,466 feet west of signal 8-R and signal 225.1,
