INVESTIGATION NO. 3045  
THE PENNSYLVANIA RAILROAD COMPANY  
REPORT IN RE ACCIDENT  
NEAR GUTHRIE, OHIO, ON  
DECEMBER 13, 1946

Kind of accident: Rear-end collision and wreckage struck by train moving on adjacent main track

Accident near Guthrie, Ohio, on December 13, 1946, caused by failure to operate the following freight train in accordance with signal indications, and wreckage obstructing an adjacent main track immediately in front of an approaching passenger train.

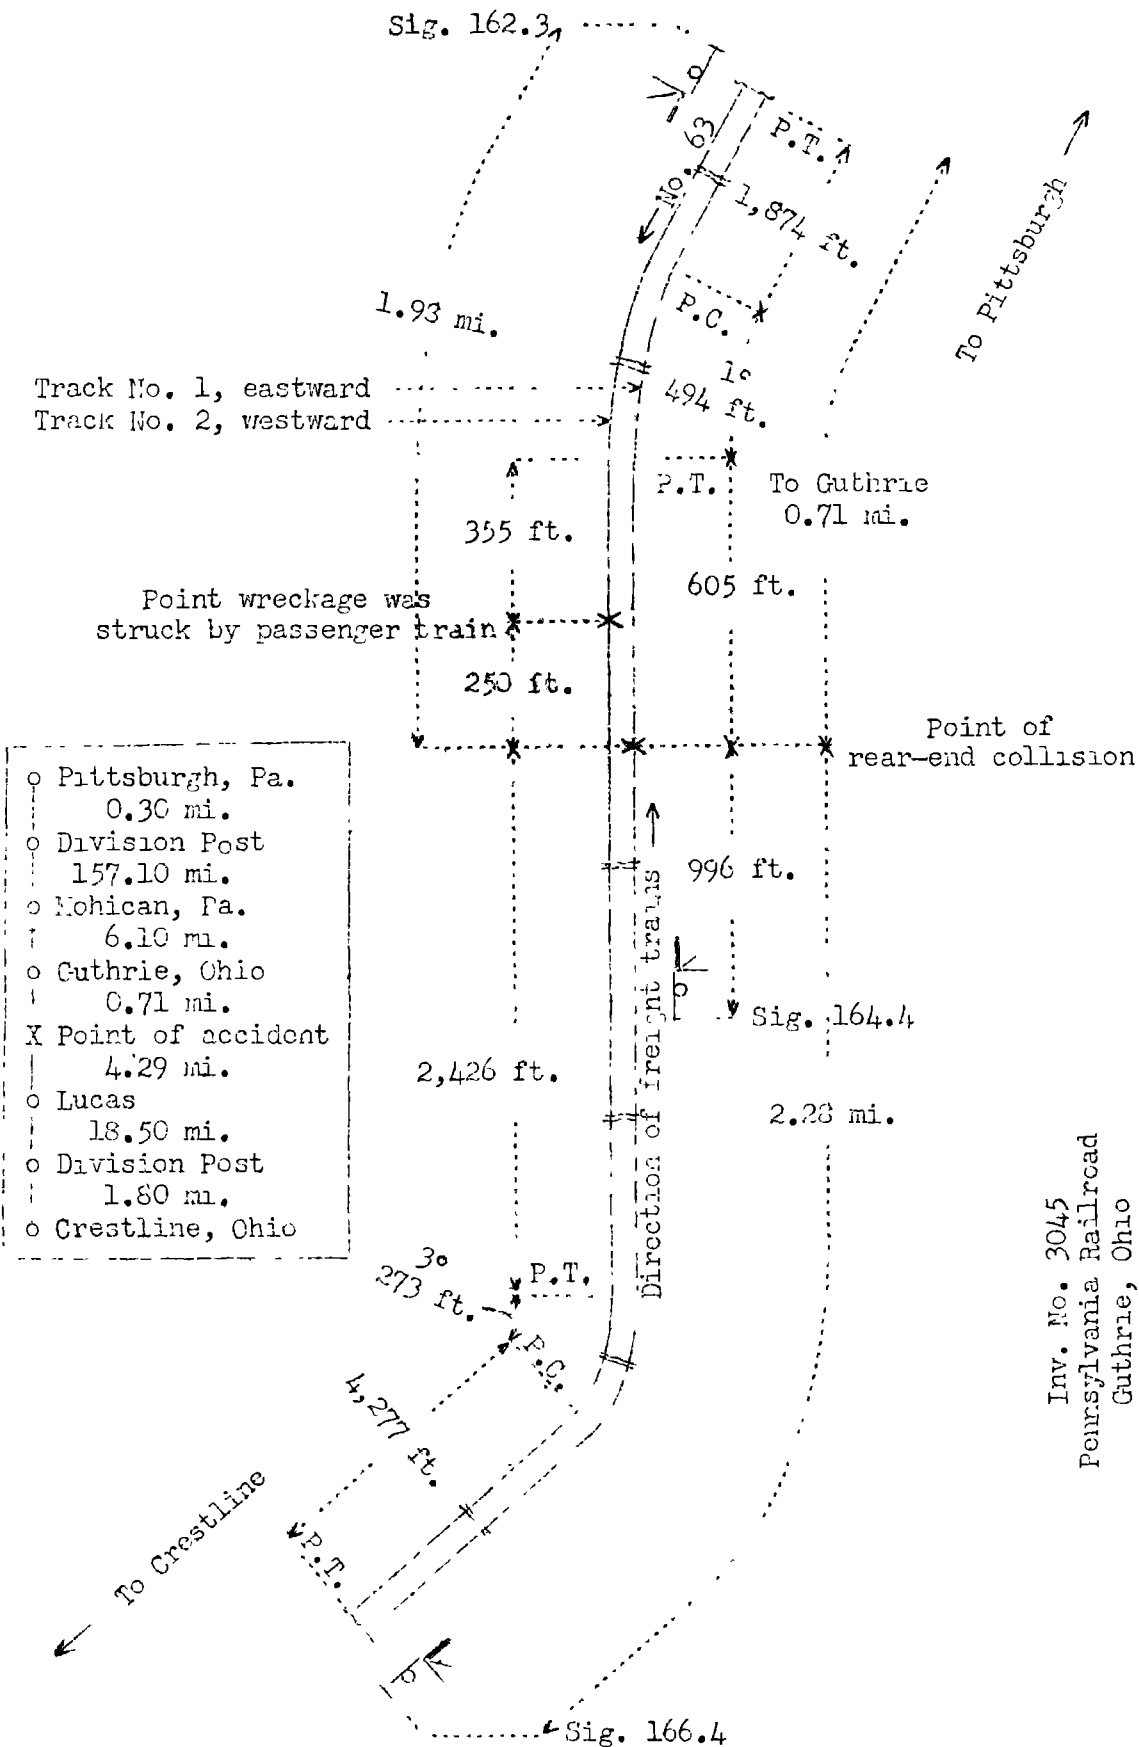
Inv. No. 3045  
 Pennsylvania Railroad  
 Guthrie, Ohio  
 December 13, 1946

Location of Accident and Method of Operation
