ACCIDENT ON THE
PENNSYLVANIA RAILROAD

IRVINETON, PA.

SEPTEMBER 9, 1940

INVESTIGATION NO. 2446

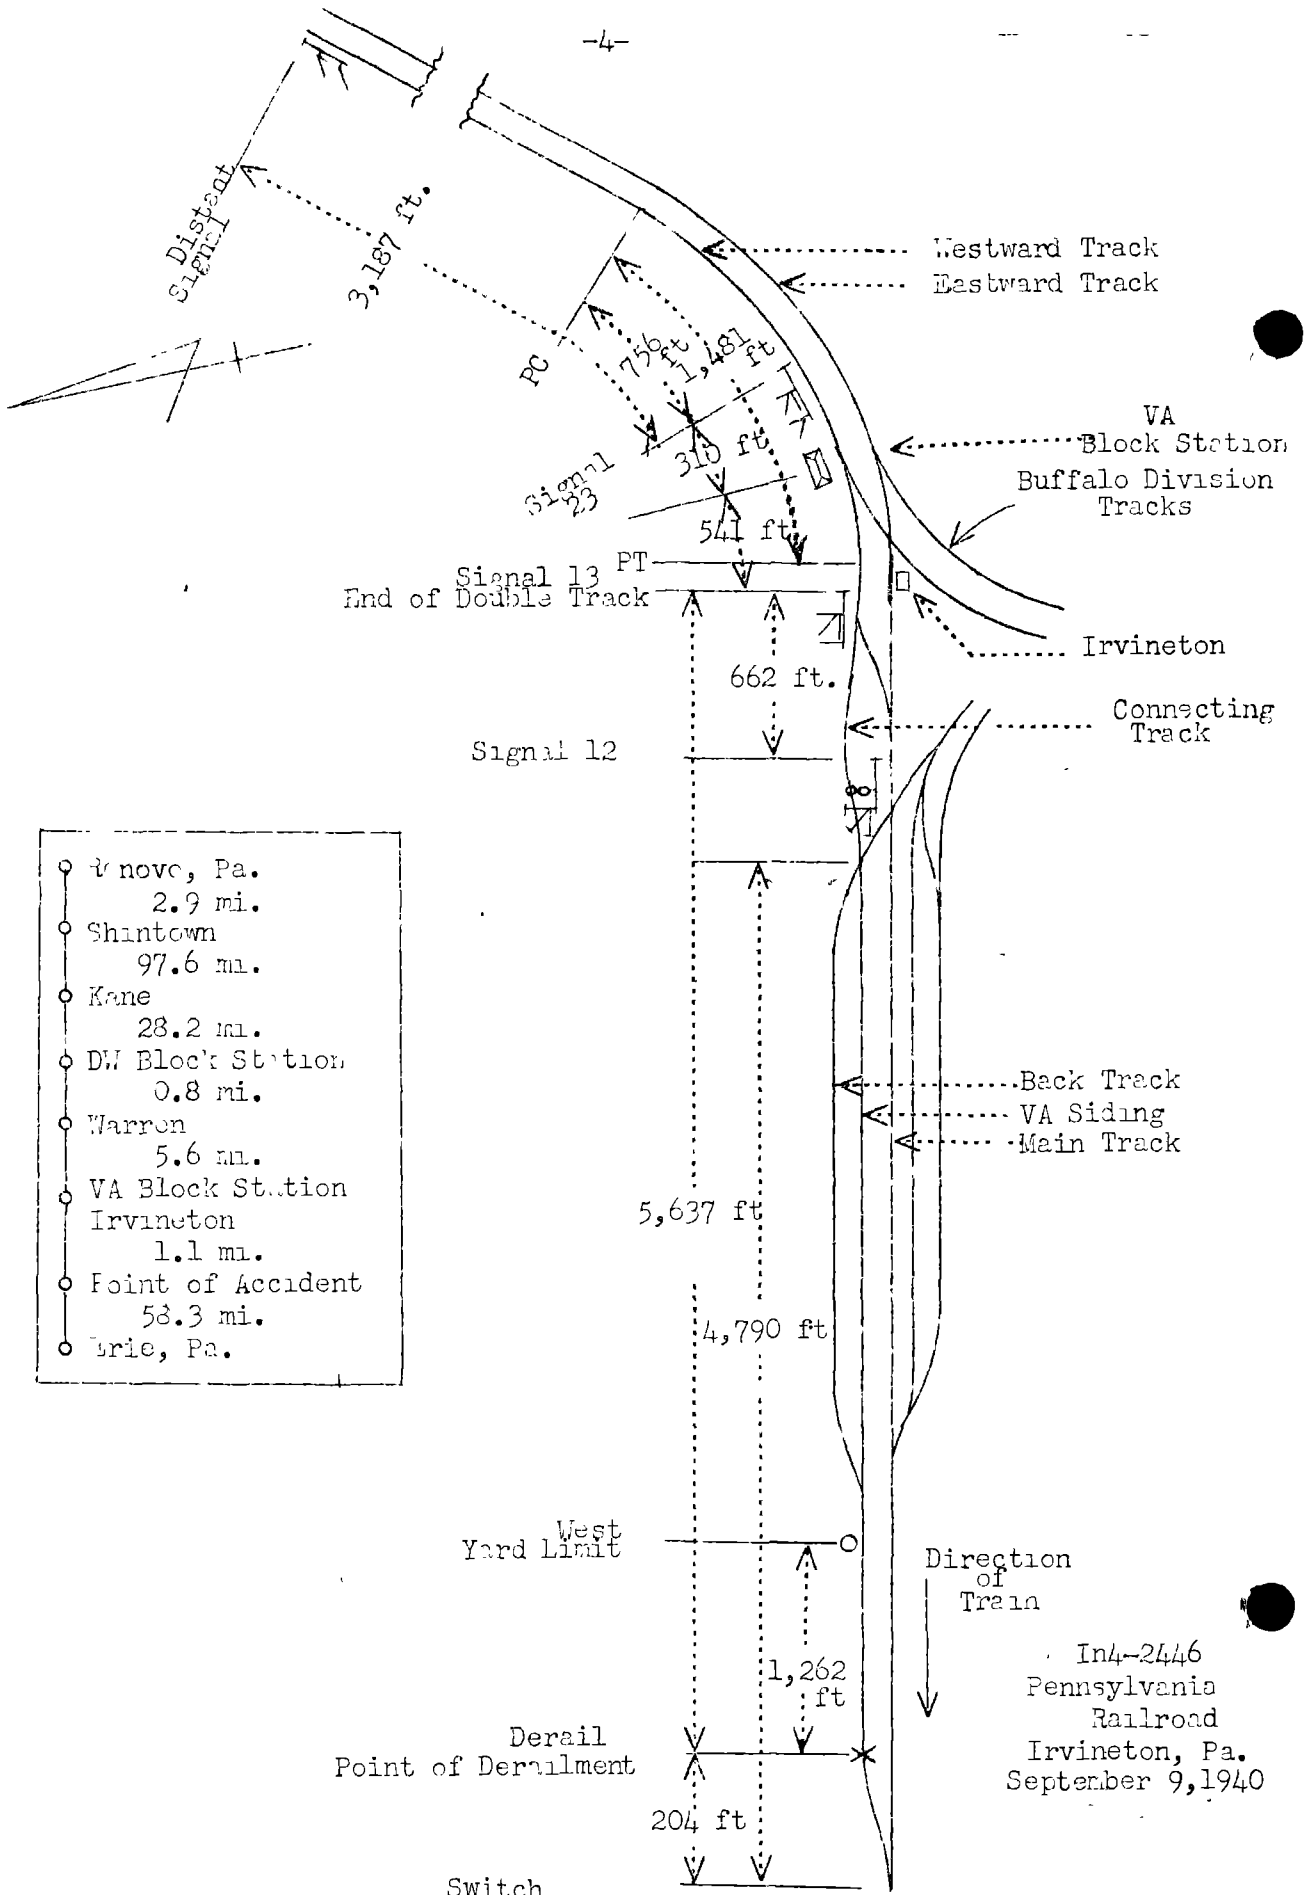
In4-2446
 Pennsylvania
 Railroad
 Irvineton, Pa.
 September 9, 1940

○	Uniontown, Pa.	2.9 mi.
○	Shintown	97.6 mi.
○	Kane	28.2 mi.
○	DW Block Station	0.8 mi.
○	Warren	5.6 mi.
○	VA Block Station	1.1 mi.
○	Point of Accident	53.3 mi.
○	Erie, Pa.

The interlocking signals involved and governing movements on the westward main track are a distant signal and home signal 23 located, respectively, 4,038 feet and 851 feet east of the end of double track and home signal 13 located at the end of double track. These signals are of the 2-arm, upper quadrant, semaphore type. The aspects and corresponding indications and names are as follows:

The westward manual block signal, signal 12, is located between the main track and the connecting track at a point 362 feet west of signal 13. It is a 1-arm, 3-position, upper quadrant, sema-
phore signal; it has a double marker and is mechanically operated from VA Tower. The aspects and indications displayed by this signal are as follows:
