REPORT OF THE DIRECTOR
BUREAU OF SAFETY

ACCIDENT ON THE
PENNSYLVANIA RAILROAD

KENNY, PA.

INVESTIGATION NO. 2347

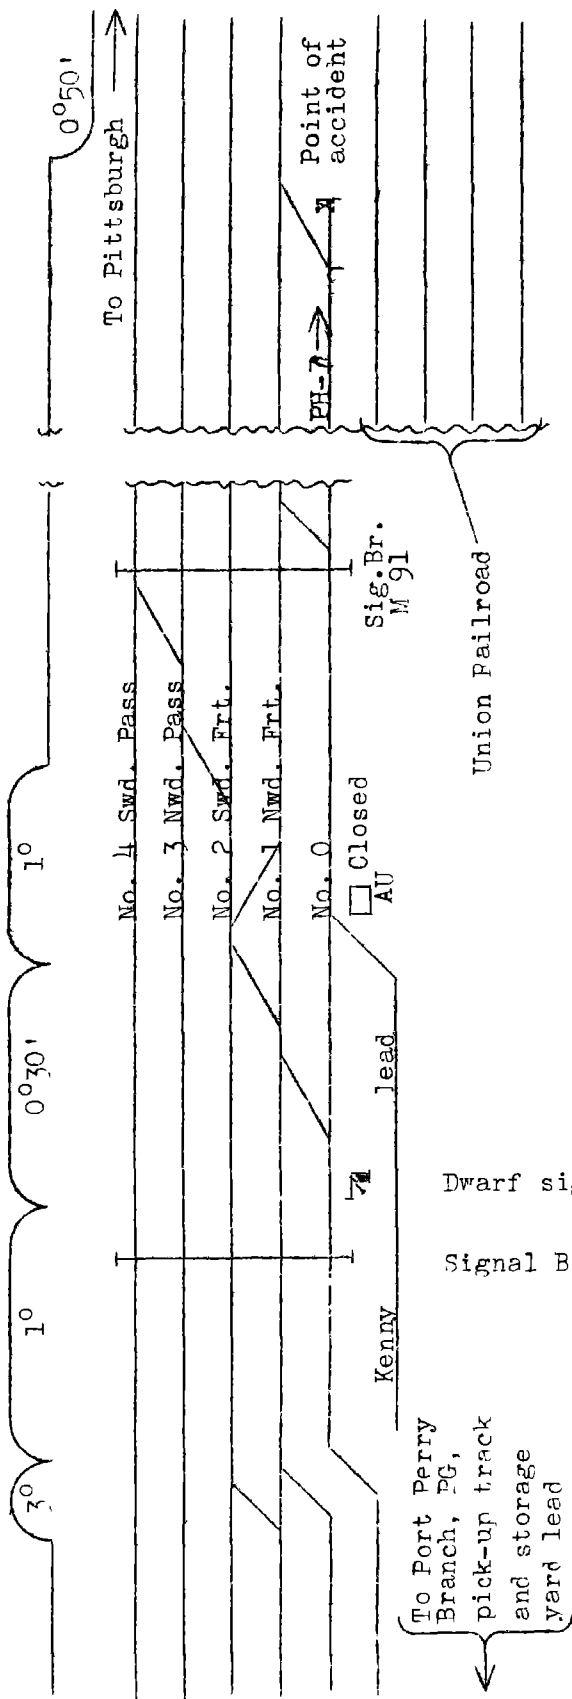
KENNY

(Pittsburgh, Pa.)
o Division Post
9.1 mi.
X Kenny (P. of A.)
0.8 mi.
o PG Block Station
51.8 mi.
o Ten Mile Run Jct., Pa.

Inv. No. 2347
 Pennsylvania RR
 Kenny, Pa.
 April 30, 1939

This accident occurred on that part of the Monongahela Division which extends between Division Post, Pittsburgh, and Ten Mile Run Junction, Pa., a distance of 61.7 miles. In the vicinity of the point of accident this is a four-track line over which trains are operated by timetable, train orders, and an automatic block-signal system; these tracks from east to west are numbered 1, 2, 3, and 4, No. 1 being the northward freight track. The accident occurred at the north end or stub end of a yard track known as track No. 0; this track is 7,993 feet long, parallels the main tracks on the east, and extends northward from the Port Perry Branch at PG Block Station, located 0.8 mile south of Kenny. Four tracks of the Union Railroad, on which tracks there are numerous switch lights, parallel track No. 0 on the east, making nine parallel tracks in the vicinity of the point of accident. Track centers of all nine tracks are spaced approximately 13½ feet apart. Approaching from the south on track No. 0 there is a compound curve to the right a distance of 2,058 feet, the curvature of the eastern portion varying from 0° 30' to 1°, a tangent 1,284 feet long, a 1° 15' curve to the right 586 feet in length, a tangent a distance of 648 feet, a 4° curve to the left 144 feet long and then a tangent 763 feet in length to the north end of track No. 0. The grade is descending northward a distance of 6,505 feet, varying from 0.01 to 0.39 percent, then it is 0.05 percent ascending a distance of 1,488 feet to the end of the track.
