REPORT OF THE DIRECTOR  
BUREAU OF SAFETY

ACCIDENT ON THE  
PENNSYLVANIA RAILROAD

LAWSONHAM, PA.

INVESTIGATION NO. 2282

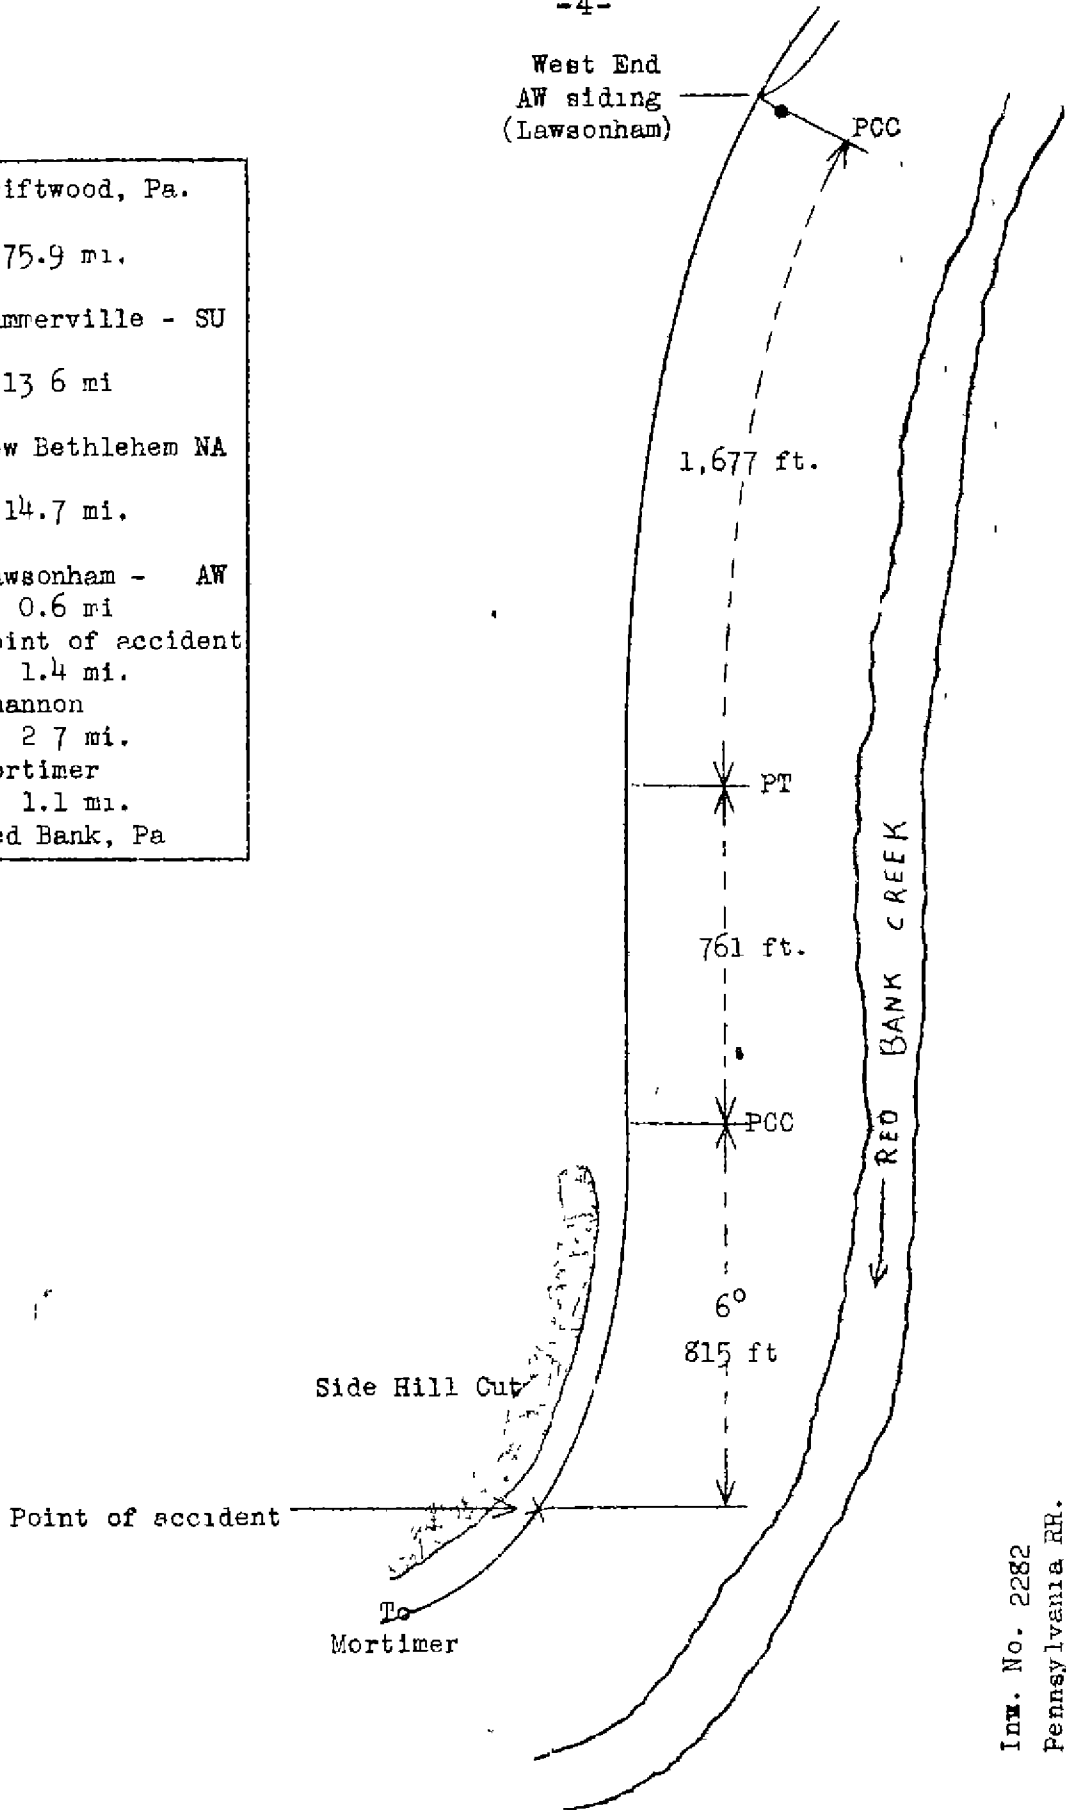
Inv. No. 2282  
 Pennsylvania RR.  
 Lawsonham, Pa.  
 July 21, 1938

○	Driftwood, Pa.	
		75.9 mi.
○	Summerville - SU	
		13.6 mi.
○	New Bethlehem NA	
		14.7 mi.
○	Lawsonham - AW	
		0.6 mi.
X	Point of accident	
		1.4 mi.
○	Shannon	
		2.7 mi.
○	Mortimer	
		1.1 mi.
○	Red Bank, Pa.

This accident occurred on the Low Grade Branch, Renovo Division, extending between Driftwood and Red Bank, Pa., a distance of 110 miles; in the vicinity of the point of accident this is a single-track line over which trains are operated by timetable, train orders and a manual block-signal system. The accident occurred at a point 3,253 feet west of the west switch of the siding at Lawsonham. Beginning at the switch, and approaching this point from the east, there is a compound curve to the left 1,677 feet long, then 761 feet of tangent, followed by a compound curve to the right 815 feet to the point of accident, this latter curve extending for more than a mile beyond and having a maximum curvature of 90°; a curvature of 60° existed at the point of accident. The grade is slightly descending westward.

In the vicinity of the point of accident the track is laid in a side-hill cut along the north bank of Red Bank Creek, approximately 35 feet above the creek bed; the hillside, which is heavily wooded, rises approximately 500 feet above the track level. Due to the dense underbrush on the hillside, and the height of the cut on the north or inside of the curve, the view of opposing trains is limited to approximately 200 feet.
